Zeitschrift: IABSE reports = Rapports AIPC = IVBH Berichte
Band: 73/1/73/2 (1995)
Rubrik: Session C3: General repair of buildings

General Repair of Buildings

Extending the Lifespan of the Architectural Heritage

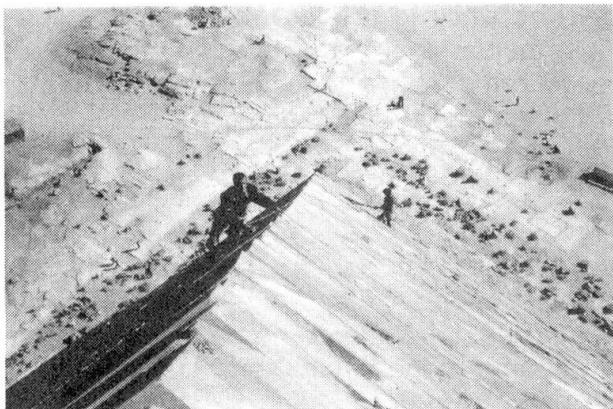
Fig. 1: The ascent of Chephren's Pyramid

On 17 November 1994, a scientific mission made an ascent of Chephren's Pyramid (Figure 1) to evaluate the role of temperature and wind in the decay of the stone and to assess the stability of some blocks that have been shifted by earthquakes in the past (Figure 2). On the one hand the survey contributed new and important elements for deeper understanding of the construction of the pyramid and, on the other, showed that, apart from the problem of weathering, no radical structural interventions were necessary, it being sufficient to add some supports in the same limestone to ensure the stability of blocks at risk.

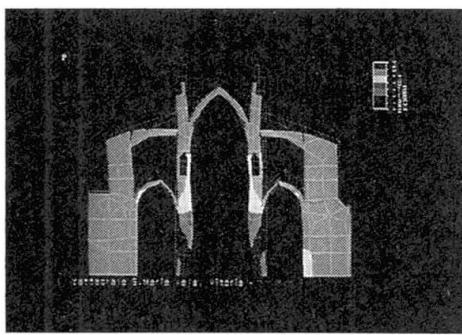
Fig. 5: Stresses and deformations where the buttresses were built before the vault

A general elastic finite element model was used to clarify first the scarce spatial cooperation in this kind of structures and, subsequently, the influence of the sequence of construction on the resulting stresses and deformations (Figures 5 and 6): the results obtained were found to correspond well with the actual state of the building (Figure 3). However, it was also necessary to carry out a non-linear analysis, taking into account the influence of the weakest zones, such as the triforium, and reductions in the resistant sections of the columns in order to define present safety levels in terms of ductility. The diagram in Figure 7 shows the equilibrium conditions in the middle section of the column, where the line "r" represents the resistant moment-curvature relationship and the line "a" is the external moment, taking account of the second order effects; the point "E" represents the equilibrium situation and the related curvature X is very close to the actual curvature measured. $AM\mu$ indicates the moment increment necessary to reach collapse, thus giving a very low real safety margin, especially taking into account possible errors in the evaluation of the limit deformations.

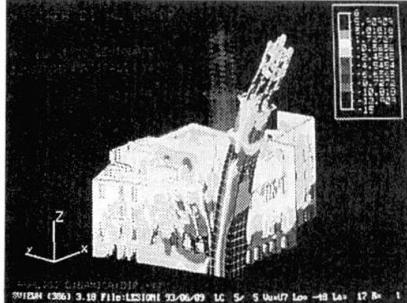
Fig. 15: Concentration of stresses and deformations revealed in a mathematic model

models (Figure 15) and direct observations, although the spontaneous cracks (Figure 16) automatically mitigate the seismic effects.

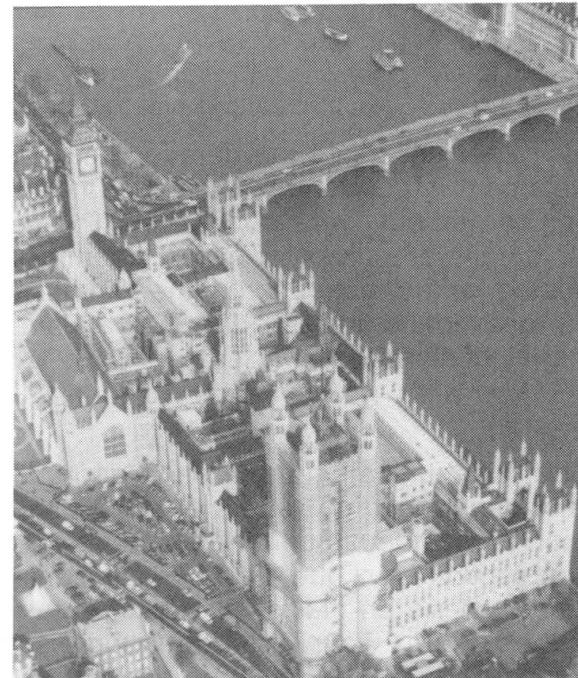
Fig. 1 The Houses of Parliament

Although Charles Barry was aware that the polluted air from coal burning in Victorian London had a severe effect on stone buildings, the stone he chose was a magnesian limestone from Anston in Yorkshire. It carved well and could be supplied in blocks up to 1300mm thick, but stone decay was apparent even before the building was completed. The surface of the stone was eroded over the decades and by 1926 some 200T of loose fragments had been handpicked, denuding much of the rich decorative carving. Because the stone was not marked at the quarry so that it could be laid in its natural bedding plane exfoliation occurred where stones were laid with the bed parallel to the surface of the masonry. A programme to restore some of the most noticeable defects was begun in the 1930s but it was interrupted by the second world war. Clean air legislation of the 1950s eliminated the smoke, smogs and airborne acidity caused by coal burning, so the rate of decay reduced and buildings which had been cleaned then remained clean.

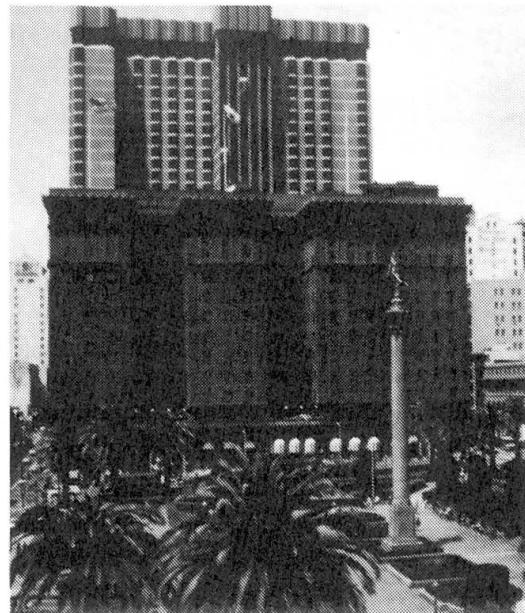
Figure 1 - St. Francis Hotel

In 1987, a condition survey of the entire sandstone facade was made from swing stages, and the condition of over 30,000 stones was recorded. The condition of each stone was recorded on scaled building elevations prepared using rectified photography. During the survey, loose pieces of stone were removed and stainless

steel anchors were installed to alleviate immediate hazards. Four years later, selected areas were resurveyed to evaluate the progress of the sandstone deterioration and to set priorities for the repairs.

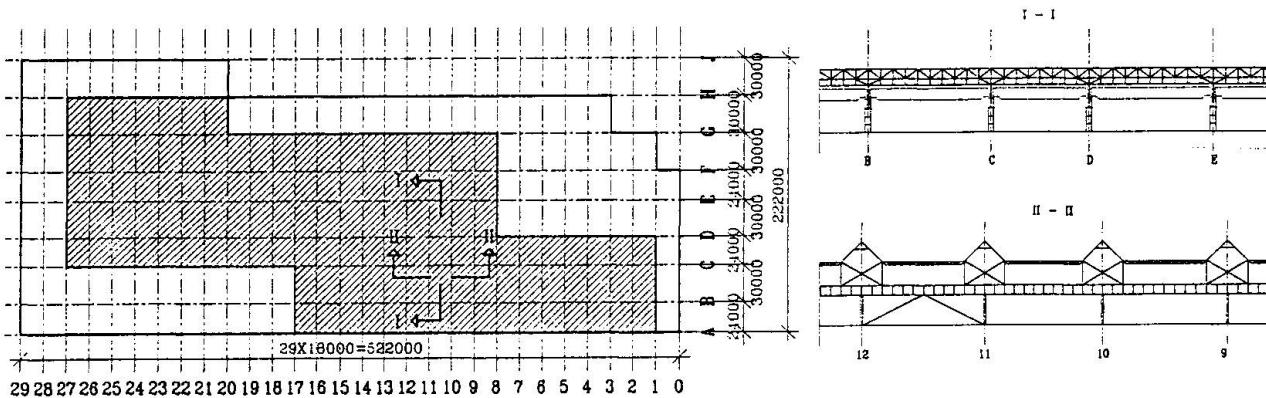
Fig. 1 Plan view and sections of the industrial building

The plan view and the sections of the industrial building (first stage is shaded part of plan drawing), having unite total useful area of 104.241 sq.m and structural steelwork of total weight 17.000 t, is given in Fig. 1.

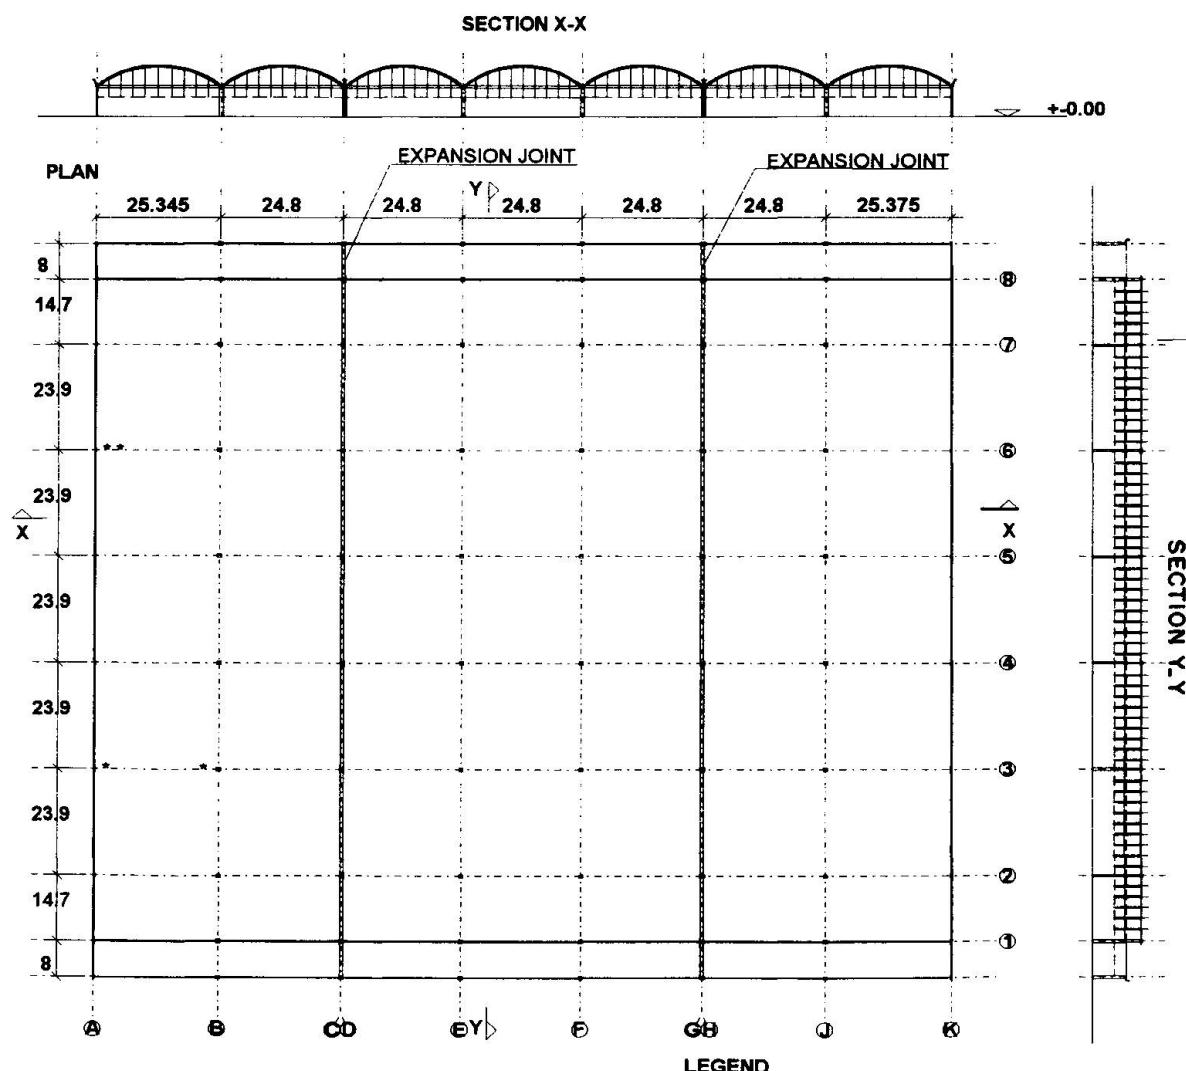
Fig. (1)

A prestressed concrete shell 164.9 x 173.9 m. for a spinning mill that was constructed and later repaired by "The Misr Concrete Development Co.". The roof consisted of concrete shell 7 to 25 cm. thickness supported on truss diaphragms with post tensioned tie beams in the longitudinal direction and on valley beams in the short direction. There was also a concrete flat plate slab hanging from the shell roof by high tensile steel bars. The shell was supported on 64 columns hinged up and down as link members and 16 fixed columns on axes 7 and 8. The mill foundations were supported on piles. Fig.(1).

• • Totally damaged tie beam
 • Partially damaged tie beam

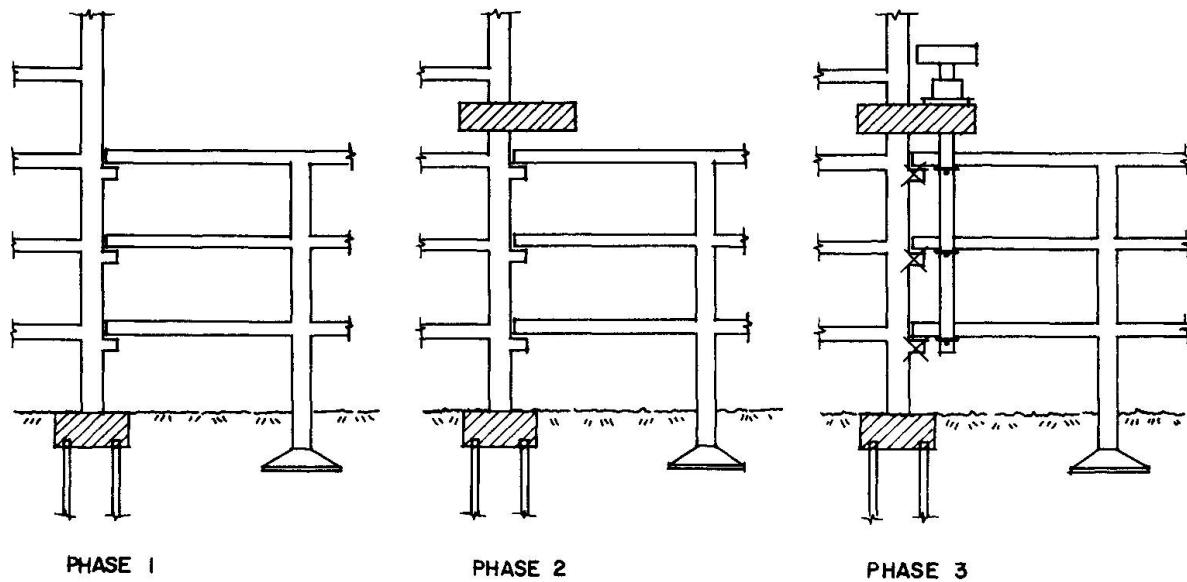
Fig 2 Construction sequence of the solution

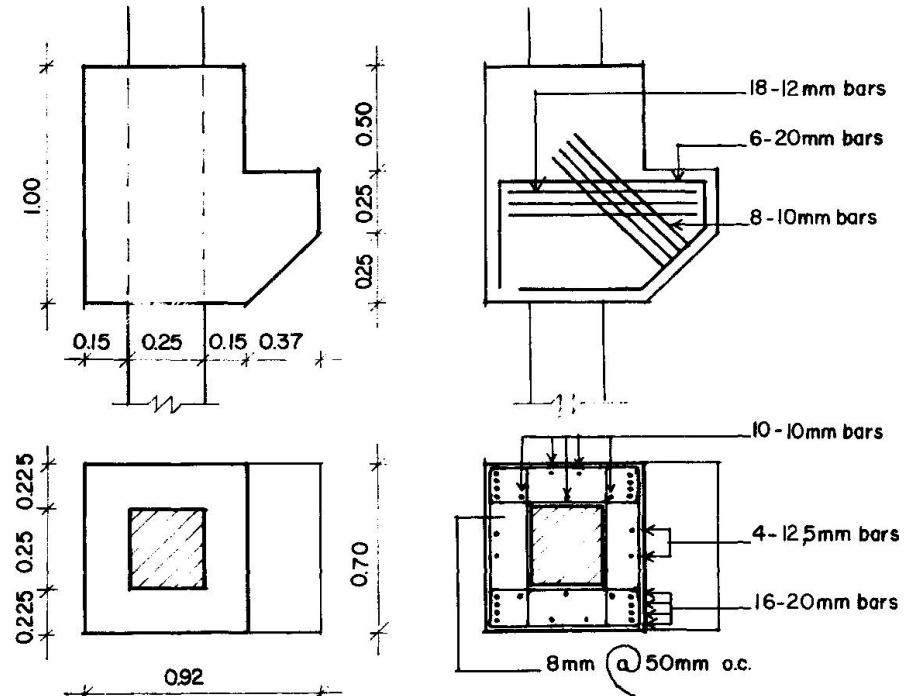
The principal effect of the solution is on the reinforced concrete frame of the tower. The structure system should be able to resist to the new load distribution with safety. The maximum tie load is 266 kN. Loads are applied symmetrically to the frame at the 4th floor, when originally they are distributed along the lower floors. The structure was calculated to this new stage of loading and found adequate to support it. The new consols in turn of the tower's columns were designed using the provisions in the Reinforced Concrete Brazilian Code (1) to $f_{ck} = 15$ MPa. Epoxy was used to bond the external encasement and the surrounding concrete. A summary of the detail is given in Figure 3.

Fig. 3 Dimension and reinforcement of the consol

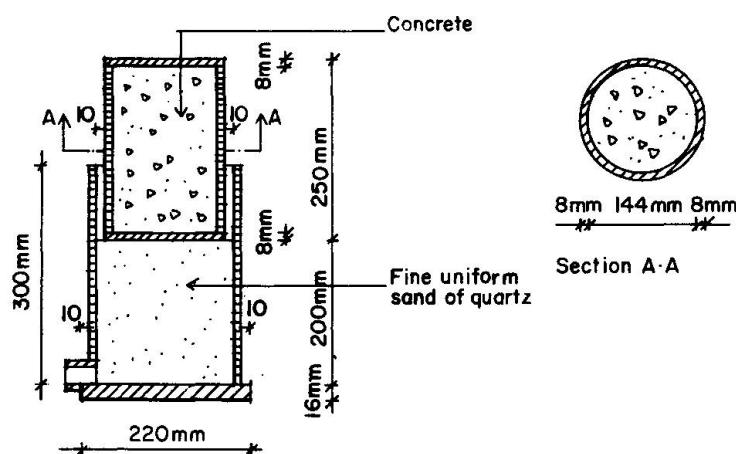
Figure 4 gives detail of the sand jack. Its 160 mm diameter piston should get out an extension of 150 mm which is the settlement predicted to be compensated along time. The cylinder below has an internal diameter of 180 mm. It is filled in by fine sand of quartz with uniform grain-size and pre-loaded to 350 kN. This load is higher than the maximum one to be transmitted by the tie system. The device has two little holes at the bottom. The sand takes out smoothly using a thin steel pointer through them. Two lateral defletometers measured the descent up to the value of the settlement to be compensated. Laboratory tests permitted to define the procedures to assure an even lowering of the piston. The field operations proved to be the sand jack a practical, simple and safe device to lower the conceived system.

Fig. 4 Detail of the sand jack

In the meantime, the sand jacks were removed once. In some jacks, their pistons had got the final course. In others, the strong confinement of the sand avoided its remotion during relaxation. The jacks were repaired and turned back to the tie system.

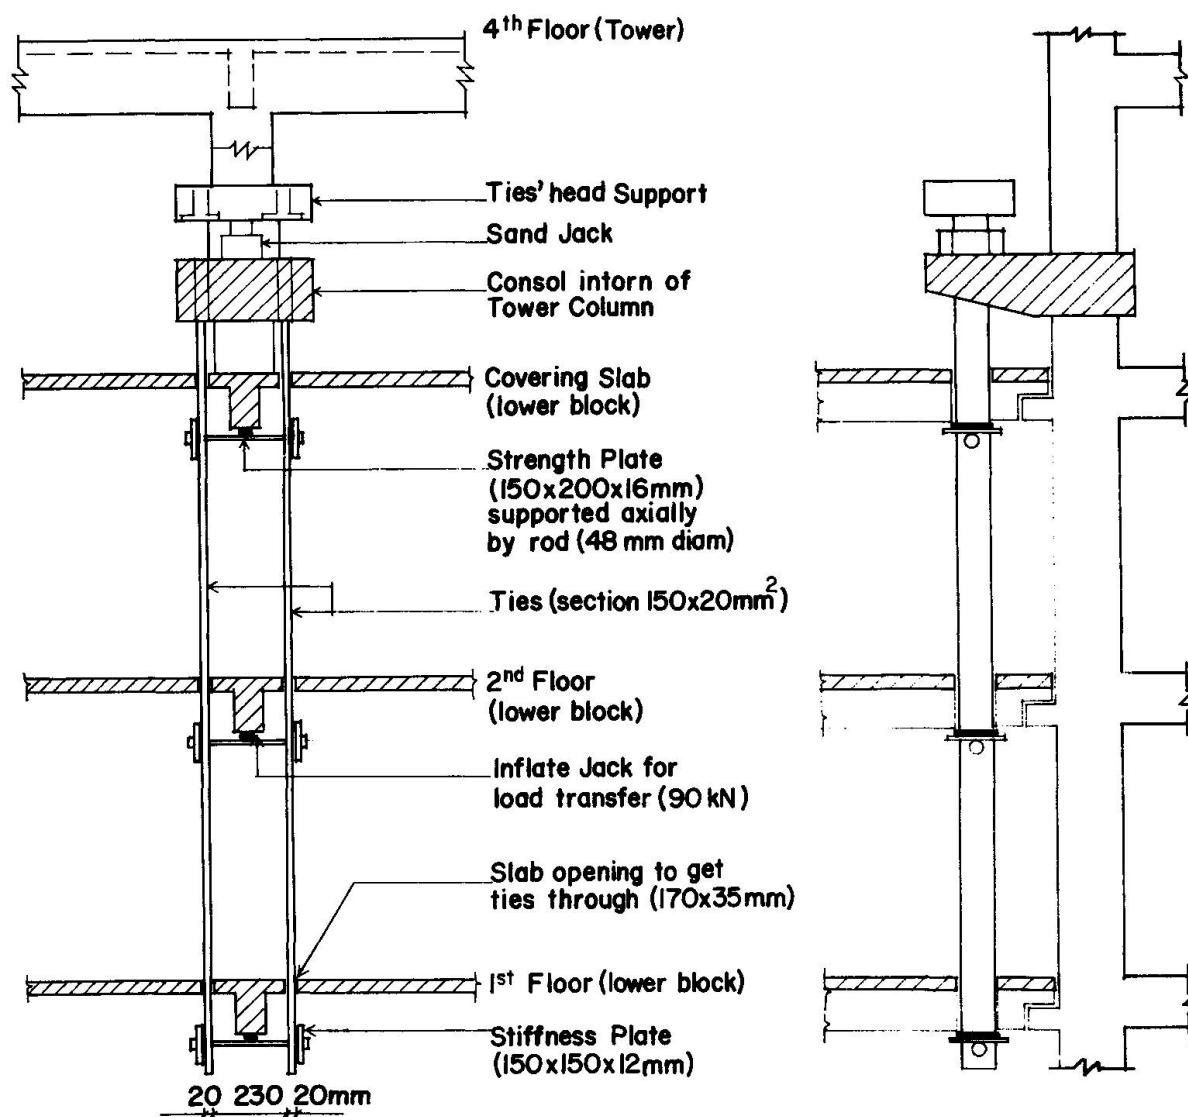
Rigid ties were used instead of cables having intermediate supports to receive the beams. The transfer of the beam's load from the fix consols to the tie should be made by parts, starting from the top beam to the one down, with the use of inflate jacks put at the contact between the beam and its support in the tie. Epoxic resin was used as fluid. In each level, the load transfer was made symmetrically in order to assure the load equilibrium at the central tower.

The system is shown in Figure 5. All parts of it as splice, hook, bolt, welding, connection, etc. were tested to failure. The system's details should facilitate the anticipated construction sequence, including provisions for its erection and descent, installation through openings made at the existing structure, change of the sand jacks, space to operate them and the placement of inflate jacks to support the beams. Finally, load test made at each installed tie system determined the load transferred by each beam using strain gages fixed on the ties.

Fig. 5 Tie device to compensate settlement

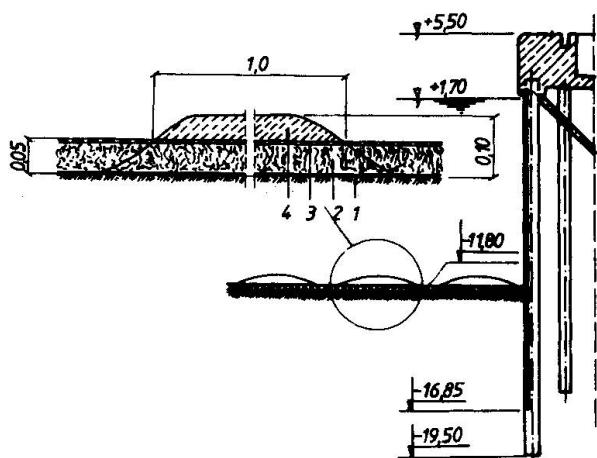
Fig.1 Bottom protection using geotextiles [2]: 1-woven textile, 2-geomembrane with sand, 3-reinforcing geotextile, 4-mortair

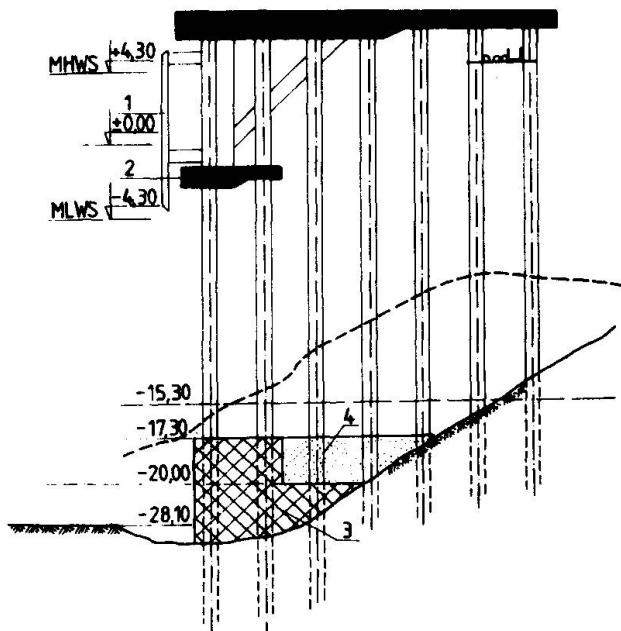
Fig.2 Strengtheing of an existing jetty through a submerged retaining wall [5] 1-main fender, 2-concrete fender tray, 3-concrete retaining wall, 4-soil refill

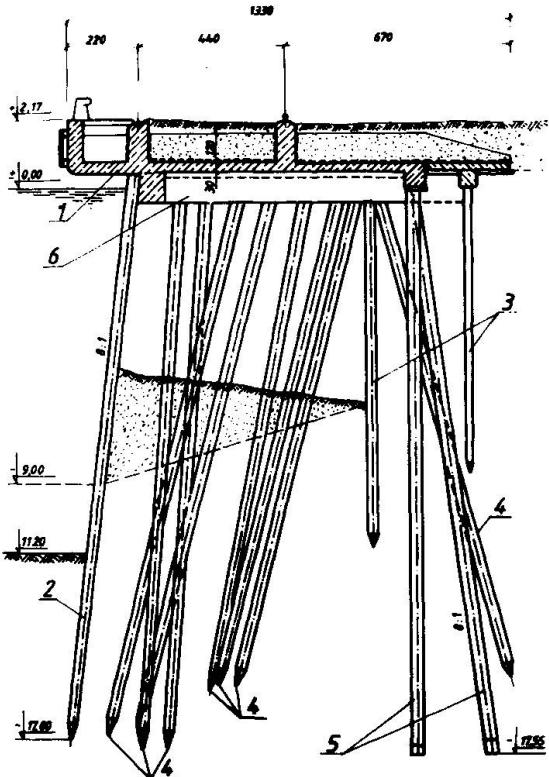
The first solution (Fig.3) [3] was adopted for the reconstruction of the Ore Terminal in the Harbour of Gdańsk. In the first phase the existing structure was equipped with a new crane connected with the construction of a new crane truck; in the second phase the construction of a new coping slab supported by the old structure and new prefabricated reinforced concrete sheet wall was made. The reconstruction allowed to increase the depth at the structure from 8.0 to 11.5 m and to load it by two crane tracks, one railway track and surcharge of 30 kN/m^2 .

Fig.3 Reconstruction of the Ore Terminal berthing structure in Gdańsk [3]: 1-new reinforced concrete slab, 2-concrete sheet wall, 3-existing timber sheet wall, 4-existing timber piles, 5-concrete piles, 6-existing concrete slab with reduced thickness

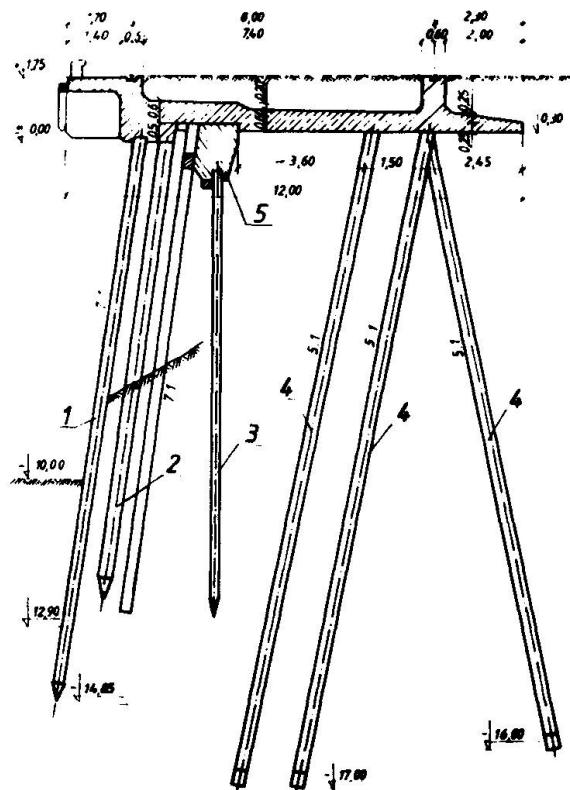
In the second case, concerning the berthing structure of the Vistula Terminal in Gdańsk (Fig.4) [3], the existing structure consisting of anchored timber sheet wall was used to decrease the influence of earth pressure and to support partially the new coping slab. An increase of the depth of 4.0 m was reached while the loadings from cranes through constructed crane tracks were allowed.

Fig.4 Strengthening of the berthing structure of the Vistula Terminal in Gdańsk [3]: 1-concrete sheet wall, 2-existing timber piles, 3-existing timber sheet wall, 4-concrete piles, 5-existing concrete coping beam

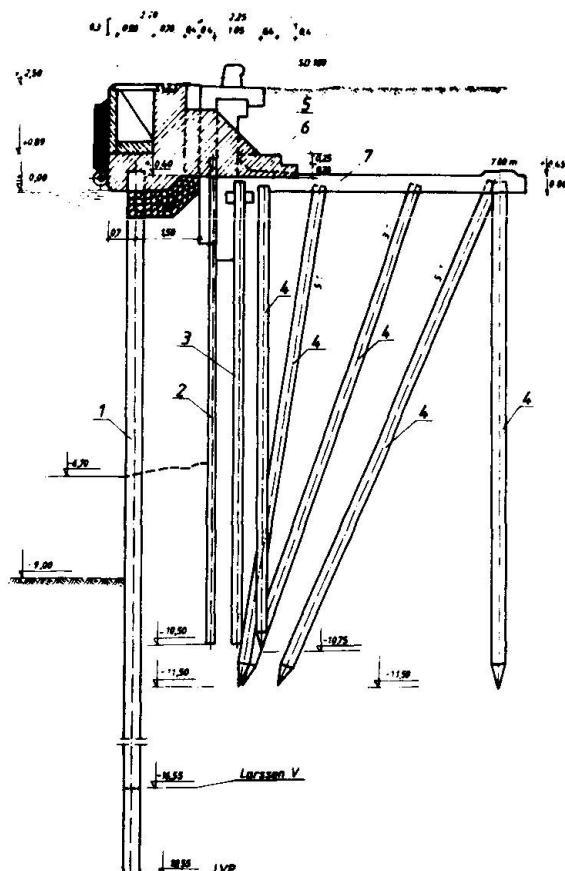
The third solution (Fig.5) [3] was introduced for the strengthening of the Swedish Quay in the Harbour of Gdynia. The reconstruction (increase of depth, new installations, new cranes) was made by driving in the front at a distance of 1.5 m a steel sheet wall of Larssen V type, strengthened by box piles LVP. The space between the existing and new sheet pile wall was filled by compacted sand while the new upper structure was used to connect and anchor the new structure with the old one.

Fig.5 Strengthening of the Swedish Quay in Gdynia [3]: 1-steel sheet wall Larssen V strengthende with box type piles LVP, 2-existing timber sheet wall, 3-steel sheet wall, 4-timber piles, 5-longitudinal anchoring beam, 6-transverse anchoring beams, 7-existing cover plate

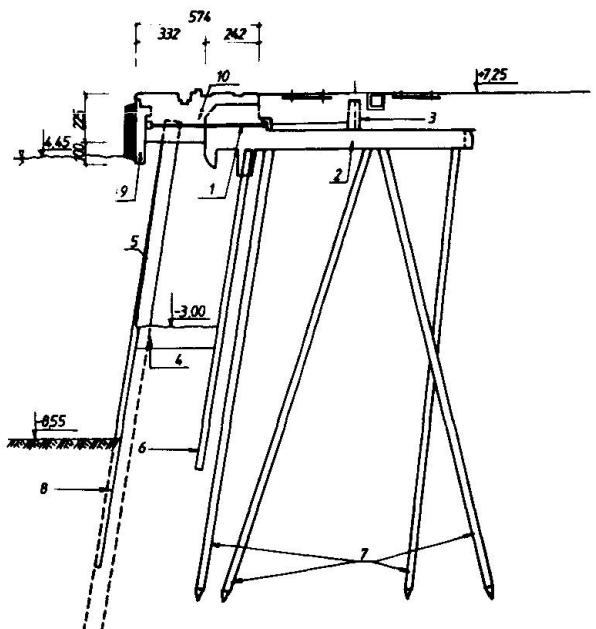
The last case (Fig.6) [4] concerns a structure consisting of a new inclined sheet piling wall, driven in front of the existing structure and attached to the remainder of the old structure by prestressed anchors. The bottom at the previous seabed level is secured by an underwater concrete plug. The strengthening of the existing berthing structure allows on the increase of the depth from -7.0 m to -12.5 m. The front wall is a combined HZ-steel wall in which the Z-sheets are driven from the level -3.5 m to -14.5 m.

Fig.6 Cross-section of the strengthened berthing structure [4]: 1-prestressed anchor, 2-existing cover plate, 3-new crane-rail beam, 4-concrete, 5-H-piles, 6-existing BZ-sheet piling, 7-existing concrete piles, 8-Z-sheets, 9-prefabricated element, 10-new head beam.
