Zeitschrift: IABSE reports = Rapports AIPC = IVBH Berichte
Band: 73/1/73/2 (1995)
Rubrik: Session A1: General repair of bridges I

Session A1

General Repair of Bridges I

Strengthening of the 120-Year-Old Substructure of a Railway Bridge

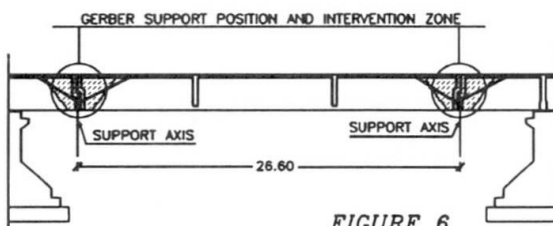
FIGURE 6

(photo n. 4-5). The seat of the supported beams - which is further restricted by degradation - is so reduced as to cast doubt on the stability of the beams. Weathering has also removed the concrete bar covering in many areas of the decks, particularly on the west side, towards the coast. A detailed program of in situ tests (pull-out tests, carbonation tests, microdrilling and sampling of concrete, endoscopic tests, etc.) on the structure was carried out to evaluate the actual state of alteration of the material, their strength and the efficiency of the supports apparatus.

The principal objective of the intervention was to improve the seismic behaviour of the structure by creating a continuous kinematic chain between the various spans so as to transfer the horizontal actions to special purpose-built structures. In consideration of the state of the Gerber joints, it was decided to demolish these parts of the structure (figure 6) and rebuild them along more suitable geometric lines in order to ensure an adequate seat to the support, insert the bearing devices and accomplish the continuity of the structure by consolidating the upper slabs. The new structure was realized in Rheoplastic high-strength concrete connected to the remaining parts through connecting bars (figures n. 7-8). The supports on the piers were removed, after lifting the decks alternately, and replaced by mobile

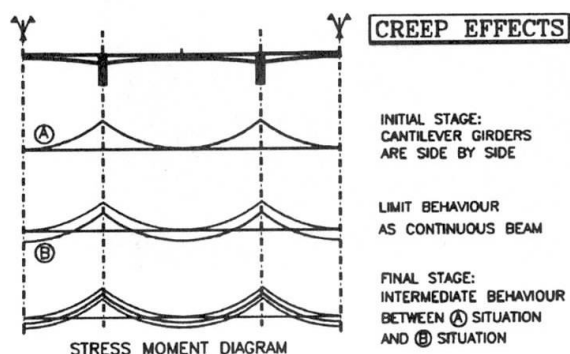
FIGURE 12

The phenomena observed are related to creep processes that cannot easily be predicted at the design stage. On account of the construction method, based on a cantilevered section-by-section procedure that involved building a structure with provisional boundary conditions that differed from the final ones, the creep effects have produced a redistribution of the stress for permanent loads and, in particular, an increase in positive bending moments in the middle of the spans and a reduction near the piers (figure 12). The individual sections of the cantilevers were poured in different stages, with non-homogeneous pouring and weathering conditions, so that they presented different creep functions. Even minor uncertainties in calculating the dead or prestressing loads could also have led to considerable variations in the creep deformations, bearing in mind the effective reciprocal influences between the creep and the steel relaxation of the prestressing cables. Another factor that should be considered is the possible effect of the insertion of provisional hydraulic jacks in the middle of the central span, which may have partially compensated the creep deformations of the third span, jeopardizing the second and fourth spans.

The strengthening measures were designed to enhance the bending and shear strength of the deck and consisted in inserting prestressing cables in the lower part of the section in the middle of the

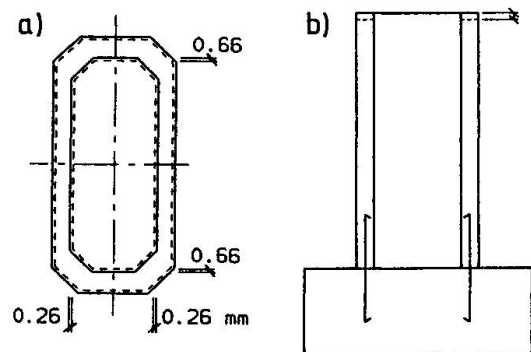
Fig. 6 Horizontal and vertical movement requirements for the surrounding concrete.

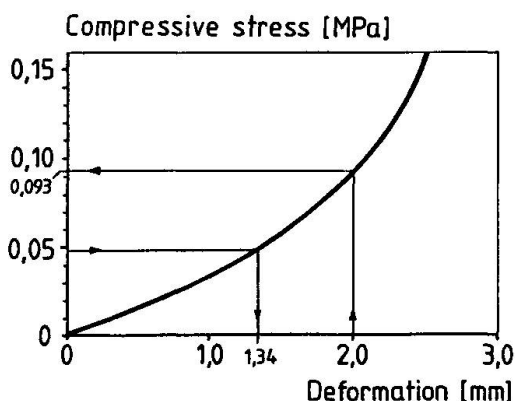
When the concrete rising rate is 0.6 m/hour there is a concrete pressure of 0.048 Mpa from 2 m concrete before setting. Fig. 7 shows that this corresponds to a compression of 1.34 mm. Cooling and shrinkage need, according to Fig. 6, a 0.66 mm movement requirement, in all 2.0 mm. When the sliding layer is compressed 2.0 mm against the pier side a counter pressure of 0.093 Mpa will occur according to Fig.7. According to Fig. 8 the tensile stress p in the long sides of the surrounding concrete is

Fig. 7 Measured working curve for a sliding layer with a cellular plastic layer.

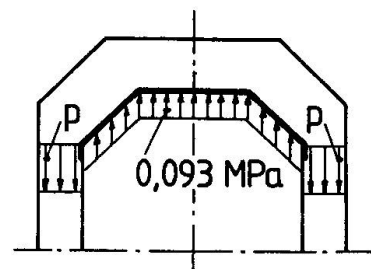
$$p \cdot (0.4 + 0.4) = 0.093 \cdot 2.0 \quad \text{I.e. } p = 0.23 \text{ Mpa}$$

The concrete reaches a tensile strength which is higher than this tensile stress after less than 1 day. Accordingly, it will not crack.

Fig. 8 Tensile stresses in the long sides of the surrounding concrete.

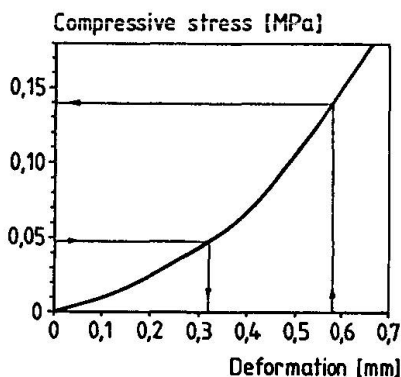
The concrete pressure is according to the previous chapter assumed to be 0.048 Mpa. Fig. 9 shows that this corresponds to a compression of 0.32 mm. Cooling and shrinkage require according to Fig. 6 a movement need of 0.26 mm, in all 0.58 mm.

Fig. 9 Measured working curve for a 3.2 mm thick sliding layer on the long sides.

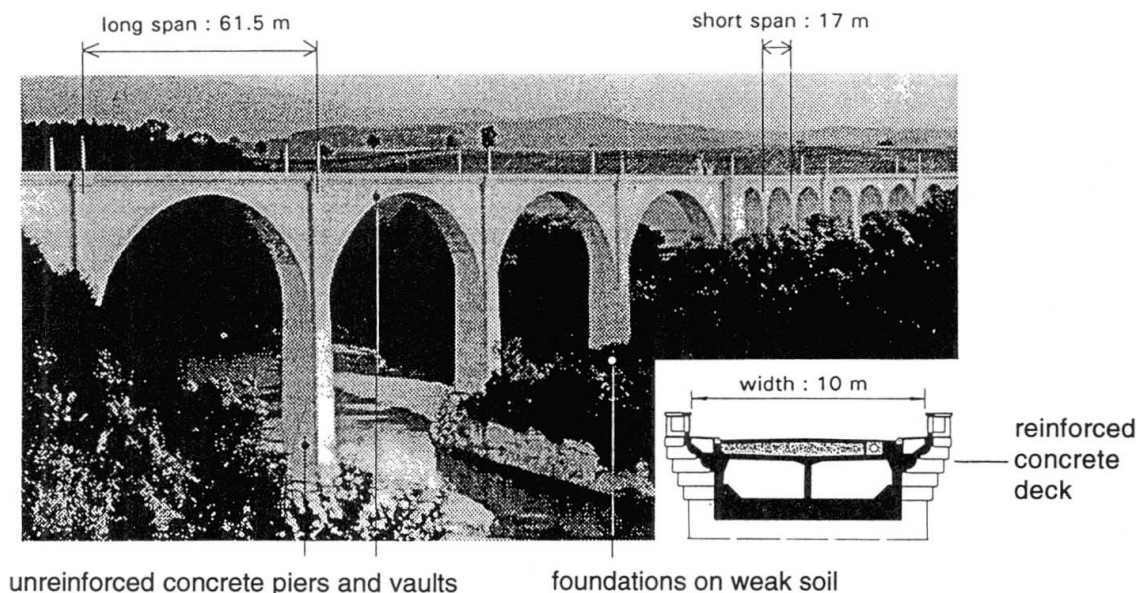
Figure 1 : Main features of old bridge

A detailed inspection of the bridge revealed severe degradation of the deck slab. The bridge had reached the end of its lifespan and consequently the deck slab had to be replaced.
