**Zeitschrift:** IABSE reports = Rapports AIPC = IVBH Berichte  
**Band:** 73/1/73/2 (1995)

**Rubrik:** Session A1: General repair of bridges I

## Strengthening of the 120-Year-Old Substructure of a Railway Bridge

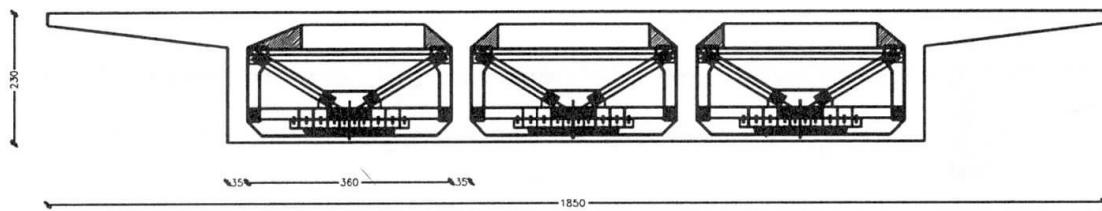
FIGURE 14

CROSS SECTION IN THE MIDDLE OF THE 2<sup>nd</sup> AND 4<sup>th</sup> SPAN

some cables are continuous from the first pier-head to the last, whilst others have only the length of one of the lateral spans. The only deviation device inside the box-girder, at midspan level (figure 14), consists of a steel frame connected to the ribs of the caisson to which the cable was connected after tensioning, so as to ensure continuity to the transversal section. Three devices were used for each span, one for each of the three cells of the box-girder. The frames were assembled with steel profiles and plates connected by high-strength bolts in order to allow transport and the mounting inside the box-girder. A horizontal strut with St. Andrew's crosses was provided in order to resist to the friction component of the prestressing forces. The work was successfully carried out without restriction traffic and restored about 10% of the previous deformations. The increase in safety levels was assessed at around 30%. Thus the measures adopted significantly increased the durability of the structure by closing the cracks caused by creep. The load test performed on the bridge on completion of the work also showed an increase of the overall stiffness of the whole structure of about 20%.

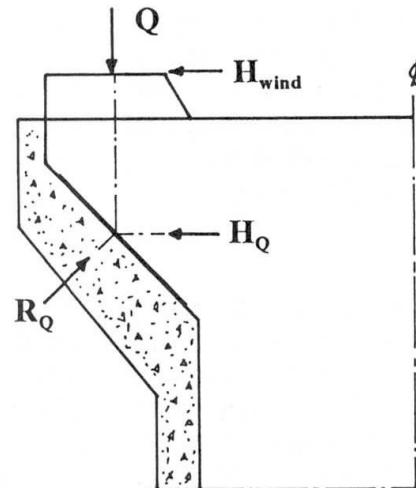
Fig. 2 Loads on pier top and reaction transferred to surround concrete structure below cantilevered beam.

The load  $Q$  from the bridge bearing (Fig. 2) is transferred in the inclined contact surface. The reaction  $R_Q$  is carried by reinforcement in the concrete walls in the direction of the force. The reaction  $H_Q$  is a compressive force in the old concrete pier. Epoxy injection into the slit under the inclined surface of the cantilevered beam means that there is contact against the new surrounding pier. The injection is carried out not earlier than half a year after casting when most of the long time deformations have occurred. The rest of the surround concrete structure is separated from the old pier by a sliding layer based on asphalt. Fig. 3 shows the suspension reinforcement in the cantilevered beam.

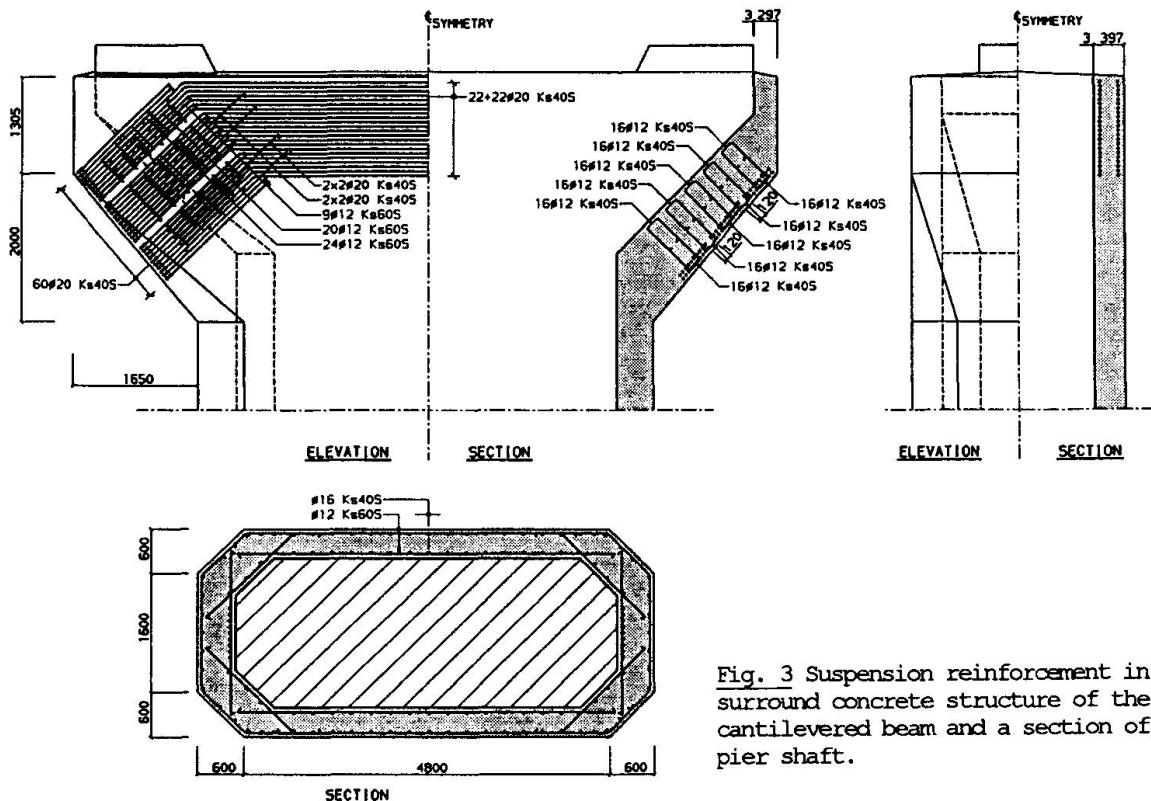
Fig. 3 Suspension reinforcement in the surround concrete structure of the cantilevered beam and a section of the pier shaft.

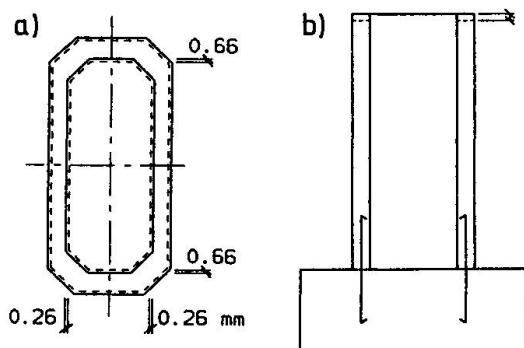
Horizontal movement requirements (Fig. 6a)

Vertical movement requirements (Fig. 6b)

Fig. 6 Horizontal and vertical movement requirements for the surrounding concrete.

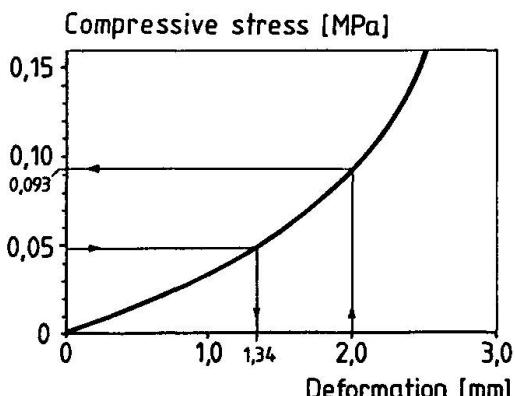
When the concrete rising rate is 0.6 m/hour there is a concrete pressure of 0.048 MPa from 2 m concrete before setting. Fig. 7 shows that this corresponds to a compression of 1.34 mm. Cooling and shrinkage need, according to Fig. 6, a 0.66 mm movement requirement, in all 2.0 mm. When the sliding layer is compressed 2.0 mm against the pier side a counter pressure of 0.093 MPa will occur according to Fig. 7. According to Fig. 8 the tensile stress  $p$  in the long sides of the surrounding concrete is

Fig. 7 Measured working curve for a sliding layer with a cellular plastic layer.

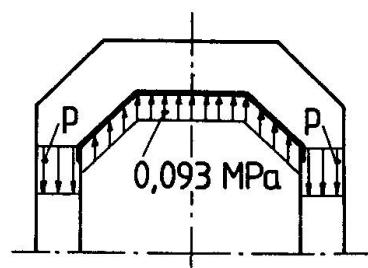
$$p \cdot (0.4 + 0.4) = 0.093 \cdot 2.0 \quad \text{I.e. } p = 0.23 \text{ MPa}$$

The concrete reaches a tensile strength which is higher than this tensile stress after less than 1 day. Accordingly, it will not crack.

Fig. 8 Tensile stresses in the long sides of the surrounding concrete.

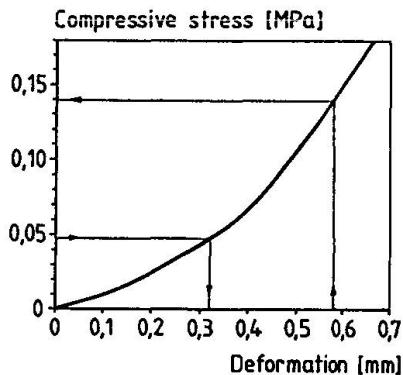
The concrete pressure is according to the previous chapter assumed to be 0.048 MPa. Fig. 9 shows that this corresponds to a compression of 0.32 mm. Cooling and shrinkage require according to Fig. 6 a movement need of 0.26 mm, in all 0.58 mm.

Fig. 9 Measured working curve for a 3.2 mm thick sliding layer on the long sides.

When the sliding layer is compressed 0.58 mm against the pier side a reaction pressure of 0.139 MPa will occur according to Fig. 9. The tensile stress  $p$  in the short sides of the surrounding concrete is according to Fig. 10

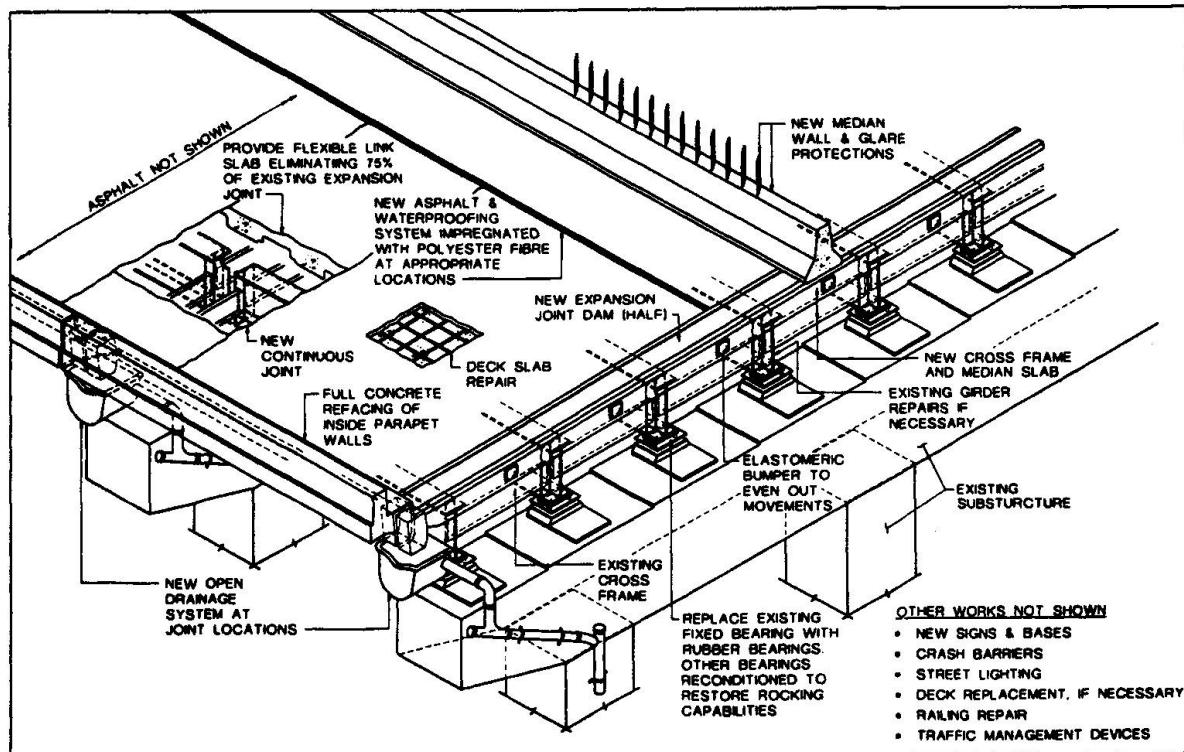
Figure 2 - General Deck Rehabilitation Scheme

3.5 Some of the above design details can be found in [4]. A general view of the repair scheme is shown in Figure 2.

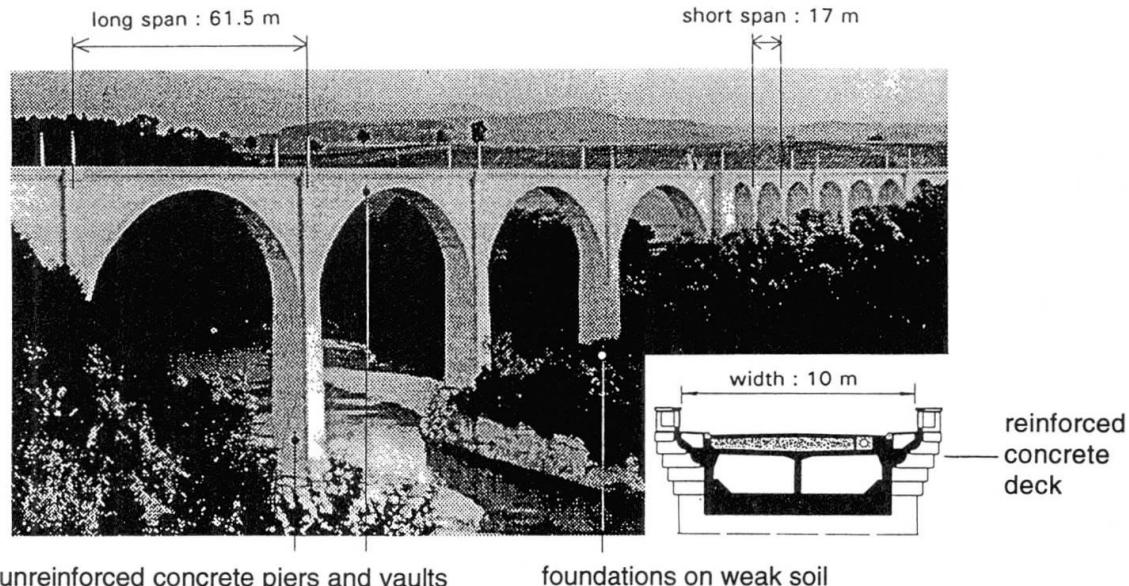
Figure 1 : Main features of old bridge

A detailed inspection of the bridge revealed severe degradation of the deck slab. The bridge had reached the end of its lifespan and consequently the deck slab had to be replaced.

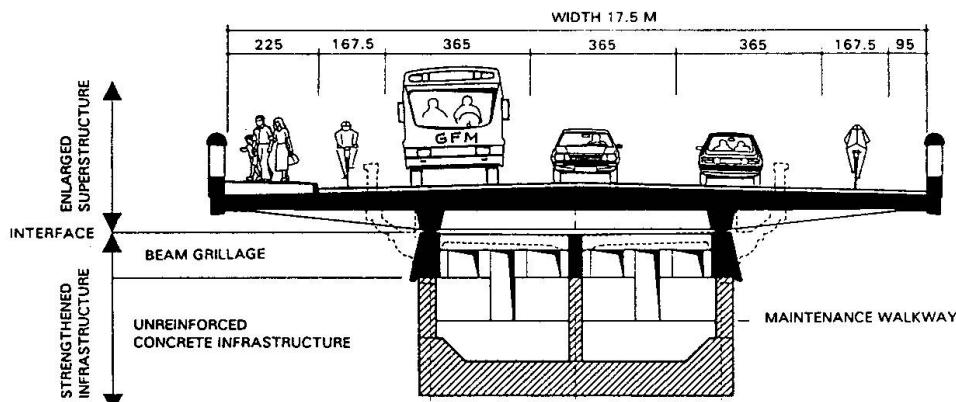
Figure 3 : Cross-section of renovated and transformed bridge

The cross-section of the renovated and transformed bridge illustrates the modifications and improvements to the existing structure (Figure 3).

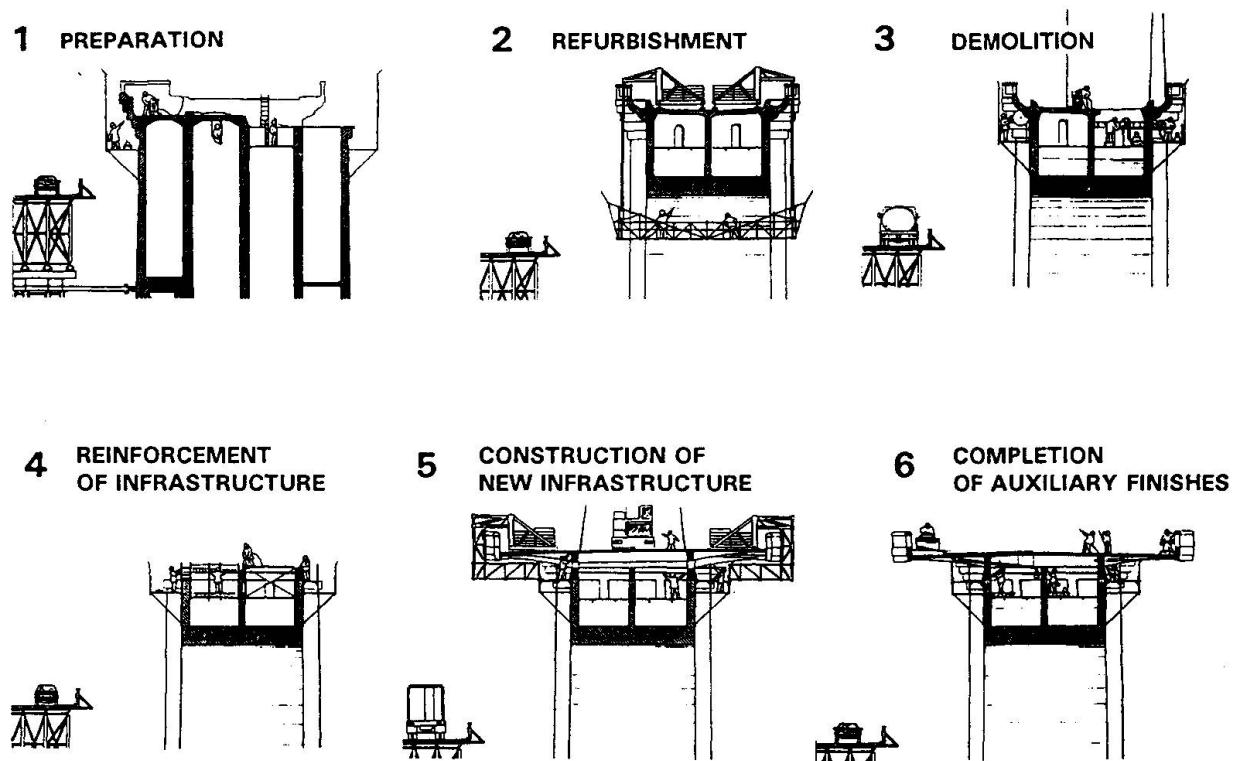
Figure 4 : Six construction phases

Project management involves six construction phases as illustrated in Figure 4.

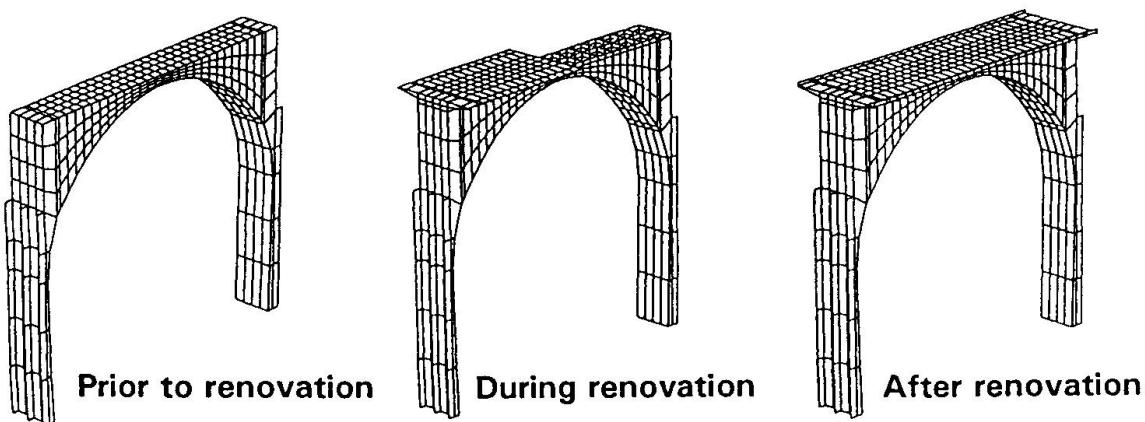
The construction of the vaults governs the design of the structure for the renovation of the bridge. The static model adopted at the time was a fully-connected arch, loaded by the fresh concrete of the walls and of the superstructure. The evaluation of the effective structural capacity, which fortunately had sufficient reserve, lead to the space frame analysis involving "arch, walls and deck-slab". Only the finite element method, through use of a precise model of the structure during the construction phases, provided a global approach to the problem by localising the critical zones. The MAPS computer program was retained for the comparative analyses performed by IBAP/EPFL (Figure 5).

Figure 5 : Evolving structural models for a 60.5 m span according to the state of renovation
