General Repair of Bridges I

Strengthening of the 120-Year-Old Substructure of a Railway Bridge

Heinrich GERBER

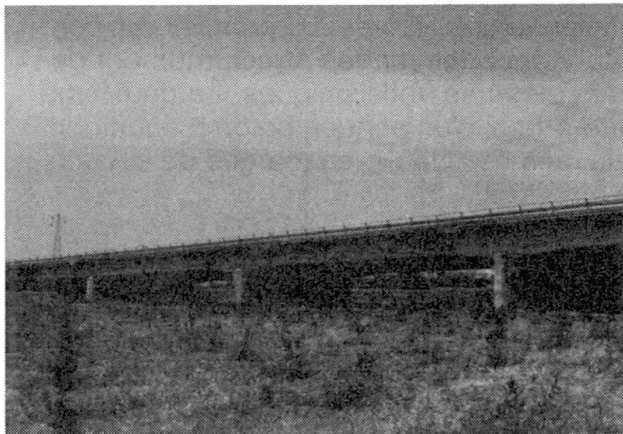
FIGURE 1

SITUATION BEFORE THE INTERVENTIONS

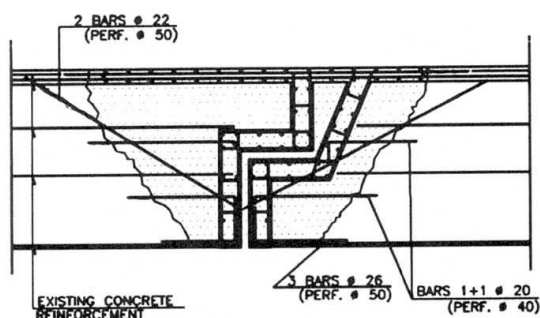
FIGURE 7

SITUATION AFTER THE INTERVENTIONS

unidirectional or bidirectional devices. The deck was connected at the ends to blocks built behind the abutments on special foundations with micropiles and steel tie-anchors. The connection was ensured through special shock-transmitting devices placed horizontally so as to permit slow displacements due to temperature variations and prevent impulsive actions. Two 1200 KN shock transmitters were inserted behind the abutments on each deck, capable of resisting an overall seismic force of little less than 5000 KN without damage (figure n. 9). In this way, the structure became an axially continuous beam whose longitudinal seismic forces are transferred to the blocks; the size of the foundations can resist such a force. Transversally, the continuity of the slabs allows most of the seismic forces to be transferred to the abutments - the most rigid supports - thus ensuring a more uniform distribution of

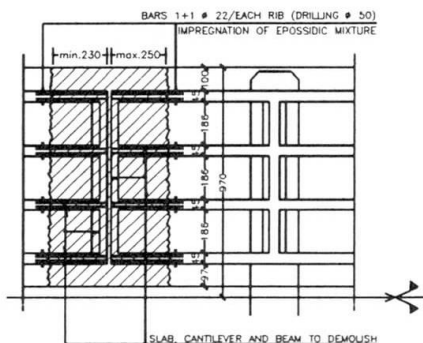
FIGURE 8

TYPICAL SLAB PLAN

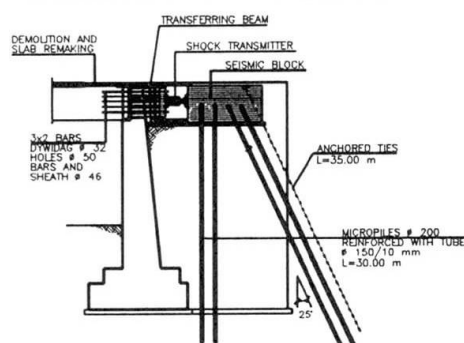
FIGURE 9

**SEISMIC BLOCK BEHIND THE ABUTMENT
TYPICAL SECTION**

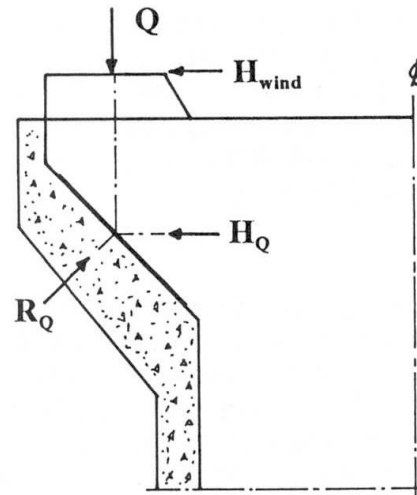
Fig. 2 Loads on pier top and reaction transferred to surround concrete structure below cantilevered beam.

The load Q from the bridge bearing (Fig. 2) is transferred in the inclined contact surface. The reaction R_Q is carried by reinforcement in the concrete walls in the direction of the force. The reaction H_Q is a compressive force in the old concrete pier. Epoxy injection into the slit under the inclined surface of the cantilevered beam means that there is contact against the new surrounding pier. The injection is carried out not earlier than half a year after casting when most of the long time deformations have occurred. The rest of the surround concrete structure is separated from the old pier by a sliding layer based on asphalt. Fig. 3 shows the suspension reinforcement in the cantilevered beam.

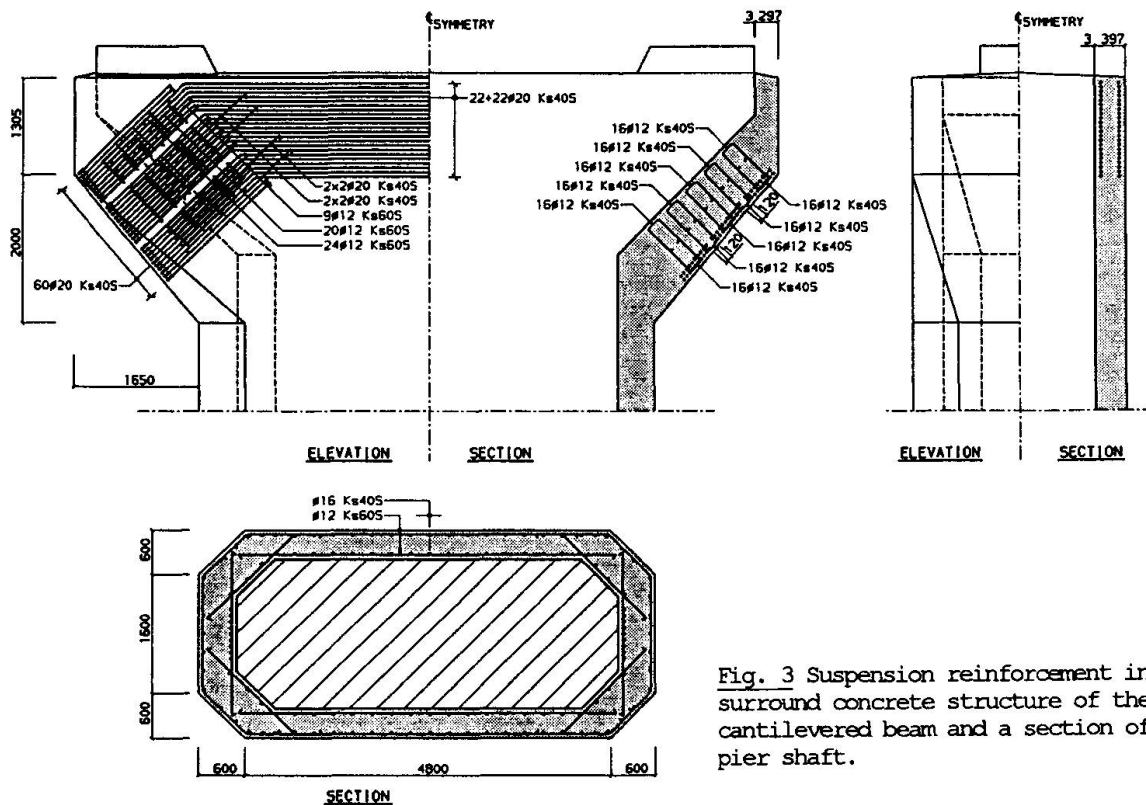
Fig. 3 Suspension reinforcement in the surround concrete structure of the cantilevered beam and a section of the pier shaft.

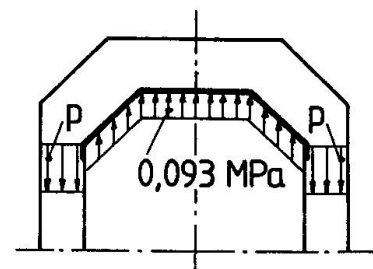
$$p \cdot (0.4 + 0.4) = 0.093 \cdot 2.0 \quad \text{I.e. } p = 0.23 \text{ Mpa}$$

The concrete reaches a tensile strength which is higher than this tensile stress after less than 1 day. Accordingly, it will not crack.

Fig. 8 Tensile stresses in the long sides of the surrounding concrete.

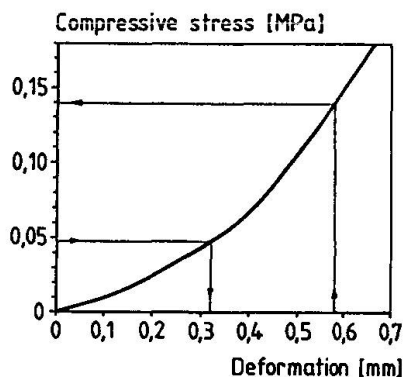
The concrete pressure is according to the previous chapter assumed to be 0.048 Mpa. Fig. 9 shows that this corresponds to a compression of 0.32 mm. Cooling and shrinkage require according to Fig. 6 a movement need of 0.26 mm, in all 0.58 mm.

Fig. 9 Measured working curve for a 3.2 mm thick sliding layer on the long sides.

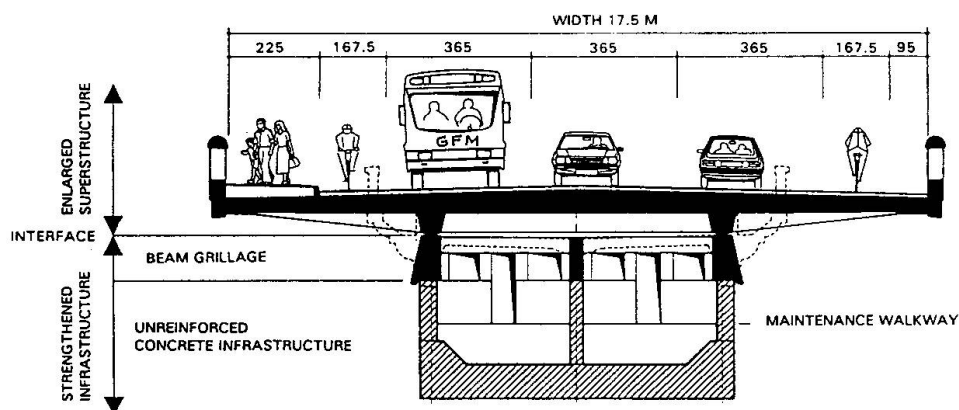
Figure 3 : Cross-section of renovated and transformed bridge

The cross-section of the renovated and transformed bridge illustrates the modifications and improvements to the existing structure (Figure 3).

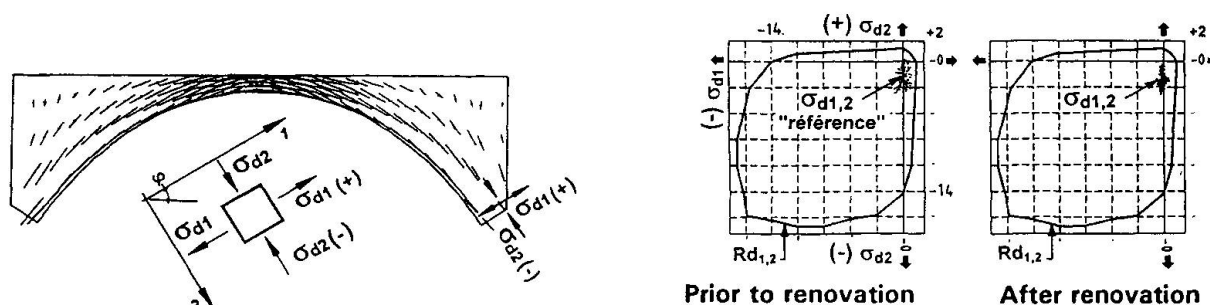
The actual stress distribution in the infrastructure serves as a reference. The structural concept creates a minimum of disturbance to the unreinforced concrete elements. The evolution of the stresses during the renovation process was simulated in order to identify critical zones vulnerable to damage. The set of tests performed by the LMC/EPFL laboratory, and the observations of the behaviour of the unreinforced concrete structure served as the basis for fixing a design value for the biaxial stress resistance in the vault, taking into account the discontinuous surface conditions of the concrete (Figure 7). The beam grillage is the only critical zone. It represents the only area reinforced concrete elements are used for strengthening the infrastructure. The non-linear analysis helped verify the cracking resulting from the imposed deformation restraints [6].

Figure 7 : Principal stress distribution in the vault prior to and after renovation, biaxial stress resistance (R_d) and normal stresses (σ_d)
