Zeitschrift:	IABSE reports = Rapports AIPC = IVBH Berichte
Band:	73/1/73/2 (1995)
Artikel:	Structural rehabilitation of a reinforced concrete and a prestressed concrete bridge
Autor:	Croci, G. / Santoro, V.M. / Macri, F.
DOI:	https://doi.org/10.5169/seals-55162

Structural Rehabilitation of a Reinforced Concrete and a Prestressed Concrete Bridge

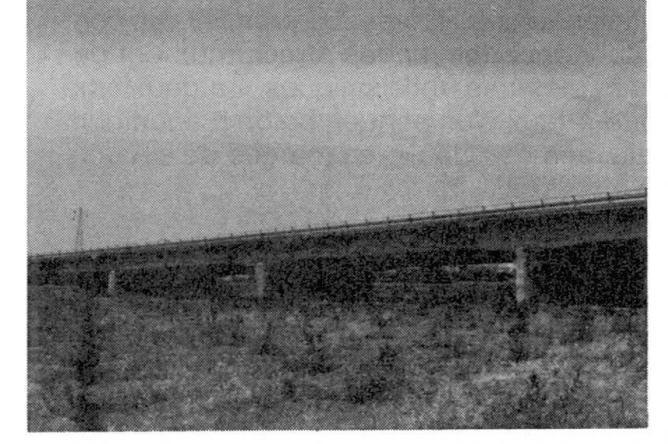
maintenance costs for the Board. The two viaducts, each of which has separate decks for each direction of traffic, consist of six 37.4-meter cast-in-place spans, three of which are cantilevered and three consist Gerber beams with 26.6-meter spans supported on six 6-7 meter high piers (photo n. 2). The Gerber beams are supported by very narrow joints girder (figure 3) with four ribs connected by a lower slab for a short distance from the pier along the cantilever.

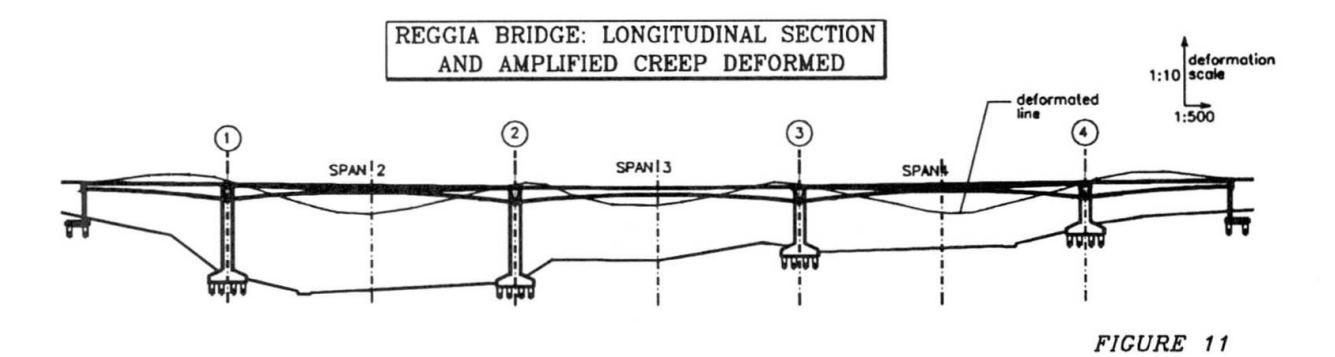
The phenomena observed are related to creep processes that cannot easily be predicted at the design stage. On account of the construction method, based on a cantilevered section-by-section procedure that involved building a structure with provisional boundary conditions that differed from the final ones, the creep effects have produced a redistribution of the stress for permanent loads and, in particular, an increase in positive bending moments in the middle of the spans and a reduction near the piers (figure 12). The individual sections of the cantilevers were poured in different stages, with non-homogeneous pouring and weathering conditions, so that they presented different creep functions. Even minor uncertainties in calculating the dead or prestressing loads could also have led to considerable variations in the creep deformations, bearing in mind the effective reciprocal influences between the creep and the steel relaxation of the prestressing cables. Another factor that should be considered is the possible effect of the insertion of provisional hydraulic jacks in the middle of the central span, which may have partially compensated the creep deformations of the third span, jeopardizing the second and fourth spans.
