Zeitschrift: IABSE reports = Rapports AIPC = IVBH Berichte
Band: 73/1/73/2 (1995)

Artikel: Structural rehabilitation of a reinforced concrete and a prestressed concrete bridge
Autor: Croci, G. / Santoro, V.M. / Macri, F.
DOI: <https://doi.org/10.5169/seals-55162>

Structural Rehabilitation of a Reinforced Concrete and a Prestressed Concrete Bridge

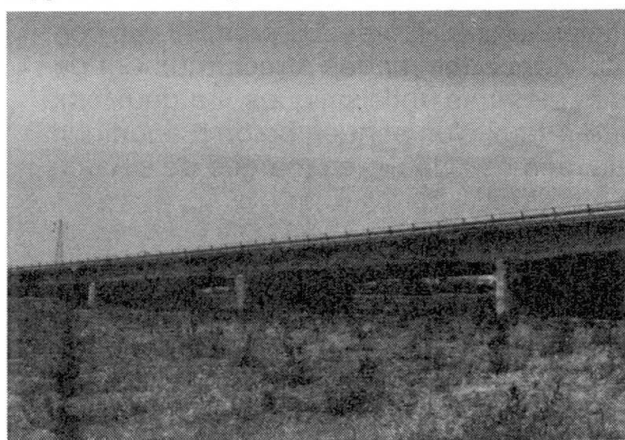
SITUATION BEFORE THE INTERVENTIONS

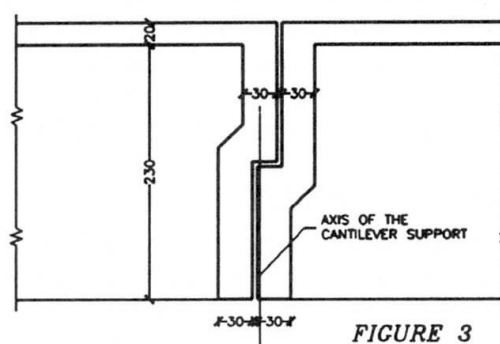
FIGURE 3

maintenance costs for the Board. The two viaducts, each of which has separate decks for each direction of traffic, consist of six 37.4-meter cast-in-place spans, three of which are cantilevered and three consist Gerber beams with 26.6-meter spans supported on six 6-7 meter high piers (photo n. 2). The Gerber beams are supported by very narrow joints girder (figure 3) with four ribs connected by a lower slab for a short distance from the pier along the cantilever.
