Artikel: Structural rehabilitation of a reinforced concrete and a prestressed concrete bridge
Autor: Croci, G. / Santoro, V.M. / Macri, F.
DOI: <https://doi.org/10.5169/seals-55162>

Structural Rehabilitation of a Reinforced Concrete and a Prestressed Concrete Bridge

Two examples of works on reinforced and prestressed concrete bridges are described, each involving different aspects of problems faced by the maintenance programs that the Italian Roadway Board has carried out in recent years. The first case involves an old reinforced concrete bridge whose heavily damaged structures required radical repairs and anti-seismic measures. The second case concerns prestressed concrete span cantilever cables to be inserted in the cross section in order to restore safety margins and correct some of the deflections due to creep.

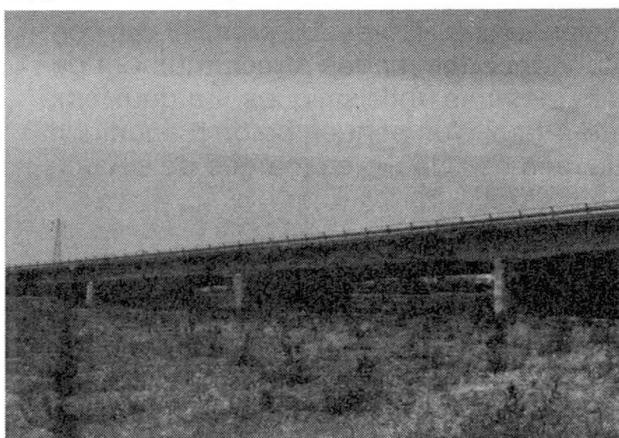
SITUATION BEFORE THE INTERVENTIONS

On account of the severe environmental conditions (marine salts in the rain water, wide temperature ranges, heavy traffic) and poor maintenance, the degradation has affected mainly structural elements such as the Gerber joints, in which the steel bars are completely uncovered and deeply corroded

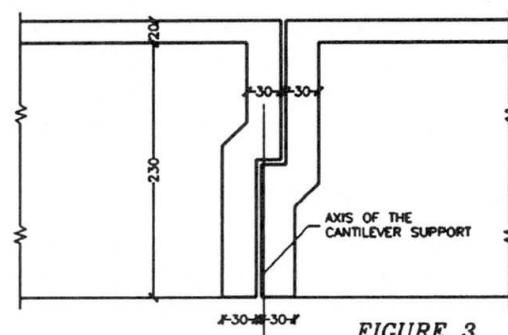
FIGURE 3

maintenance costs for the Board. The two viaducts, each of which has separate decks for each direction of traffic, consist of six 37.4-meter cast-in-place spans, three of which are cantilevered and three consist Gerber beams with 26.6-meter spans supported on six 6-7 meter high piers (photo n. 2). The Gerber beams are supported by very narrow joints girder (figure 3) with four ribs connected by a lower slab for a short distance from the pier along the cantilever.
