Zeitschrift:	IABSE reports = Rapports AIPC = IVBH Berichte
Band:	999 (1997)
Artikel:	Damage of SRC building structures by 1995 Hyogo earthquake
Autor:	Sakai, Junichi / Minami, Koichi / Matsui, Chiaki
DOI:	https://doi.org/10.5169/seals-1035

# Damage of SRC Building Structures by 1995 Hyogo Earthquake

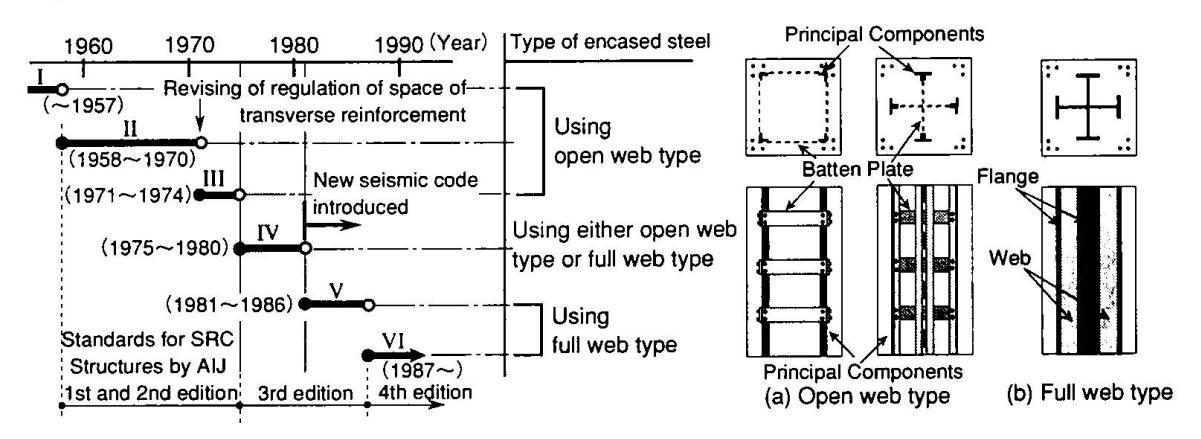
Fig. 2 Decision of Classification of Years of Completion of Buildings

Figure 2 shows the relation of SRC type and construction year of buildings, and the construction years are divided into six periods according to the revising of the standards for structural calculation of SRC structures published by Architectural Institute of Japan [3] (AIJ standard). The term IV (1975-1980) show the period that buildings were constructed with either open web type or full web type.
