Artikel: Damage of SRC building structures by 1995 Hyogo earthquake
Autor: Sakai, Junichi / Minami, Koichi / Matsui, Chiaki
DOI: <https://doi.org/10.5169/seals-1035>

Damage of SRC Building Structures by 1995 Hyogo Earthquake

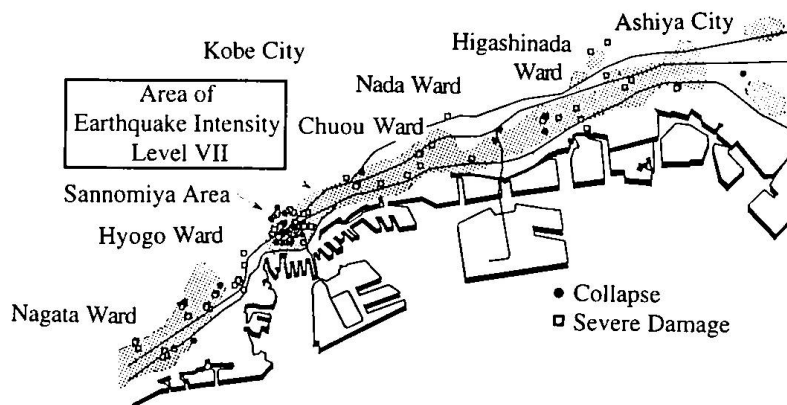
Fig. 1 Distribution of SRC buildings subjected collapse or severe damage.

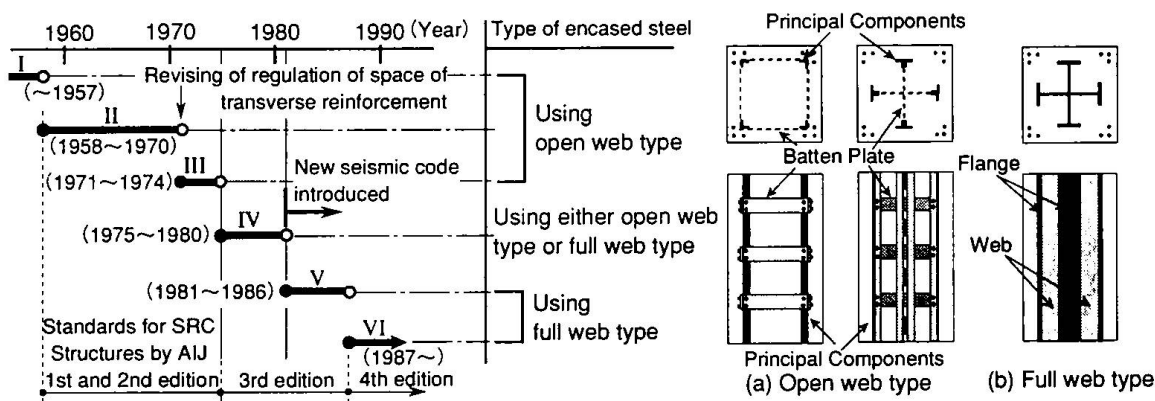
Figure 2 shows the relation of SRC type and construction year of buildings, and the construction years are divided into six periods according to the revising of the standards for structural calculation of SRC structures published by Architectural Institute of Japan [3] (AIJ standard). The term IV (1975-1980) show the period that buildings were constructed with either open web type or full web type.

Fig. 2 Decision of Classification of Years of Completion of Buildings
