Collapse and Rehabilitation of Composite Trussed Structures

A failure case of a 2.400 m^2 area of an industrial roofing structure is presented. The investigation leading to the cause of the disaster, the numerical and experimental study using reduced models the rehabilitation procedures for the remaining part of the structure are described. Conclusions are also drawn concerning the application of external tension reinforcements to restore the original load capacity of the structure.

Major Repairs to Frank Lloyd Wright's Largest House: Wingspread, Racine, WI, USA

Frank Lloyd Wright's design for Wingspread was a brilliant conception but contained several inherent structural deficiencies. These did not manifest themselves significantly for the first 56 years of the house's life, but in 1994 large displacements occurred due to heavy snows. Repairs were made using a carbon fiber-epoxy thin shell laminated directly to the timber roof to form a composite structure. This shell was built up *in situ* from 13 layers of quad-axial carbon fiber.

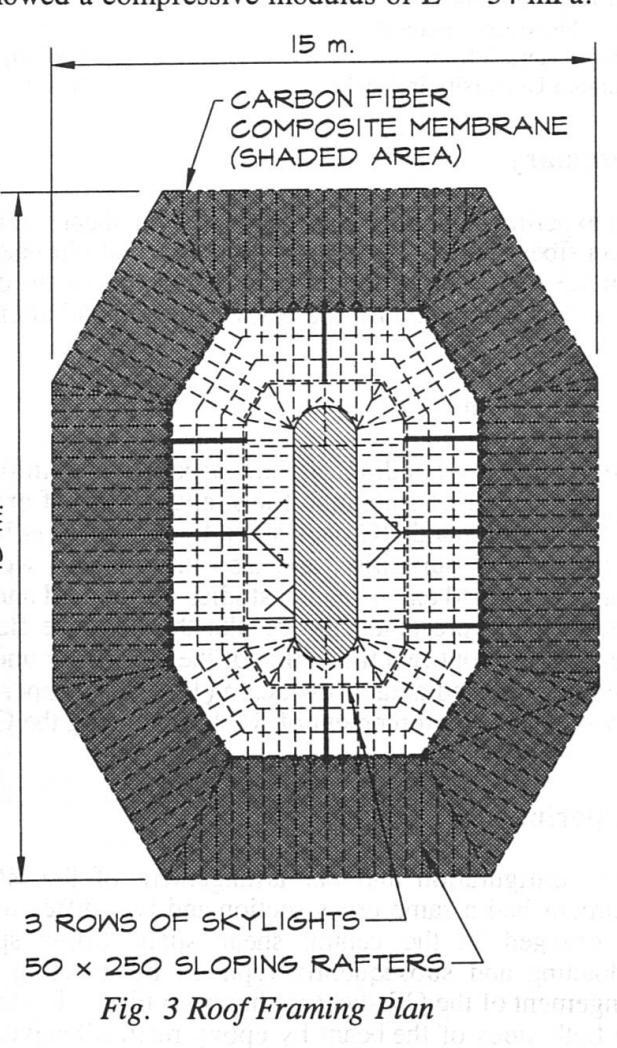
Fig. 2 Impregnating Fabric with Epoxy

Temporary shoring was installed and the roof tiles were removed (they were not original in any case, having been replaced in 1993). The permanent repair for the great Hall sought to achieve several objectives. First it should never be visible in the completed work. Second it should minimize disturbances to the existing interior finishes. And third it should be as economical as possible while still conforming to the rules of historic preservation. After extensive computer modeling using Finite Element Analysis, it was decided to create a shell structure out of the lower roof by coating the bare wood sheathing with 13 layers (12 mm total thickness) of quad-axial carbon fiber fabric set in a 50%-50% matrix of epoxy resin which was bonded to the wood. Prior to the first layer of carbon fiber installation the wood was thoroughly cleaned and large diameter screws were installed through the sheathing into the rafters at 15 cm on centers in oversized holes flooded with epoxy. Thus the carbon fiber was bonded to the wood sheathing which was in turn acting compositely with the rafters. Each layer of carbon was offset approximately 7-8 cm from the layer below to provide a scarf joint at every lap of fabric. Vacuum bagging was not practical for this on site installation so air bubbles were forced out using toothed rollers. The entire operation was conducted inside an environmentally controlled temporary timber framed structure built over the top of the roof. Upon completion, the composite membrane was post cured at 60° C for 24 hours.
