**Artikel:** Structural rehabilitation of an industrial steel building

## Structural Rehabilitation of an Industrial Steel Building

Nicolae TARANU, Petru STRATEANU and Dorina ISOPESCU

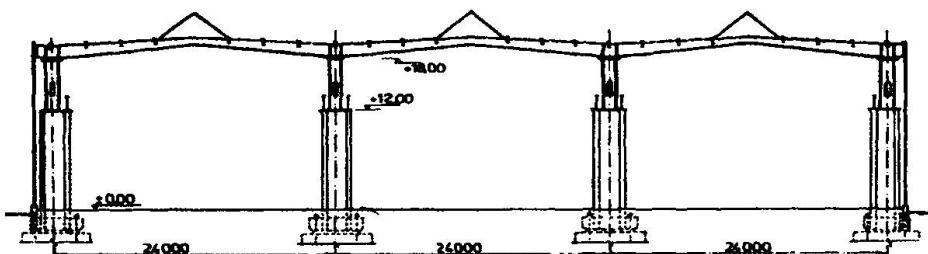
Fig. 1 The transverse frame of the industrial steel building

The structural steel members were exploited in a very aggressive environment (involving the use of sulfuric acid, chlorine hydride and hot water) between 1967 and 1980 and in a less corrosive atmosphere until 1992. All structural steel members have been severely affected by the corrosion process. Depending on the type of the element, the stress level and the local corrosive factors, extensive damages of the protective coatings, from 7% to 100% have been identified and corrosion penetrations up to 1.5 mm have been determined.

The verification procedures for ultimate limit states and for serviceability limit states have been applied according to the Romanian Standard STAS 10108/0, and to the Code P-100-92, for design of structures in seismic zones. To assess the corrosion effect on the loadbearing capacity of the structural steel members the initial geometric characteristics ( $A_o$ =the noncorroded initial area and  $W_o$ =the noncorroded initial section modulus) have been compared with the same properties after exploitation in corrosive atmosphere ( $A_c$ =the corroded cross-sectional area and  $W_c$ =the section modulus of the corroded structural members). The numerical values of the deterioration ratios have been calculated for all main structural members as follows: purlins,  $W_c/W_o = 0.785$ ; crane girders,  $W_c/W_o = 0.912$ ; columns,  $W_c/W_o = 0.789$  and  $A_c/A_o = 0.820$ ; frame girders,  $W_c/W_o = 0.823$  at midspan, and  $W_c/W_o = 0.901$  on columns.

To restore the initial loadbearing capacity of the steel members, the strengthening solutions presented in figs.2 and 3, have been proposed. The strengthening pieces illustrated by dashed areas have been attached to the weakened members after careful cleaning of the corroded elements. The dimensions given in the parenthesis correspond to the corroded areas. After consolidation the ratios between the strengthened sections characteristics ( $W_1$ ,  $A_1$ ) and the initial ones ( $W_o$ ,  $A_o$ ) have been calculated: purlins,  $W_1/W_o = 1.03$ ; columns,  $W_1/W_o = 1.04$  and  $A_1/A_o = 1.02$ ; frame girders,  $W_1/W_o = 1.08$  at midspan, and  $W_1/W_o = 1.02$  on columns.
