**Zeitschrift:** IABSE reports = Rapports AIPC = IVBH Berichte  
**Band:** 78 (1998)  
**Rubrik:** Session 6: Maintenance and repair

### **Maintenance and repair**

## Session 6 - MAINTENANCE AND REPAIR

### Keynote address

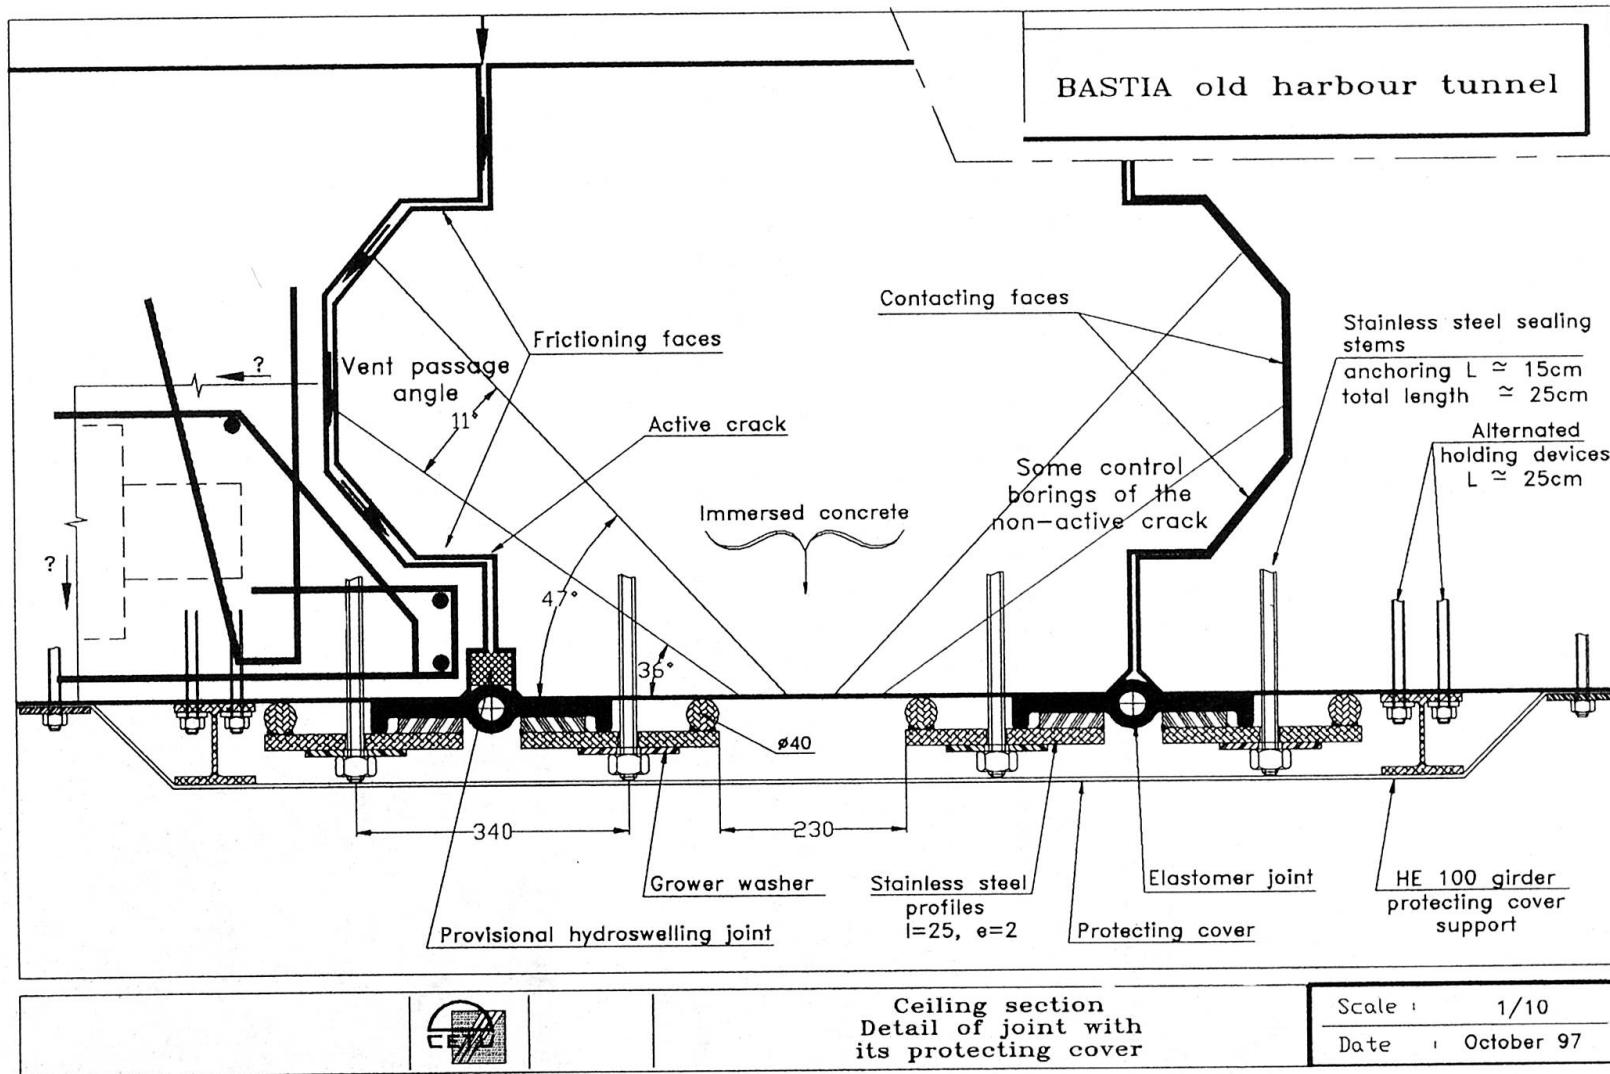
Fig. 5 BASTIA old harbour tunnel. Ceiling section: detail of joint with its protecting cover

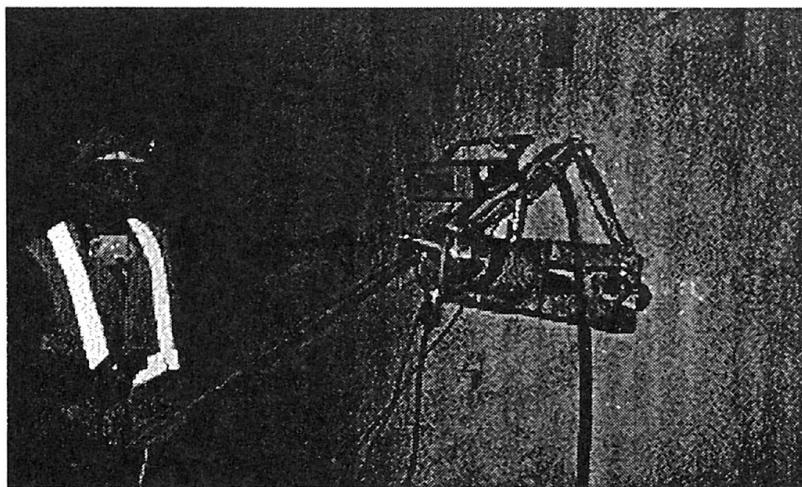
*Fig. 8 After sprayed concreting, tearing tests on pins to test the equipment securing conditions*

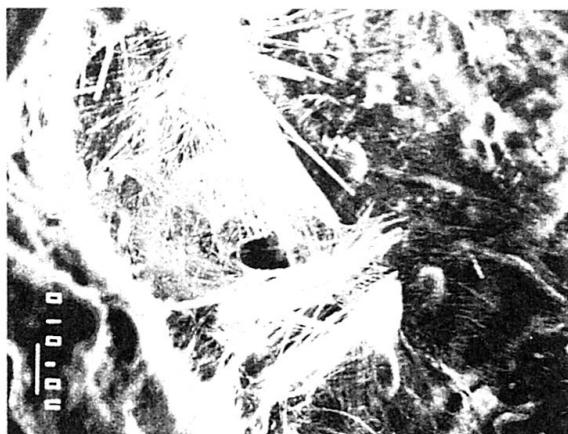
shown in Figure 5 and Figure 6. Each photo is 1000 times enlarged photo of inside the pore of thereabout 100  $\mu$ m in diameter in size of hardened cement structure of each sample. Figure 5 is the SEM photo of core No.1 and Figure 6 is the core No.3. In Figure 5, increased cement crystals in the pore are observed.

Figure 5. Inside the pore of core No.1

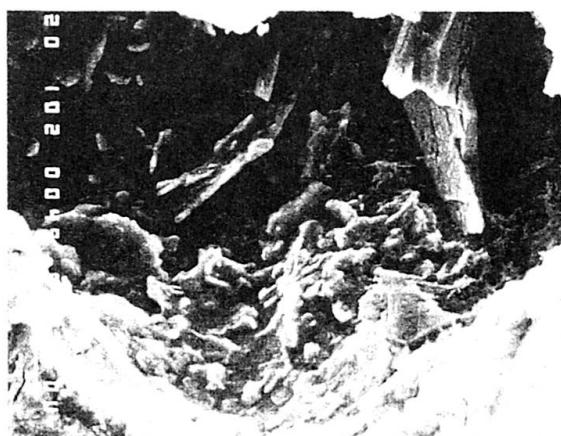
Figure 6. Inside the pore of core No.3

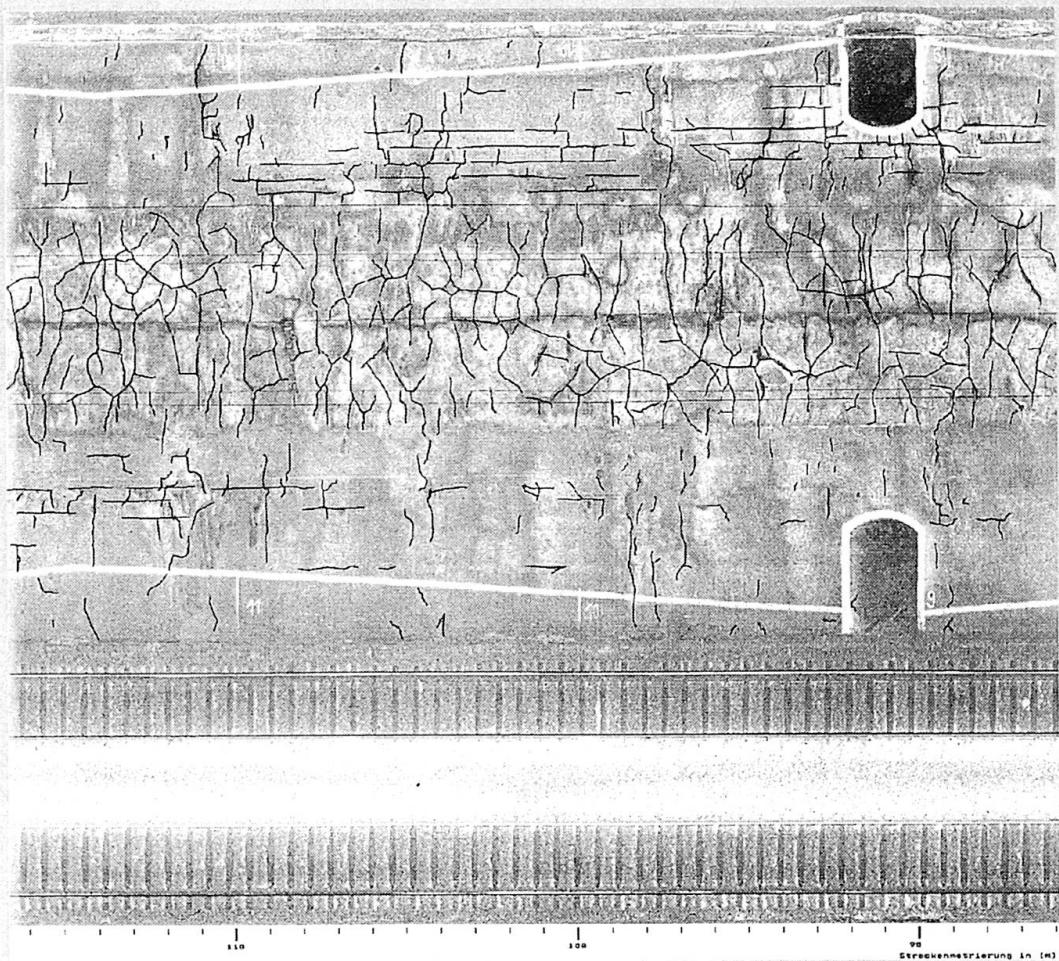
The high-resolution scanner is used for charting small surface structures. Cracks in the walls larger than 0,3 mm can be charted with close surface coverage (Figure 4). If these surveys are repeated at regular intervals, objective results on cracks and crack development can be obtained and repair works can be planned and calculated.

**Figure 4:** Crack chart

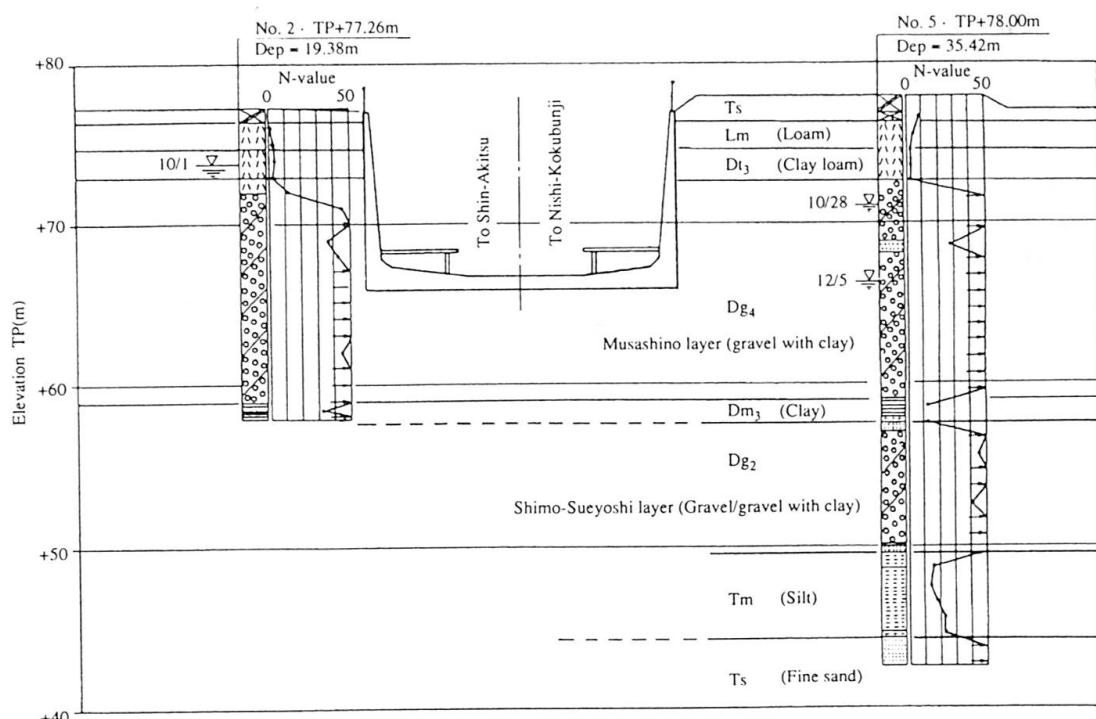
Fig. 2 Geological Profile

The Musashino Plateau, the diluvial plateau on which Shin-Kodaira station is located, is known as the largest plateau in Japan. Around Shin-Kodaira station, the Musashino gravel layer has a depth of 20m, below which are found alternating layers of clay containing shells and of sandy gravel. The Musashino gravel layer is covered with around 5m of Kanto loam soil. Groundwater is found under rather different conditions in the Musashino gravel layer and the sand layers further down. The Musashino gravel layer has a high void ratio and permeability and contains large quantities of groundwater. The groundwater in this area flows south-westwards towards the edge of the Musashino Plateau, crossing below the station (Figure 2).

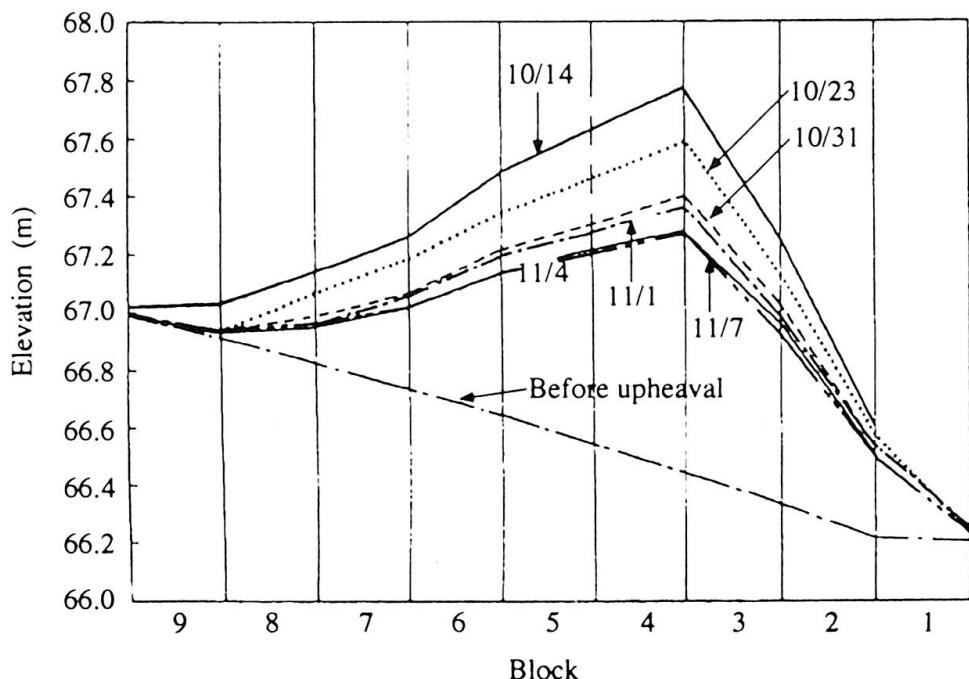
Fig. 4 Elevation of Lower Slabs (Slab Crests) : Measurement Results

Reduction of the buoyancy through lowering of the water level was chosen as the method for lowering the structural frame, as this was judged to be the quickest and most efficient method. Deep wells were arranged to lower the water level, seven inside the U-shaped retaining walls ( $l = 7\text{m}$ ,  $\varnothing = 650\text{mm}$ , lifting pipes: 100A, high lift underwater pumps: 15kw) and nineteen surrounding the outside of the retaining walls ( $l = 20\text{m}$ ,  $\varnothing = 700\text{mm}$ , lifting pipes: 100A, high lift underwater pumps: 15kw). Pumping began gradually on 22nd October and continued until 30th November, after the completion of the new slabs. There had been no past cases, however, where complete lowering of the structural frame was achieved after an upheaval as large as 1.3m and there were concerns as to whether adequate lowering of the water level could be achieved through use of deep wells. (Figure 4).

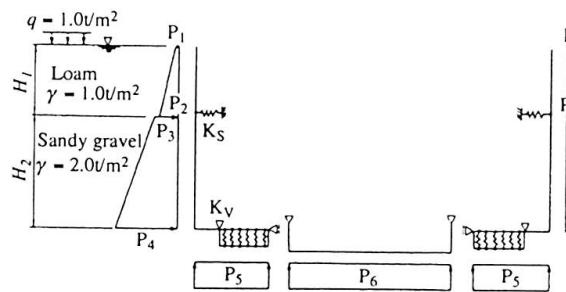
Fig. 5 Analysis Model

The analysis model of the structural frame is shown in Figure 5. In the analysis, four rows of vertical anchors were installed to provide resistance to buoyancy and struts were installed on the upper parts of the structural frame. Through a comparison of the construction periods required, roller bearings were selected for use in the connections between the old slabs and sections where excavation was to be conducted below the slabs.
