Zeitschrift: IABSE reports = Rapports AIPC = IVBH Berichte
Band: 78 (1998)

SESSION 6

Maintenance and repair

Session 6 - MAINTENANCE AND REPAIR

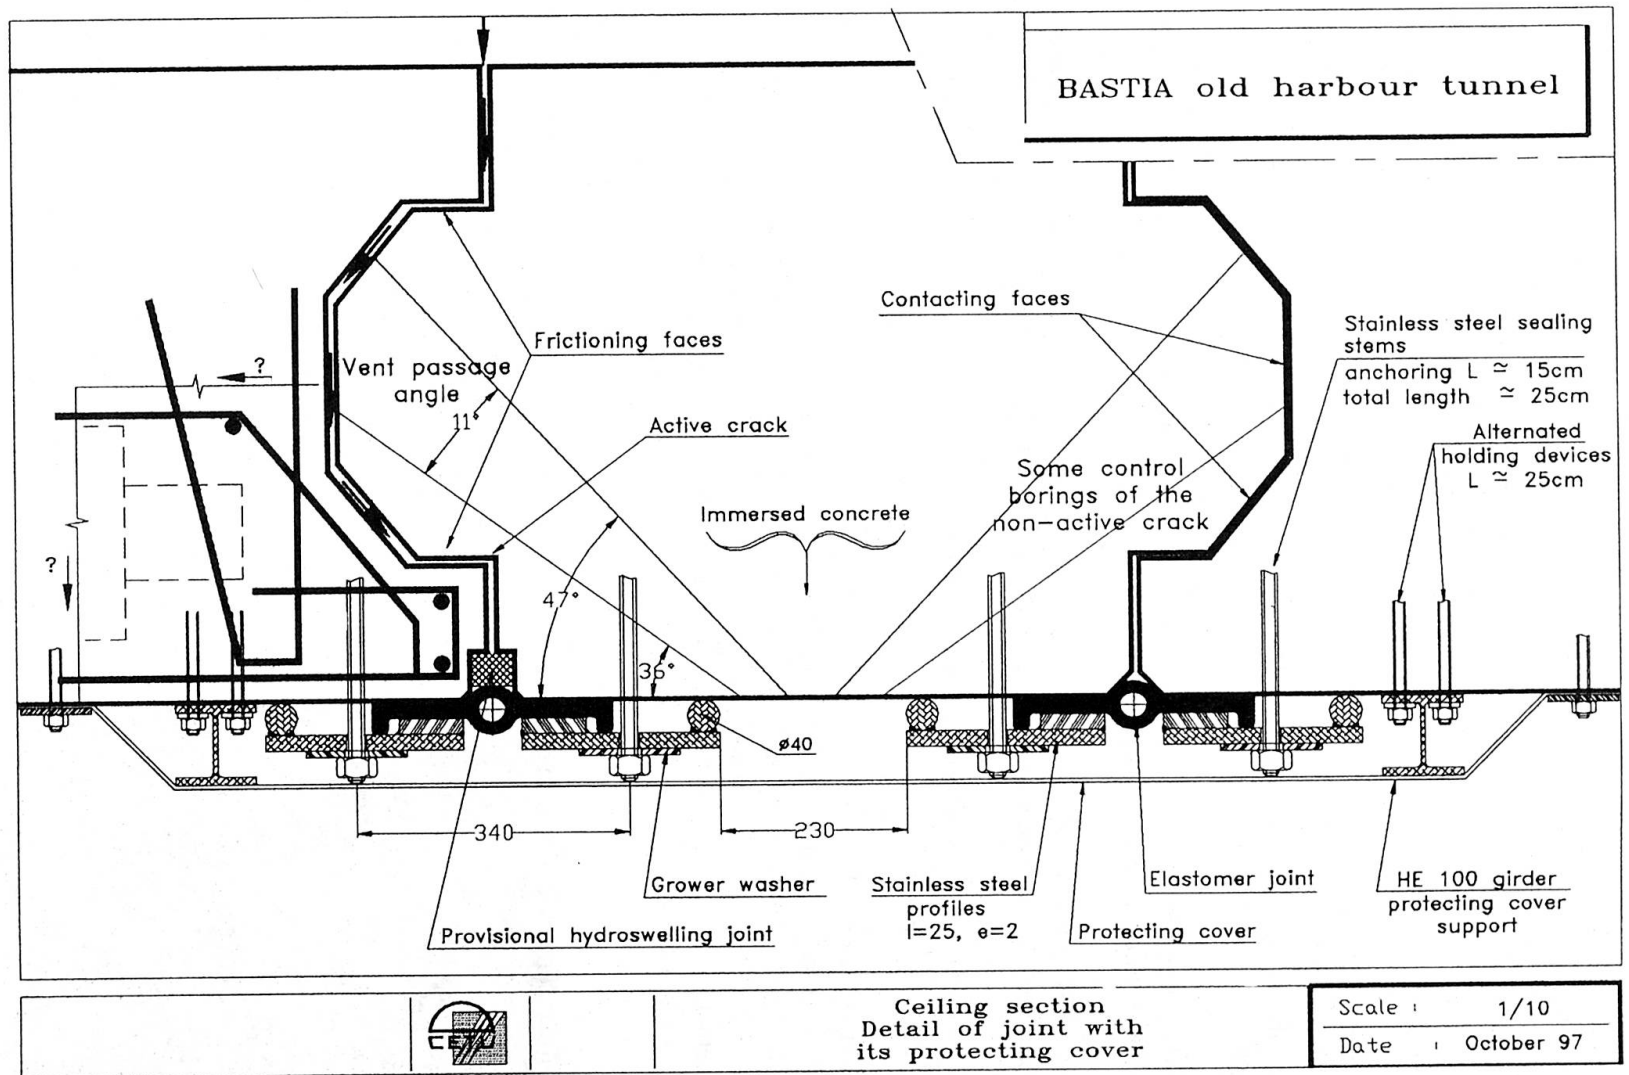
Fig. 5 BASTIA old harbour tunnel. Ceiling section: detail of joint with its protecting cover

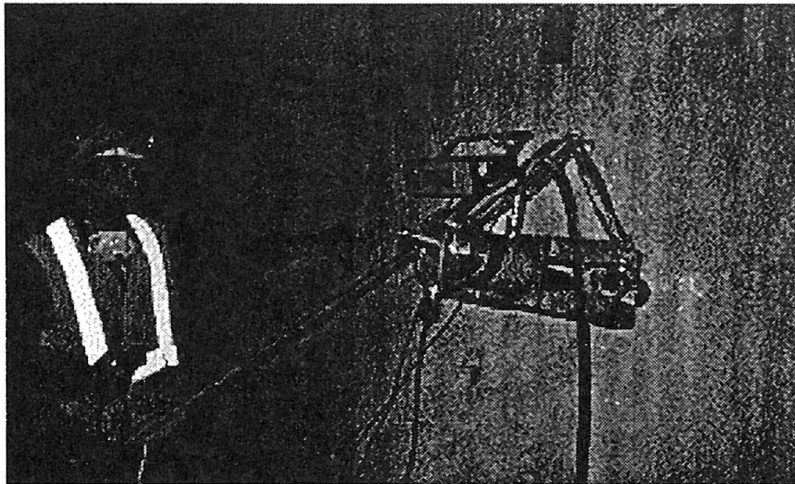
Fig. 8 After sprayed concreting, tearing tests on pins to test the equipment securing conditions

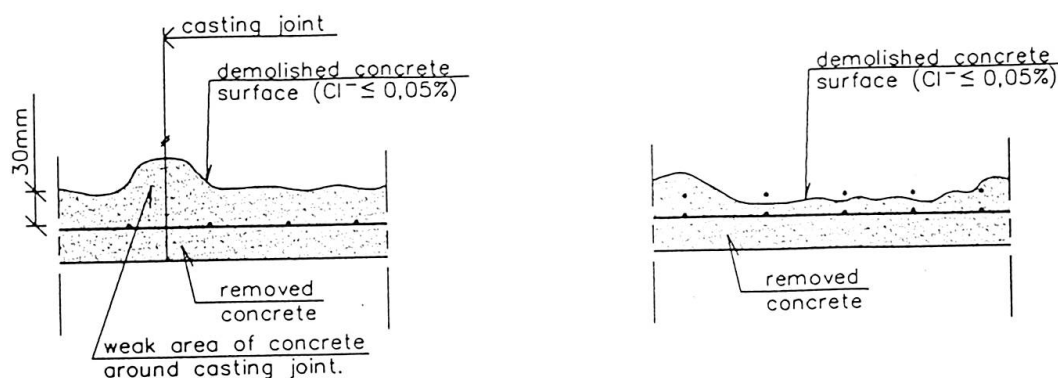
Generally concrete is removed until the amount of chlorides in the concrete is less than 0.05% by weight of concrete, however, never deeper than 30 mm behind the deepest layer of reinforcement unless weak areas of concrete facilitate deeper demolition.

Two typical demolition profile is schematically shown below.

Due to the large extend of concrete needing to be removed and the amount of reinforcement being exposed in this process, static considerations have necessitated guidelines on how the demolition work must be carried out, imposing the contractor to split up larger continuous demolition areas - especially on ceilings - into smaller sections, and replacing concrete in one section before removing damaged concrete from adjacent sections.

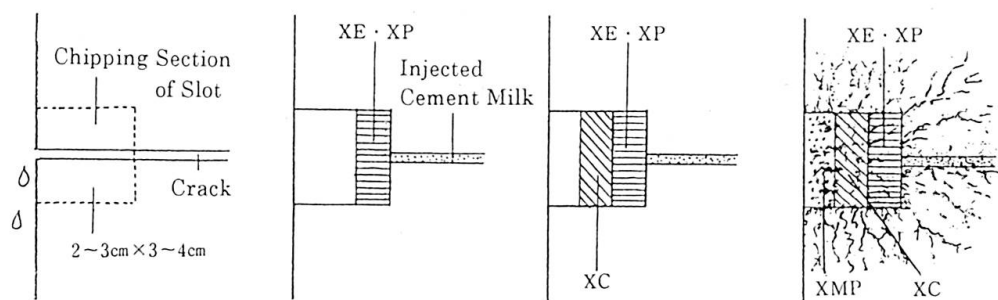
Figure 2. Rough Sketch of Triple Plugging Method

The main material of this Plugging method is XC itself. Steadily plugged XC increases cement crystals inside of concrete, the other materials and all contact surfaces around XC itself. This is the special feature of this method. In case of big cracks, as shown in Figure 2, inorganic cementitious materials such as cement milk etc. are injected into them. And XC increases crystals inside of such injected materials and in the contact surface between the material and concrete, and impermeate the cracks completely.

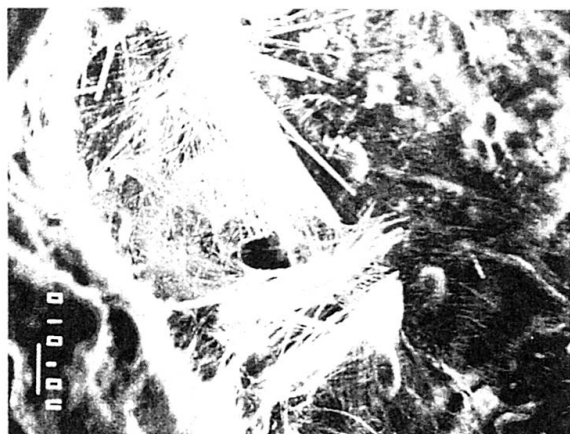
Figure 5. Inside the pore of core No.1

shown in Figure 5 and Figure 6. Each photo is 1000 times enlarged photo of inside the pore of thereabout 100 μ m in diameter in size of hardened cement structure of each sample. Figure 5 is the SEM photo of core No.1 and Figure 6 is the core No.3. In Figure 5, increased cement crystals in the pore are observed.

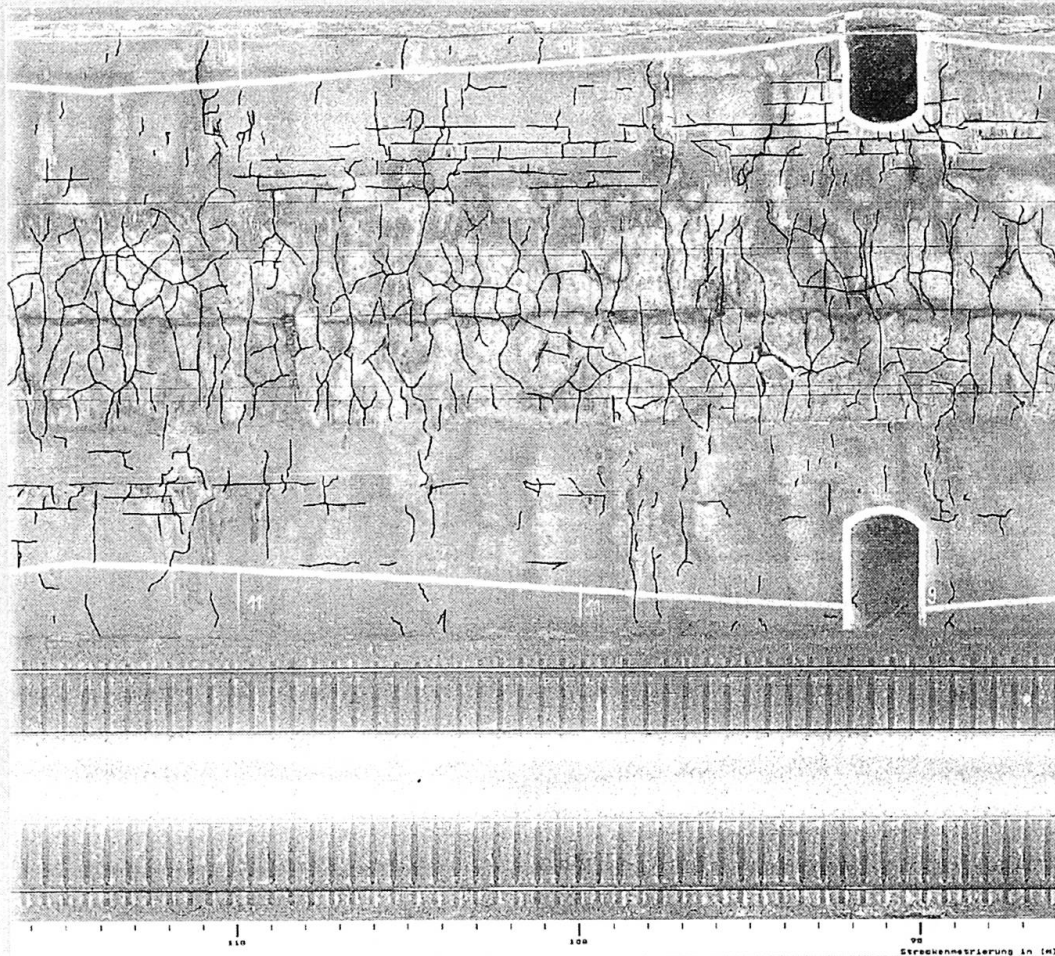
Figure 4: Crack chart

The high-resolution scanner is used for charting small surface structures. Cracks in the walls larger than 0,3 mm can be charted with close surface coverage (Figure 4). If these surveys are repeated at regular intervals, objective results on cracks and crack development can be obtained and repair works can be planned and calculated.

□ Rattenberg tunnel (taking of evidence)

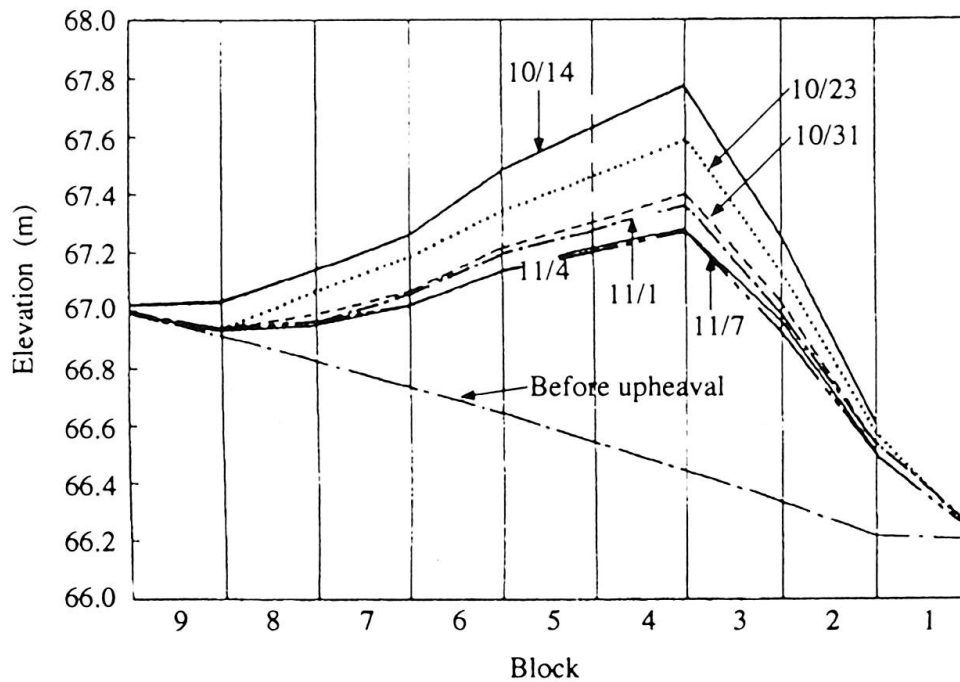
Fig. 4 Elevation of Lower Slabs (Slab Crests) : Measurement Results

Reduction of the buoyancy through lowering of the water level was chosen as the method for lowering the structural frame, as this was judged to be the quickest and most efficient method. Deep wells were arranged to lower the water level, seven inside the U-shaped retaining walls ($\ell=7\text{m}$, $\varnothing=650\text{mm}$, lifting pipes: 100A, high lift underwater pumps: 15kw) and nineteen surrounding the outside of the retaining walls ($\ell=20\text{m}$, $\varnothing=700\text{mm}$, lifting pipes: 100A, high lift underwater pumps: 15kw). Pumping began gradually on 22nd October and continued until 30th November, after the completion of the new slabs. There had been no past cases, however, where complete lowering of the structural frame was achieved after an upheaval as large as 1.3m and there were concerns as to whether adequate lowering of the water level could be achieved through use of deep wells. (Figure 4).
