**Zeitschrift:** IABSE reports = Rapports AIPC = IVBH Berichte

**Band:** 78 (1998)

# Maintenance and repair

# Session 6 - MAINTENANCE AND REPAIR Keynote address

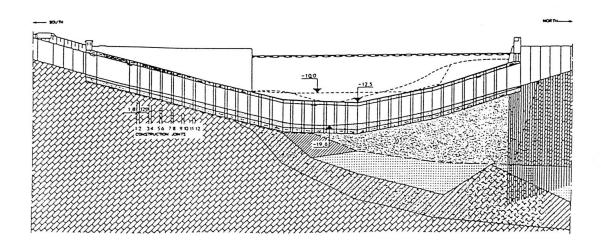
The immersed part consists of five 102 m long precast reinforced concrete units joined together to form a monolithic structure. The units were cast in a dry dock in 12,8 m long sections, separated by 1,8 m wide gaps into which reinforcement bars protruded. The concrete for these gaps was poured after the sections had shrunk.

The units were waterproofed with a 2 mm butyl membrane which, as described in the introduction, has never been fully effective.

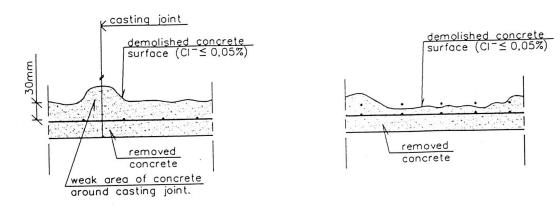
Two typical demolition profile is schematically shown below.

Due to the large extend of concrete needing to be removed and the amount of reinforcement being exposed in this process, static considerations have necessitated guidelines on how the demolition work must be carried out, imposing the contractor to split up larger continuous demolition areas - especially on ceilings - into smaller sections, and replacing concrete in one section before removing damaged concrete from adjacent sections.

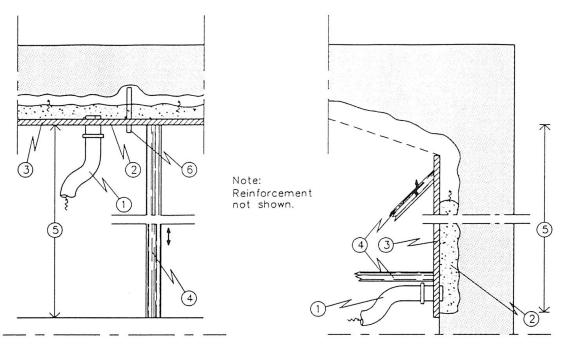
Principle - replacing concrete on tunnel ceiling

The principle of pumping high-slump concrete is schematically shown on the illustrations below.
