Zeitschrift: IABSE reports = Rapports AIPC = IVBH Berichte
Band: 78 (1998)

Rubrik: Session 6: Maintenance and repair

Maintenance and repair

Session 6 - MAINTENANCE AND REPAIR

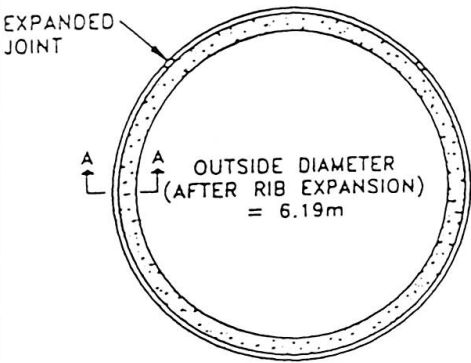
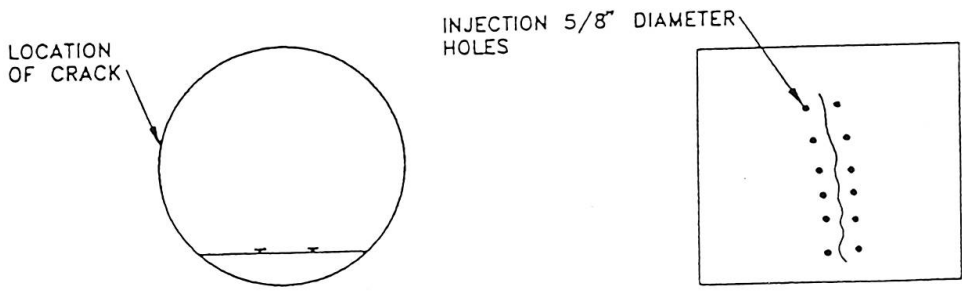
Fig. 4 Example of measures against water leakage in tunnel

Classification		COUNTRY	CANADA
Classification	WATER STOPPAGE		
Method	CRACK INJECTION		
Outline of tunnel			
Type	SUBWAY		
Tunnelling method	TBM		
Length of service	10 YEARS		
Lining materials	(Primary) STEEL RIBS/ WOODEN LAGGING		
	(Secondary) CAST-IN-PLACE CONCRETE		
Degree of leakage	DRIP		
Location of leakage	SIDEWALLS		
Presence of frost	NO		
Cross-section of tunnel (Add geological information if available) GLACIAL TILL

- LIMITATION OF CLEARANCE			
- SMALL TOOLS ONLY NEEDED			
Description of trouble caused by water leakage			
PREVENTION OF DETERIORATION OF ELECTRICAL EQUIPMENT			
Materials used			
CHEMICAL GROUT			
Outline of method			
INJECTION HOLES ARE DRILLED AT 30° ANGLE TO THE CRACK. HOLES ARE DRILLED ON BOTH SIDES OF THE CRACK AND THEN ARE INJECTED WITH A CHEMICAL GROUT THAT EXPANDS AND SEALS CRACK WHEN IT COMES INTO CONTACT WITH WATER.			
Schema of method

Evaluation of method (workability, cost, etc.)			
METHOD IS TIME CONSUMING AND EXPENSIVE			
Post-repair Inspection Observations			
CRACKS HAVE MINOR LEAKS AFTER 10 YEARS

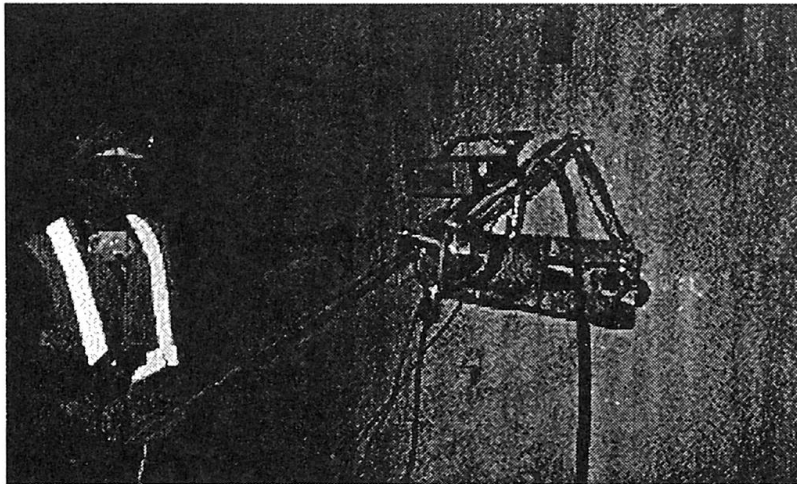
Fig. 8 After sprayed concreting, tearing tests on pins to test the equipment securing conditions

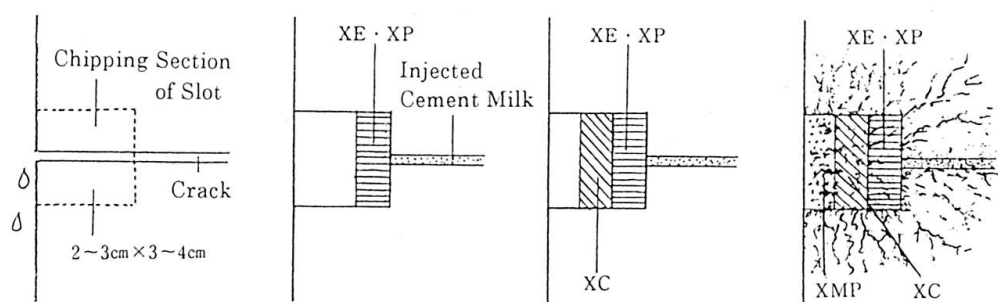
The main material of this Plugging method is XC itself. Steadily plugged XC increases cement crystals inside of concrete, the other materials and all contact surfaces around XC itself. This is the special feature of this method. In case of big cracks, as shown in Figure 2, inorganic cementitious materials such as cement milk etc. are injected into them. And XC increases crystals inside of such injected materials and in the contact surface between the material and concrete, and impermeate the cracks completely.

Figure 2. Rough Sketch of Triple Plugging Method

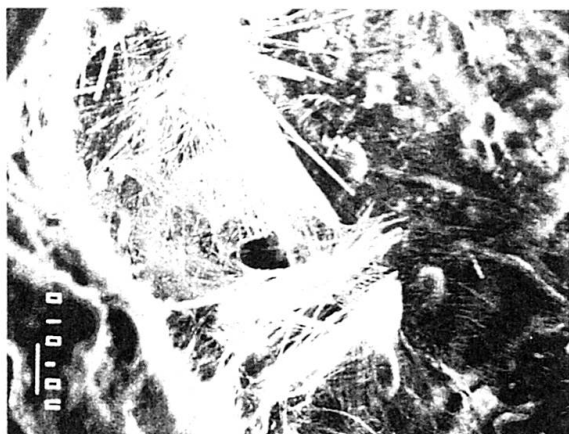
shown in Figure 5 and Figure 6. Each photo is 1000 times enlarged photo of inside the pore of thereabout 100 μ m in diameter in size of hardened cement structure of each sample. Figure 5 is the SEM photo of core No.1 and Figure 6 is the core No.3. In Figure 5, increased cement crystals in the pore are observed.

Figure 5. Inside the pore of core No.1

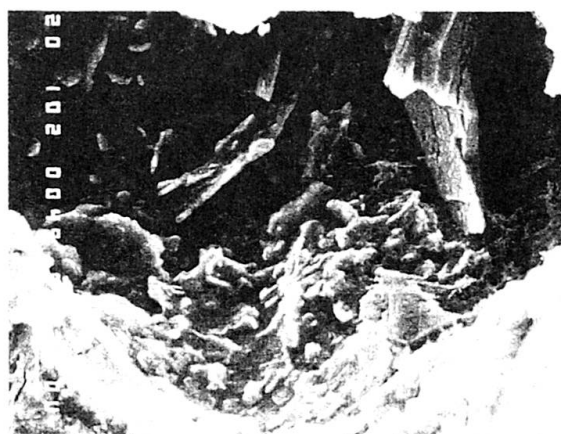
Figure 6. Inside the pore of core No.3

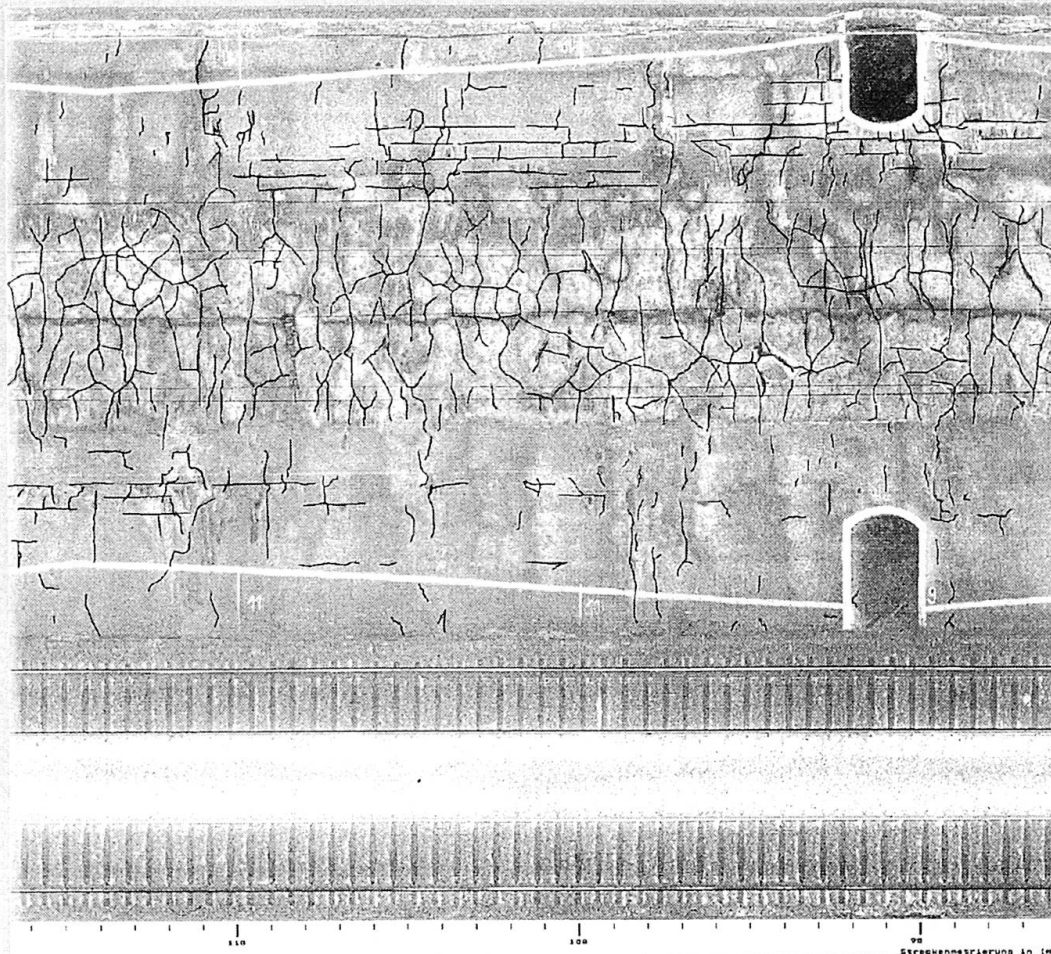
The high-resolution scanner is used for charting small surface structures. Cracks in the walls larger than 0,3 mm can be charted with close surface coverage (Figure 4). If these surveys are repeated at regular intervals, objective results on cracks and crack development can be obtained and repair works can be planned and calculated.

Figure 4: Crack chart

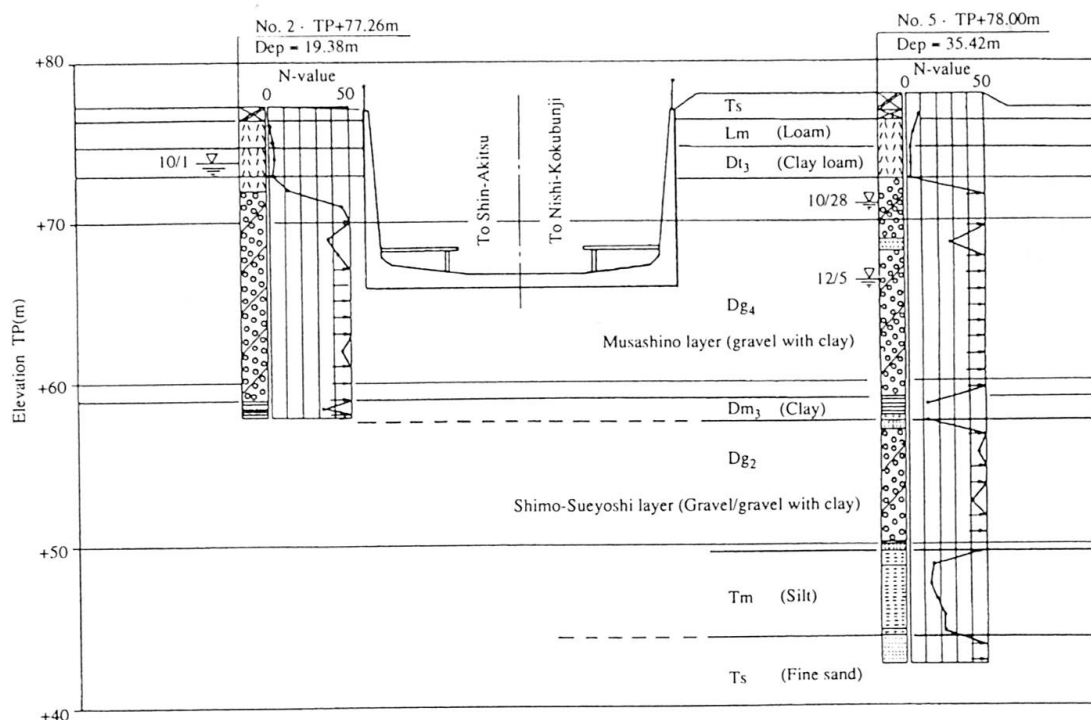
Fig. 2 Geological Profile

The Musashino Plateau, the diluvial plateau on which Shin-Kodaira station is located, is known as the largest plateau in Japan. Around Shin-Kodaira station, the Musashino gravel layer has a depth of 20m, below which are found alternating layers of clay containing shells and of sandy gravel. The Musashino gravel layer is covered with around 5m of Kanto loam soil. Groundwater is found under rather different conditions in the Musashino gravel layer and the sand layers further down. The Musashino gravel layer has a high void ratio and permeability and contains large quantities of groundwater. The groundwater in this area flows south-westwards towards the edge of the Musashino Plateau, crossing below the station (Figure 2).

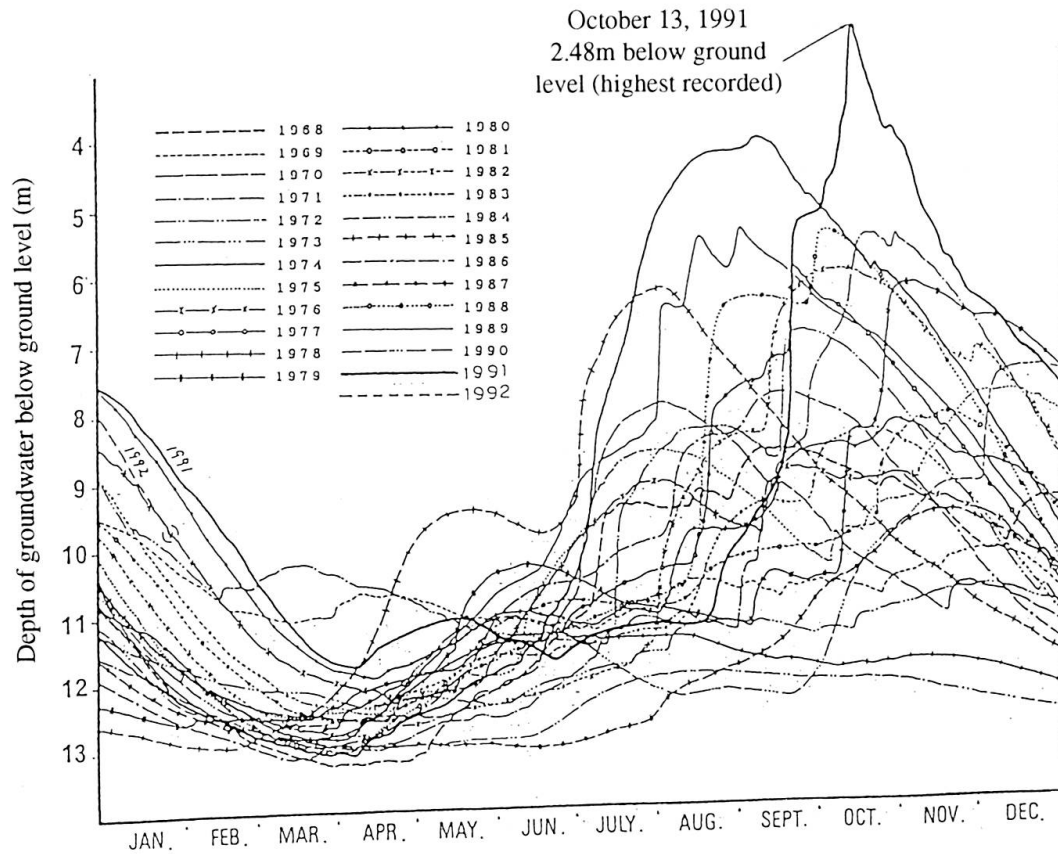
Fig. 3 Changes in Water Level Over Time in a Well at Kodaira-Nakamachi (produced by Hosono committee member)

Investigation of the relation between the groundwater level and rainfall over these 23 years confirmed that the amount of rainfall over the preceding several months combined with the rainfall over the immediately preceding days produced a rapid rise in groundwater level. A relationship between cumulative rainfall over the preceding 60 and 90 days and the rise in groundwater level was also confirmed. Using 116 years of the precipitation data from the Central Weather Agency in Otemachi, Tokyo (27km away) the period of recurrence of the cumulative rainfall seen in the 60 days and 90 days surrounding the disaster was studied. In either case the recurrence period was 100 years (Tables 1 and 2). Calculations based on actual water level data put the recurrence period at 66 years.

The balance point between the self-weight of the structure of Shin-Kodaira station and buoyancy due to groundwater (neglecting the effects of friction with the soil) is reached when the groundwater level rises to approximately 5m below ground level. Thus it can be inferred that the continuing rain from mid-August to early October raised the groundwater to a level unprecedented in the life of the station and caused buoyant upheaval of the U-shaped retaining walls.
