**Artikel:** Rehabilitation of two existing tunnels in West Malaysia: a case study  
**Autor:** Singh, Parnam  
**DOI:** <https://doi.org/10.5169/seals-59073>

## Rehabilitation of Two Existing Tunnels In West Malaysia: A Case Study

The Meru and Menora tunnels situated along West Malaysia's North-South Expressway were recently rehabilitated after more than 10 years in service. As part of the rehabilitation scheme an investigation programme was carried out to determine the nature and extent of defects in the ten year old concrete lined tunnels. Two main types of deterioration were investigated namely cracking and faulty expansion joints. The most widespread type of defects observed in the lining of the two tunnels was cracking. After having carried out the investigation programme a rehabilitation scheme was implemented to reinstate the existing defects. This paper highlights findings of the investigation programme including details of the overall rehabilitation scheme. It also makes recommendations for future maintenance and suggests long term monitoring of functionality and durability of the tunnel structure based on local Malaysian practice.

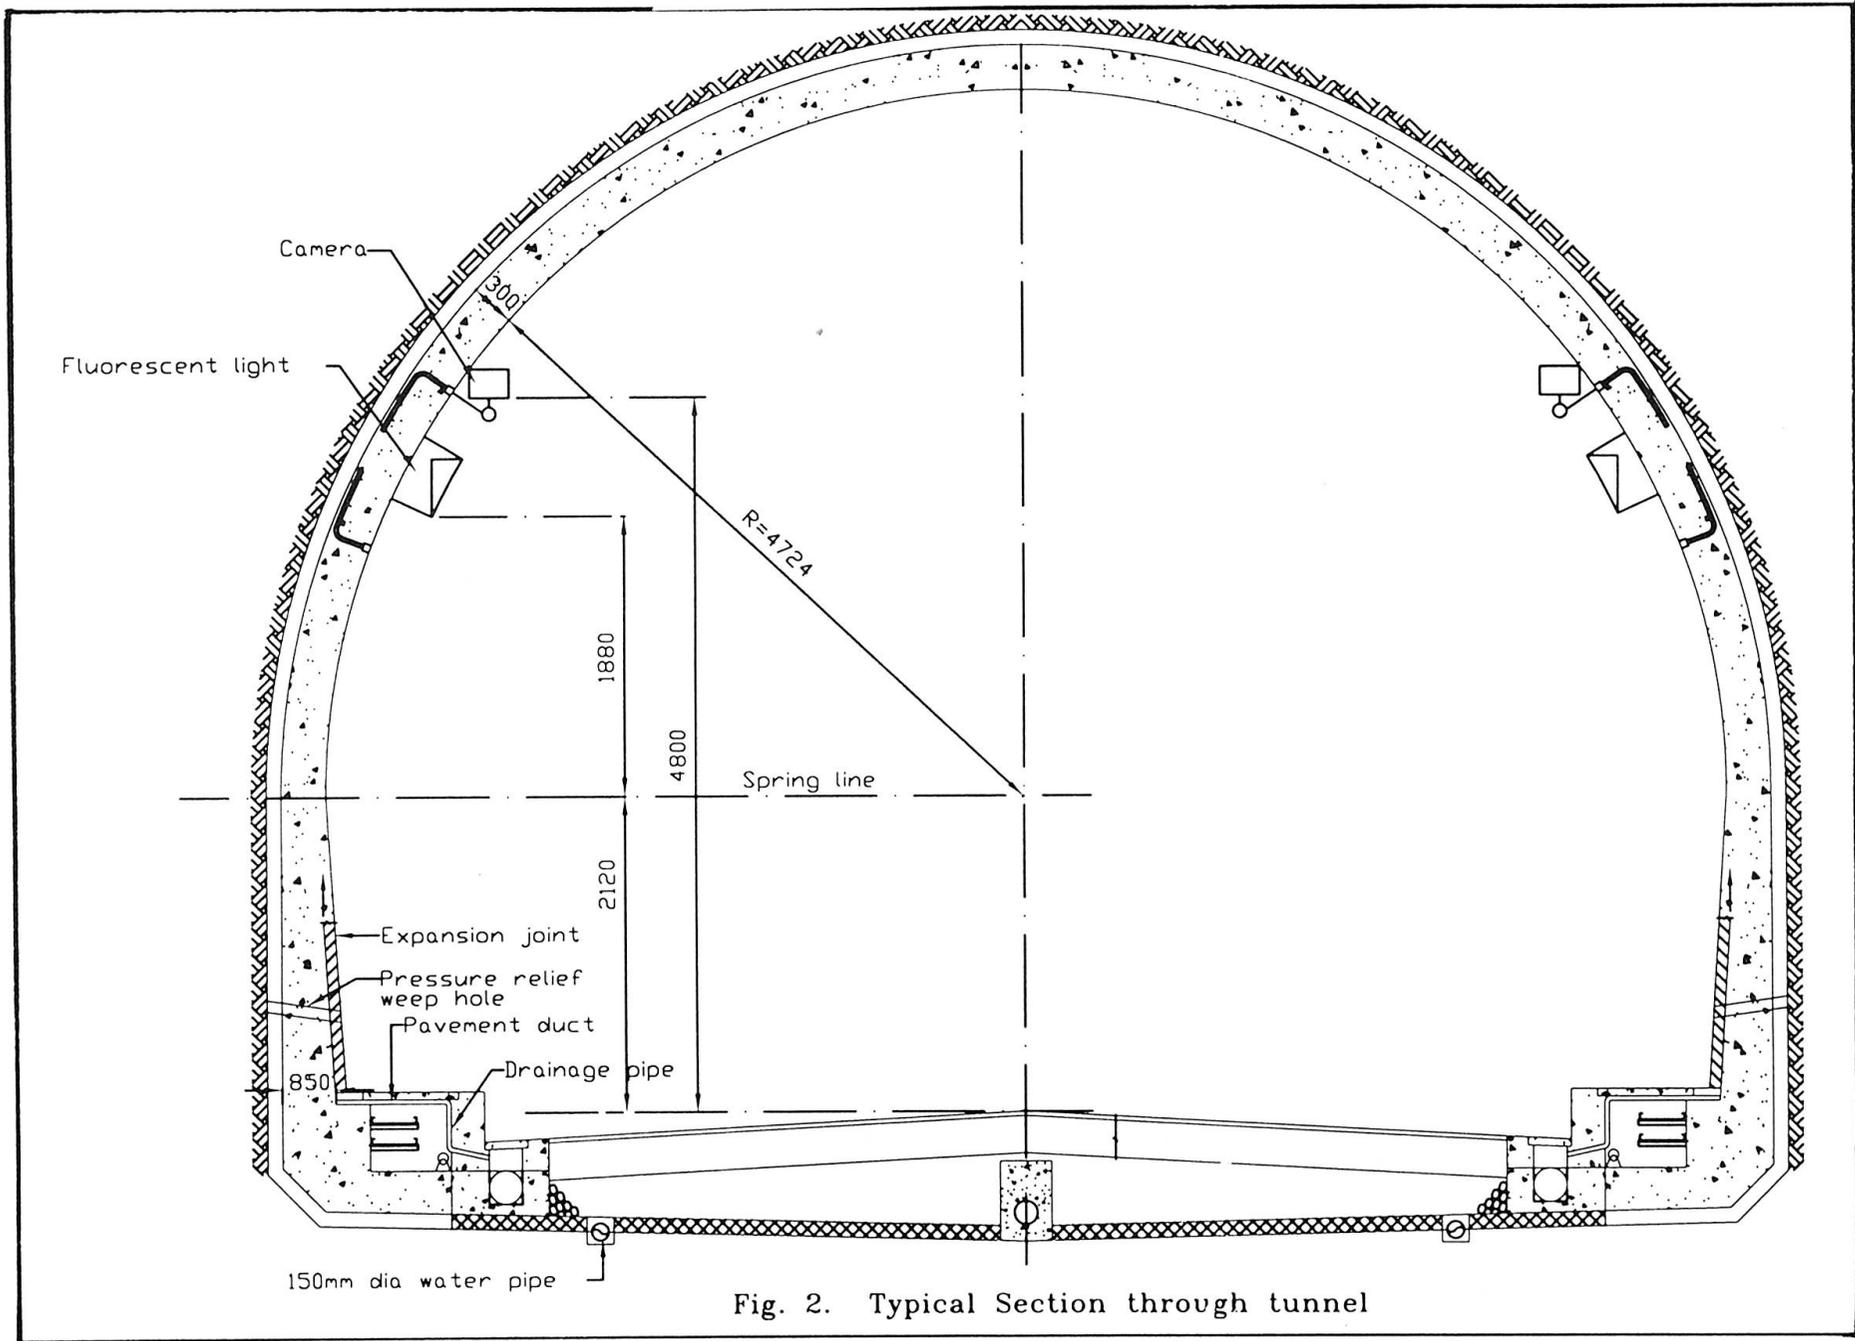
Fig. 2. Typical Section through tunnel

A detailed inspection was also carried out to determine the extent of damage in the existing expansion joints. It was noted that most of the sealant in the expansion joint was loose and damaged. A separate inspection was carried out to check on the efficiency of the existing fire hydrant system. The inspection confirmed that a section of the existing fire hydrant system in the north bound tunnel was faulty. Further inspections were carried out on the existing drainage system along side the kerbs. This was to ensure that water collected behind the concrete lining could be effectively conveyed into the drainage system via the existing weep holes.
