Rehabilitation of Two Existing Tunnels In West Malaysia: A Case Study

Parnam Singh
Manager
L&M Structures Sdn
Bhd, West Malaysia

The Meru and Menora tunnels situated along West Malaysia's North-South Expressway were recently rehabilitated after more than 10 years in service. As part of the rehabilitation scheme an investigation programme was carried out to determine the nature and extent of defects in the ten year old concrete lined tunnels. Two main types of deterioration were investigated namely cracking and faulty expansion joints. The most widespread type of defects observed in the lining of the two tunnels was cracking. After having carried out the investigation programme a rehabilitation scheme was implemented to reinstate the existing defects. This paper highlights findings of the investigation programme including details of the overall rehabilitation scheme. It also makes recommendations for future maintenance and suggests long term monitoring of functionality and durability of the tunnel structure based on local Malaysian practice.

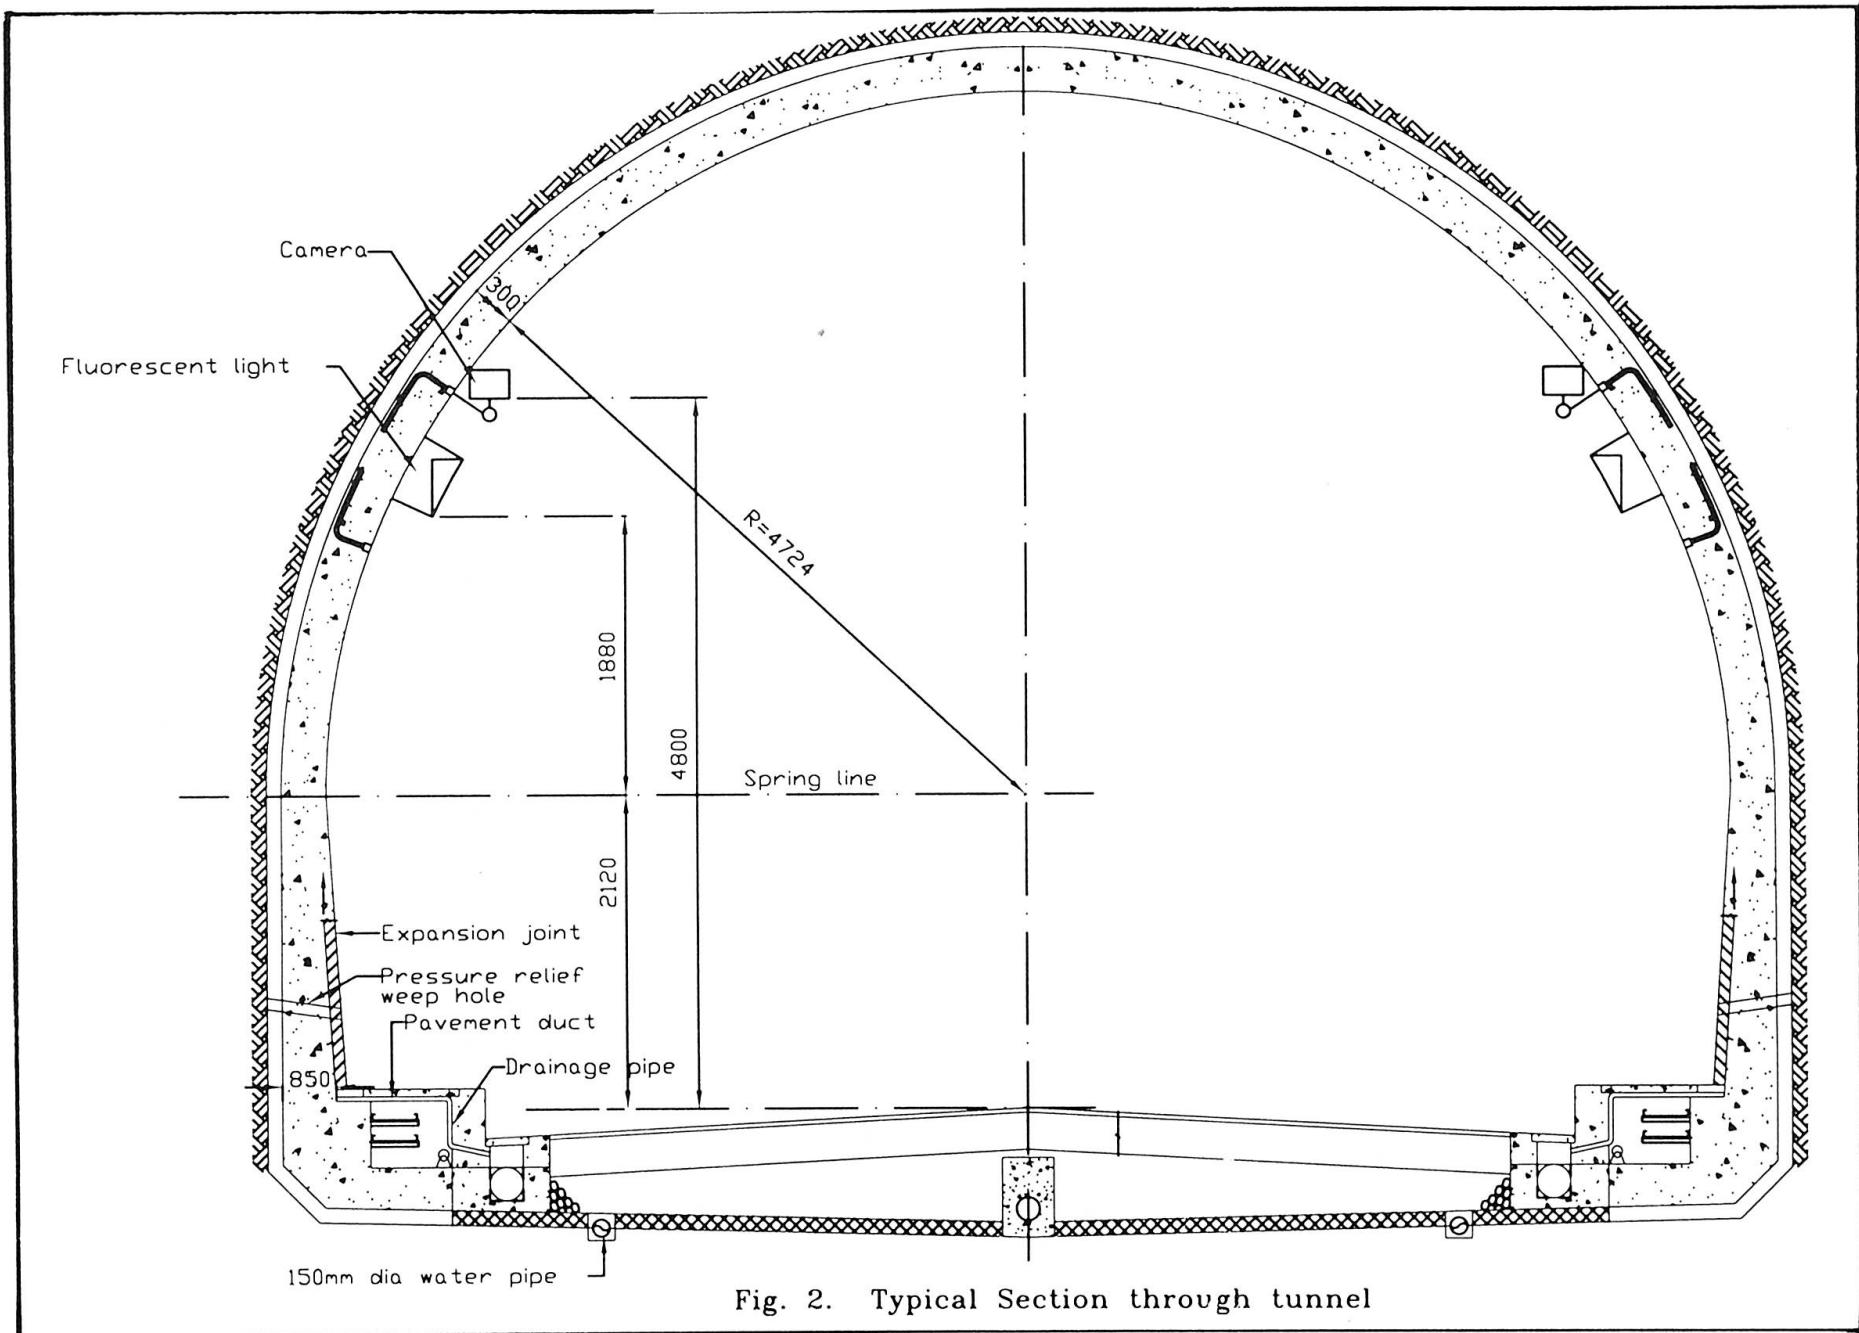
A detailed visual inspection carried out on the cracked concrete did not reveal signs of rust or corrosion of rebars. Localised break-outs were carried out to confirm the absence of rebar corrosion. Leaching of cement through wet cracks was evident in cracks located above the spring line of the tunnel. A detailed crack mapping exercise was carried out to document the extent and pattern of cracks in the lining. This was done by dividing the entire length of the tunnel into chainages and marking individual cracks according to their chainage. The total length of cracks measured for both the tunnels was close to 8500 metres. Most of these cracks were between 0.3mm to 3mm wide.

A detailed inspection was also carried out to determine the extent of damage in the existing expansion joints. It was noted that most of the sealant in the expansion joint was loose and damaged. A separate inspection was carried out to check on the efficiency of the existing fire hydrant system. The inspection confirmed that a section of the existing fire hydrant system in the north bound tunnel was faulty. Further inspections were carried out on the existing drainage system along side the kerbs. This was to ensure that water collected behind the concrete lining could be effectively conveyed into the drainage system via the existing weep holes.
