**Zeitschrift:** IABSE reports = Rapports AIPC = IVBH Berichte  
**Band:** 78 (1998)

**Artikel:** Rehabilitation work for the upheaval disaster at underground station caused by the groundwater rising  
**Autor:** Nozawa, Shinichiro / Kaneko, Shizuo / Matsuda, Takaji  
**DOI:** <https://doi.org/10.5169/seals-59074>

## Rehabilitation Work for the Upheaval Disaster at Underground Station Caused by the Groundwater Rising

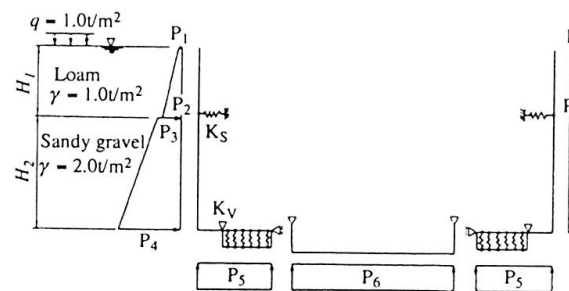
Fig. 5 Analysis Model

The analysis model of the structural frame is shown in Figure 5. In the analysis, four rows of vertical anchors were installed to provide resistance to buoyancy and struts were installed on the upper parts of the structural frame. Through a comparison of the construction periods required, roller bearings were selected for use in the connections between the old slabs and sections where excavation was to be conducted below the slabs.

The analysis results are given in Table 4. It was confirmed that the stress generated in the lower slabs would not exceed the resistance stress. At the connections between the old and new slabs, taking into account the fact that complete roller bearings and pin bearings cannot be created in concrete structures, reinforcement was provided with steel rebars and anchors to prevent opening and dislocation. The details are given in Figure 6. To ensure early generation of strength, the concrete strength was set at  $\sigma_{28}=360\text{kgf/cm}^2$  in the mix design.

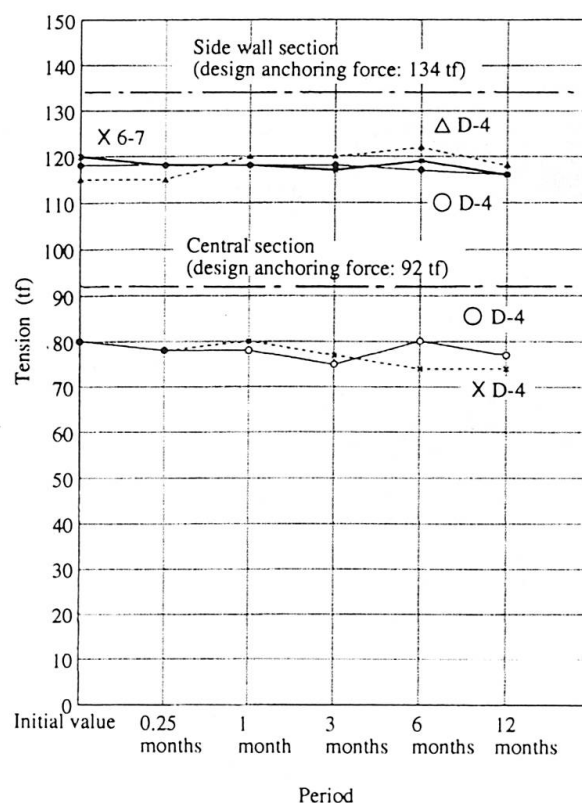
Fig. 14 Vertical Anchor Load: Measurement Results

The initial values given above are those at the time of the completion of the restoration work. A slight lowering can be observed in the tension both in the side wall section and the central section after the passage of one year.
