**Artikel:** Construction and maintenance problems of Kallabhomara bridge across river Brahamputra near Tezpur on NH-37a  
**Autor:** Balramamurthy, C.S. / Kumar, Satish  
**DOI:** <https://doi.org/10.5169/seals-60788>

## CONSTRUCTION AND MAINTENANCE PROBLEMS OF KALIABHOMARA BRIDGE ACROSS RIVER BRAHMAPUTRA NEAR TEZPUR ON NH-37A

### **SUMMARY**

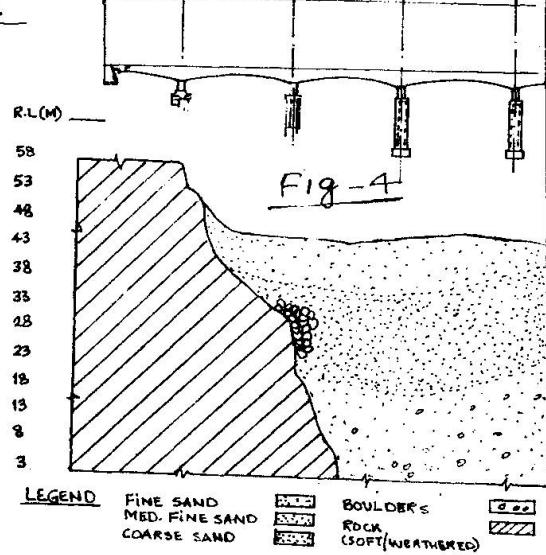
Fig. 3

During initial sub-soil investigations conducted in 1980 it was observed that the founding strata for pier well P1 would be on a dipping surface of rock. To overcome this the bridge was shifted by about 60m towards northwards. However when detailed boring was conducted at the shifted location of P1, it indicated the presence of a combination of hard

strata in northern half at a higher location and soft strata in southern half. On practical considerations, it was clear that it was not possible to provide a well foundation for shallow depth due to risk of tilting. Thus there was a design problem.

SECTIONAL ELEVATION AT A-A P-1

A separate design for pier P1 was carried out by providing a raft foundation for supporting the pier. The raft was designed in the following way: -

- 1) On the south side where the strata was soft, the raft was supported on 6 No. of bored piles of 1.50m dia.
- 2) On the north side where hard strata was found, the raft was anchored into the rock by means of 98 Nos. 36 mm dia HYSD rock anchors.
