Artikel: Construction and maintenance problems of Kallabhomara bridge across river Brahmaputra near Tezpur on NH-37a
Autor: Balramamurthy, C.S. / Kumar, Satish
DOI: <https://doi.org/10.5169/seals-60788>

CONSTRUCTION AND MAINTENANCE PROBLEMS OF KALIABHOMARA BRIDGE ACROSS RIVER BRAHMAPUTRA NEAR TEZPUR ON NH-37A

The Kaliabhomara Road Bridge across Brahmaputra near Tezpur, Assam (India) has 24 main spans 120.00m and two shore spans 67.50m each. The span arrangement consists of Pre stressed Concrete balanced cantilever arms of 52.50m long on either side of piers with a central Reinforced Cement Concrete suspended span of 15.00m.

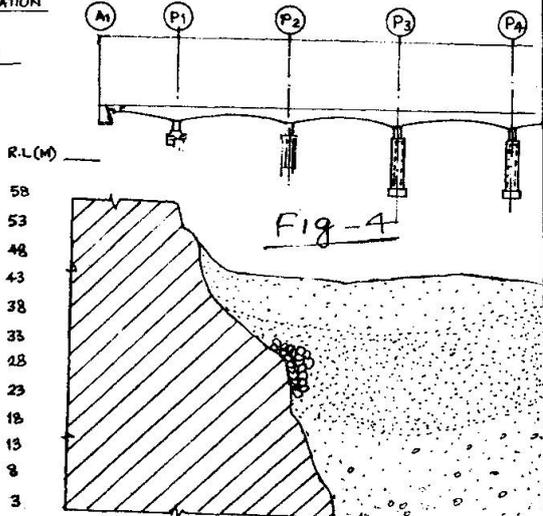
SECTIONAL ELEVATION AT A-A P-1 Fig. 3

During initial sub-soil investigations conducted in 1980 it was observed that the founding strata for pier well P1 would be on a dipping surface of rock. To overcome this the bridge was shifted by about 60m towards northwards. However when detailed boring was conducted at the shifted location of P1, it indicated the presence of a combination of hard

strata in northern half at a higher location and soft strata in southern half. On practical considerations, it was clear that it was not possible to provide a well foundation for shallow depth due to risk of tilting. Thus there was a design problem.

A separate design for pier P1 was carried out by providing a raft foundation for supporting the pier. The raft was designed in the following way: -

- 1) On the south side where the strata was soft, the raft was supported on 6 No. of bored piles of 1.50m dia.
- 2) On the north side where hard strata was found, the raft was anchored into the rock by means of 98 Nos.36 mm dia HYSD rock anchors.
