**Artikel:** Rehabilitation of the Luangwa Bridge  
**Autor:** Reinholdt, Peter / Veje, Ejgil / Kalvslund, Jimmy  
**DOI:** <https://doi.org/10.5169/seals-62169>

## Rehabilitation of the Luangwa Bridge

### Abstract

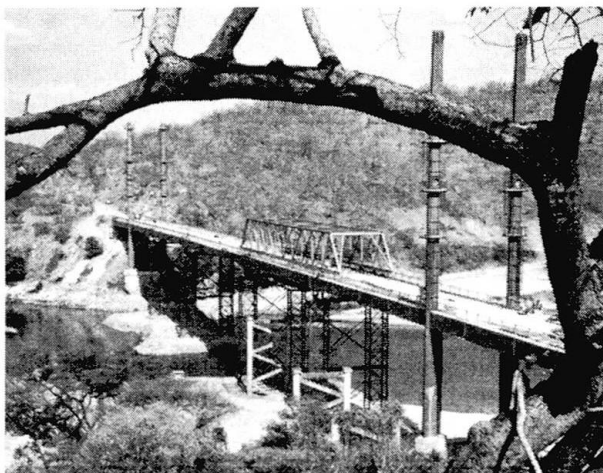
The travelling girder was designed to span neighbouring support points lifting the deck section undergoing rehabilitation. Spanning a maximum of 56 m and weighing 90 tonnes, it was designed to carry both the weight of 55 m bridge girder and the traffic loads.

The travelling girder was successively moved on top of the bridge deck on temporary rails into positions between two temporary towers. Once in position the weight of the bridge girder underneath was transferred to the travelling girder. The virtual “stress free” condition was achieved in this way and the required opening of bolted joints could be performed to allow fitting of the new splice plates and new bolts.

As the rehabilitation included installation of new bottom plates, splice plates and bolts in the main steel girders of the bridge deck, all bolted connections had to be opened. To do so the connections had to be either in a virtually “stress free” state or had to be temporarily fixed by clamps or equivalent. The chosen method of rehabilitation involved bringing the deck into a “stress free” state. This was achieved by use of temporary towers at the cable anchorage points and a travelling girder.
