Artikel: Emergency rehabilitation of the Zárate-Brazo Largo Bridges, Argentina
Autor: Andersen, Henrik / Hommel, Dietrich L. / Veje, Ejgil M.
DOI: <https://doi.org/10.5169/seals-62172>

Emergency Rehabilitation of the Zárate-Brazo Largo Bridges, Argentina

In November 1996 a cable ruptured on the Guazú Bridge across the Paraná River in Argentina, one of the two almost identical Zárate-Brazo Largo Bridges. COWI was immediately after retained as consultant by the bridge owner Dirección Nacional de Vialidad in order to ensure and document the safety of the bridges and to investigate the causes of the cable failure.

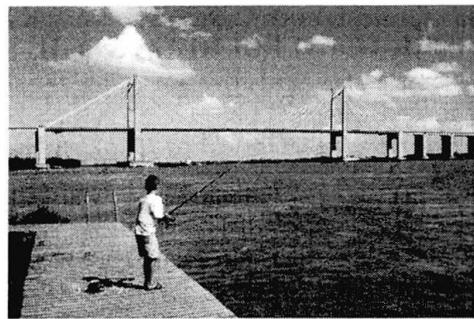
Fig. 1 Guazú Bridge across Paraná

The two cable stayed bridges are both 550 m long with a main span of 330 m. The bridges carry a 4 lane highway and a single railway track placed eccentrically. The bridges were opened to roadway traffic in 1977 and railway traffic in 1978. During the service life of the bridge there had been no prior indication of the critical situation of the cables.
