# Ohara Bridge fatigue crack repair (Japan)

### 6. Ohara Bridge Fatigue Crack Repair (Japan)

Owner: Toyama Prefecture  
 Engineer & Contractor: Kawada Industries  
 Work's duration: 6 months  
 Date of repair: 1984 – 1985

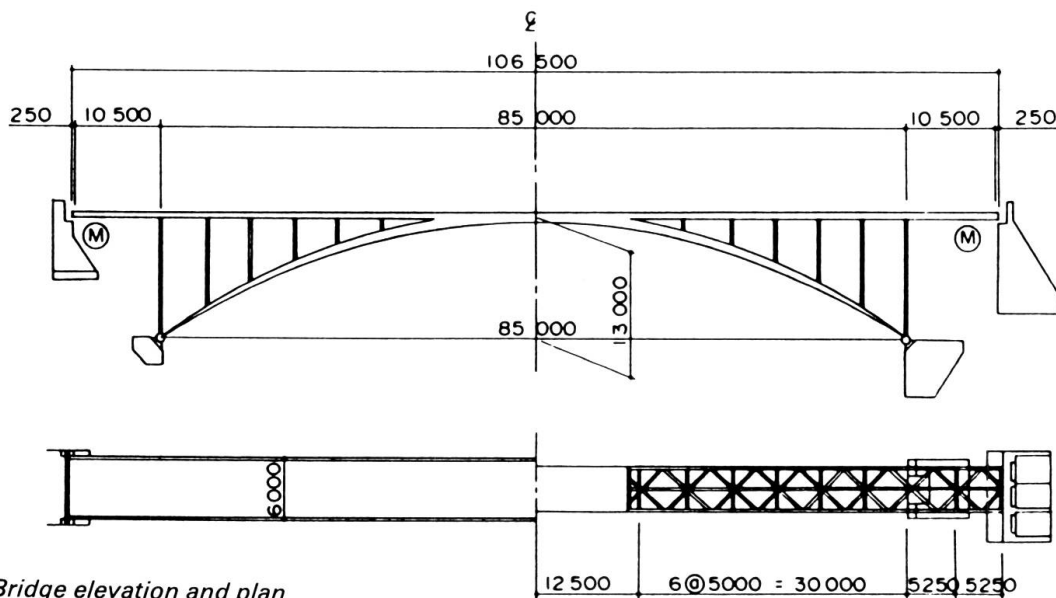
Fig. 1 Bridge elevation and plan

The Ohara Bridge is a two-hinged arch bridge with the bridge span of 106.5 m and the roadway width of 6.0 m, completed in 1963 (Fig. 1). This bridge was designed with the longitudinal support condition as being movable at both ends and had a single box construction with arch ribs having a very small depth. After the elapse of more than 20 years since its erection, fatigue cracks occurred in parts of the members of this bridge, mainly due to increased traffic volume in recent years and frequent passage of heavy motor vehicles associated with dam construction work. Therefore, this bridge was repaired to reinforce the members against loads.
