Short communications

Zeitschrift: **IABSE reports of the working commissions = Rapports des commissions de travail AIPC = IVBH Berichte der Arbeitskommissionen**

BEHAVIOUR OF AN ASEISMIC STRUCTURE
DURING CAUCETE EARTHQUAKE
OF NOVEMBER 23, 1977

DAMAGE TO BRIDGES DURING THE NORTH CAUCASUS EARTHQUAKES

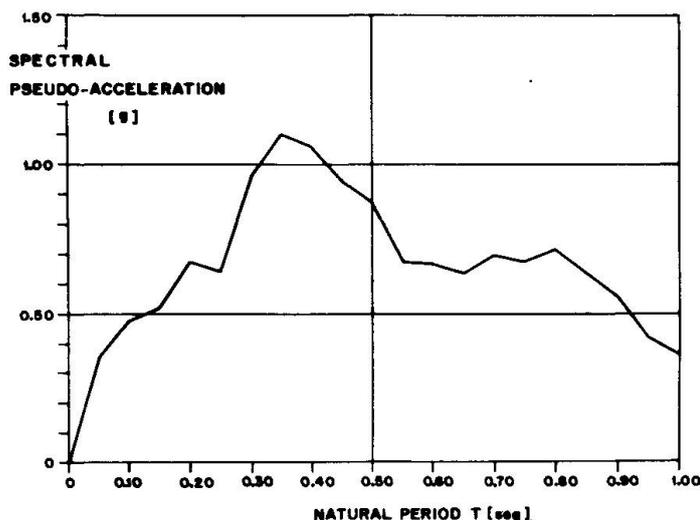
Fig. 3 - Pseudo-accelerations spectrum of Caucete 23.11.77 earthquake

To investigate this behaviour we used the spectrum shown on fig. 3, which was obtained from the spectrum calculated by IDIA, by multiplying its ordinates by the ratio between the records of two seismoscopes, one located in Caucete town, about 200 m distant from the structure, and the other beside the IDIA accelerograph in the city of San Juan,

These spectra are calculated for a damping ratio of 5% of critical damping. This figure is assumed to occur in reinforced concrete structures reaching yield, according to records from San Fernando earthquake of 1971.

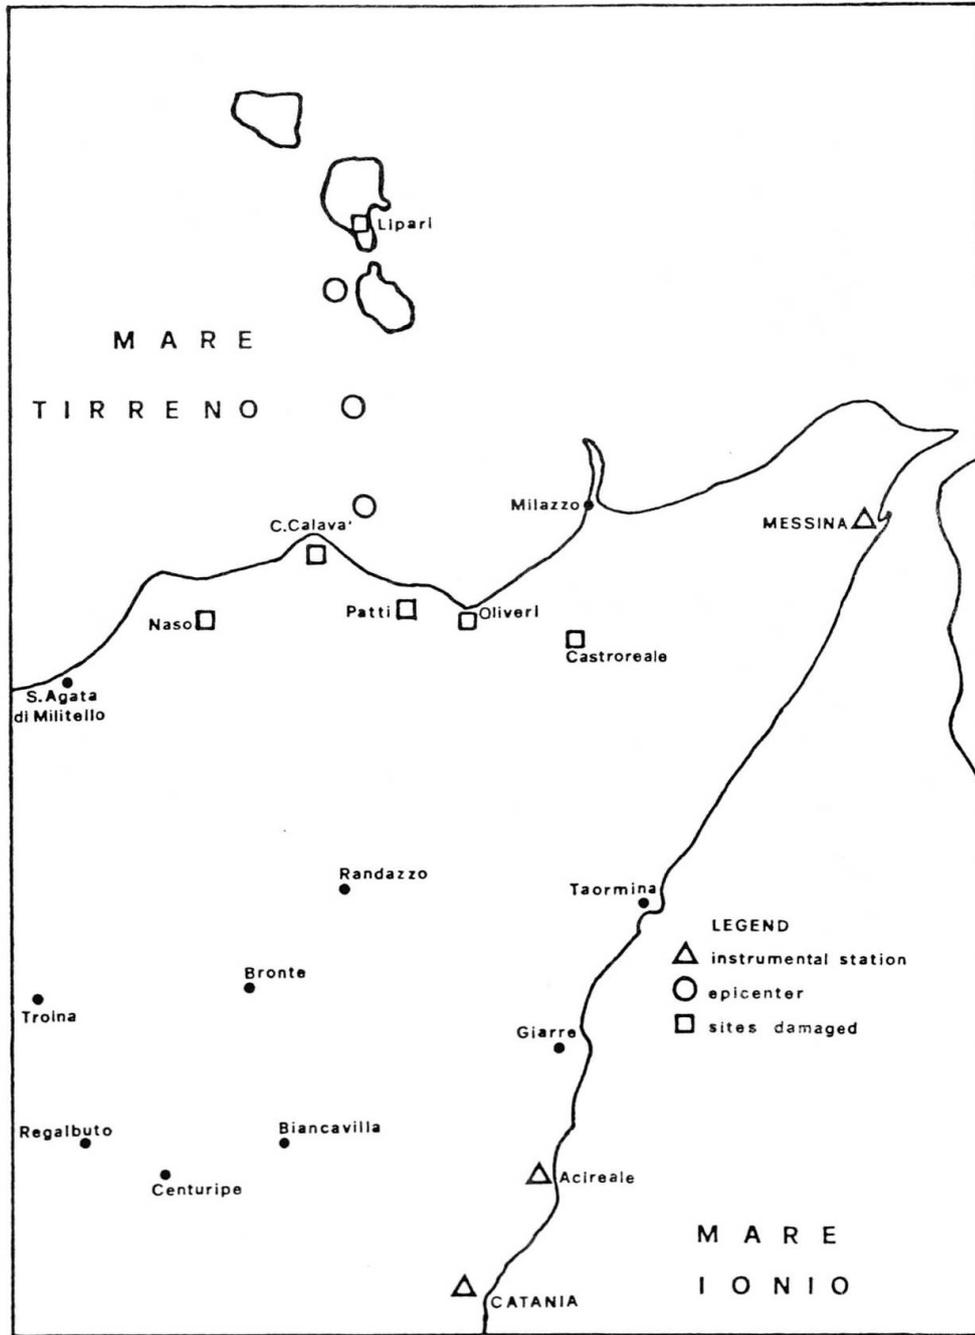
Fig. 1: Patti Earthquake, April 15, 1978.

On Saturday 15th April 1978, at about half past midnight (local time), a 5.5 magnitude earthquake occurred in the Aeolian Islands between Lipari and Vulcano, opposite Marina di Patti, a small coastal township in the Commune of Patti (fig. 1).

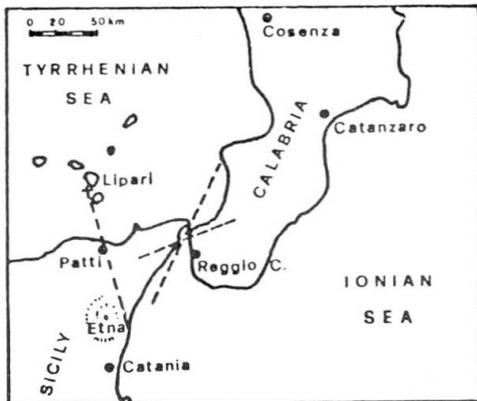
The earthquakes appeared to be of tectonic origin and several faults are present in the region, as sketched schematically in fig. 2. It is interesting to note the presence of a fault passing by Mt Etna through Patti till it reaches the Island of Vulcano, which probably was active during the earthquake.

Fig. 2: Sketch of fault probably related to earthquake

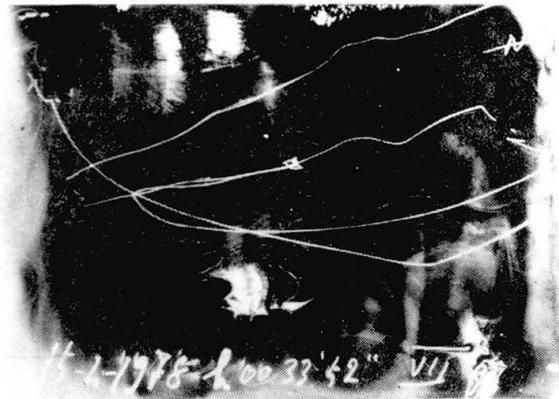
Fig. 4: Seismoscope record at Collegio Pennisi of Patti earthquake.

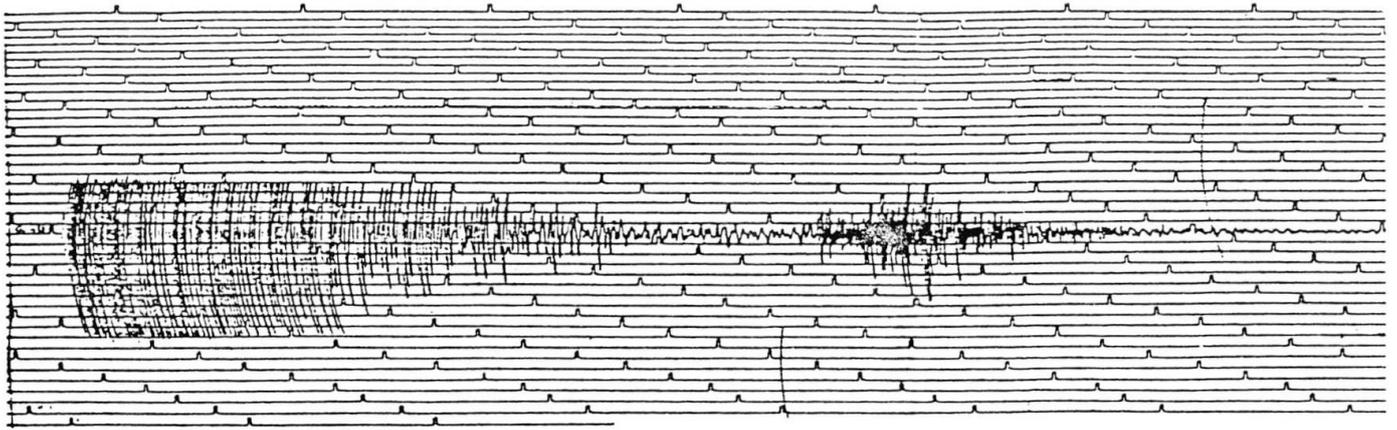
The main shock was preceded by a small shock a few minutes before. Its record is incomplete because the seismograph at Catania University went off the scale (fig. 3) as did the one at Messina University.

As appears clear from fig. 3 the main shock was very quickly followed by an induced sussultory earthquake.

Fig. 3: The Patti earthquake recorded at the University of Catania.

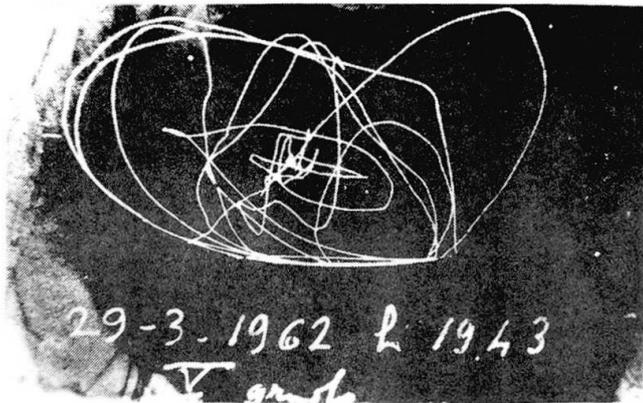
By way of comparison, the record with the same historical seismoscope (called Vicentini) of a 4.3 magnitude earthquake which occurred on 28th March 1962 at 3km from the Acireale station (Costa, 1977) is represented in fig. 5.

Fig. 5: Seismoscope record of a 4.3 magnitude earthquake.
