## **The Clifton Suspension Bridge – Preservation for Utilisation**

### **M. Stuart CULLIMORE**

Deputy Chairman  
Clifton Suspension Bridge Trust  
Bristol, UK

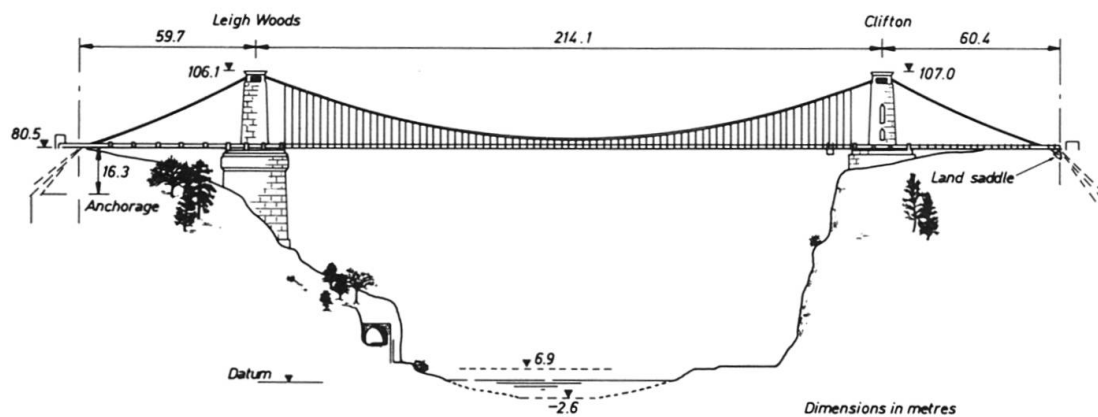
Fig. 1 South elevation of bridge

The promontory from which the bridge springs on the Clifton side is a stable formation of massive blocks of rock. The Leigh Woods masonry abutment is approximately 23m square, rising some 40m from the side of the cliff (Fig. 1). There has been no evidence of any movement at either abutment although there had recently been 'slips' in other parts of the Avon Gorge. Large solution cavities are known to exist in the limestone in this region together with clay layers within the limestone sequence. In view of this and the presence of water seepage in the vicinity, a site investigation of the Leigh Woods abutment was ordered in 1969.

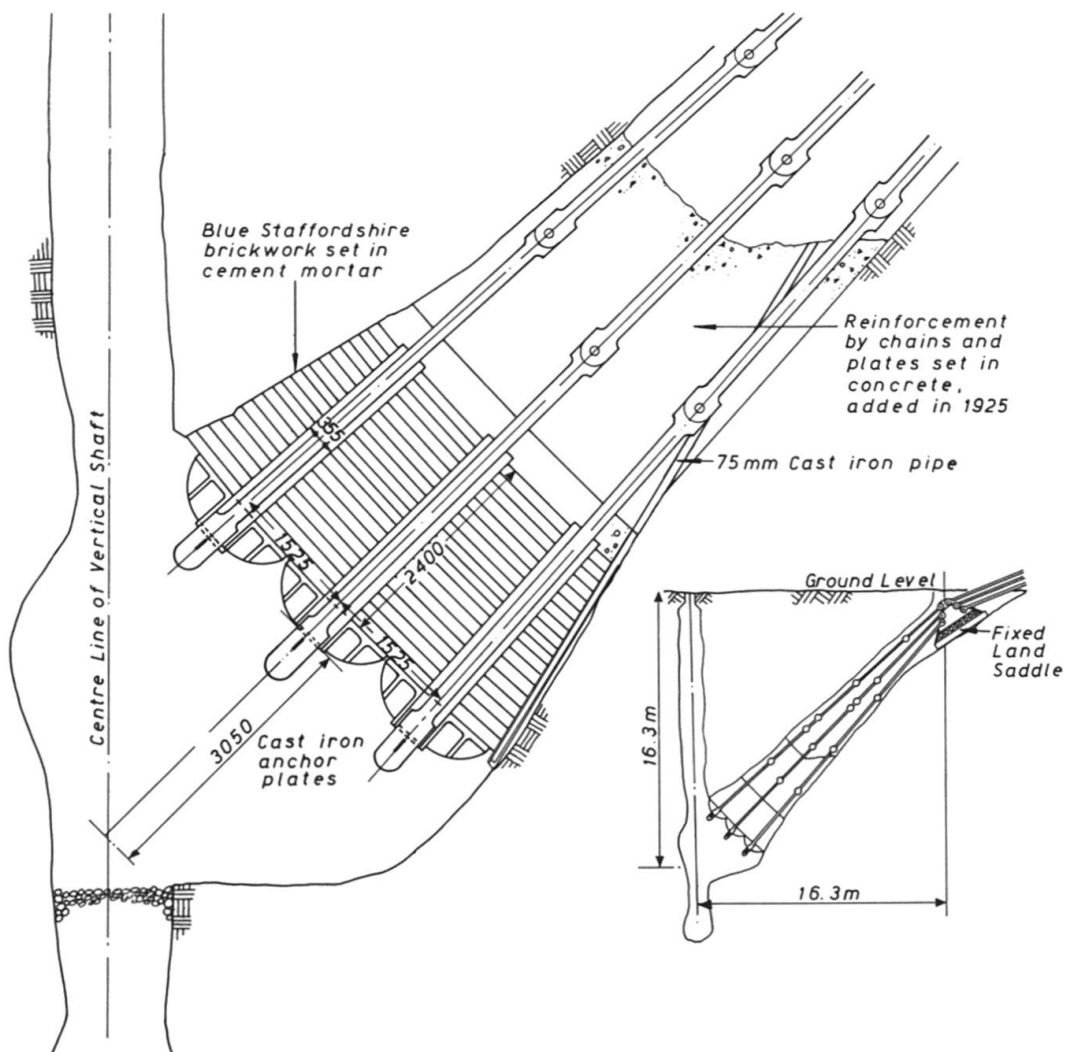
**Fig 4** Anchorage

The mass masonry abutments are faced with red sandstone ashlar. The towers, faced in local Pennant stone, have a freestone capping with a cast iron parapet. They carry the saddles and roller beds which also came from the Hungerford bridge and were increased in height to accommodate the third chain. The land chains are attached to the tower saddles and span freely to fixed land saddles just below ground level. From there they dip down at about  $45^\circ$  for 18m separating to pass through separate cast iron anchor plates which are supported by brick arches abutting on the solid rock (Fig. 4).

The ironwork was originally coated with tar and later with bituminous compounds and paints, although no records are available to indicate how frequently painting was necessary in the increasingly aggressive atmosphere caused by developing local industry. However, by 1924, serious corrosion had occurred in the chains at the bottom of the anchorages, particularly in the Leigh side, caused by drainage from the roadway and inadequate ventilation. The chains were strengthened by adding a new link to each chain where it entered the anchorage arch and reinforcing the sections in the anchorage tunnels by open-link chains from below the land saddles outwards to new anchorages in the tunnel walls. The whole was then embedded in concrete. The Clifton anchorages were similarly treated in 1939.
