Health and Safety in the Humber Bridge Construction, 1973 – 1981

Michael SPARKES

Principal Inspector
Health and Safety Executive
Sheffield, England

The construction of the Humber Bridge, UK, with a central span of 1410 m took over 8 years employing a workforce averaging 420 men. At the planning stage already a site safety coordinator was appointed, having jurisdiction for safety over the whole project. The article reviews the phases of construction of the bridge and hazards encountered. Accidents statistics are presented and safety measures recommended.

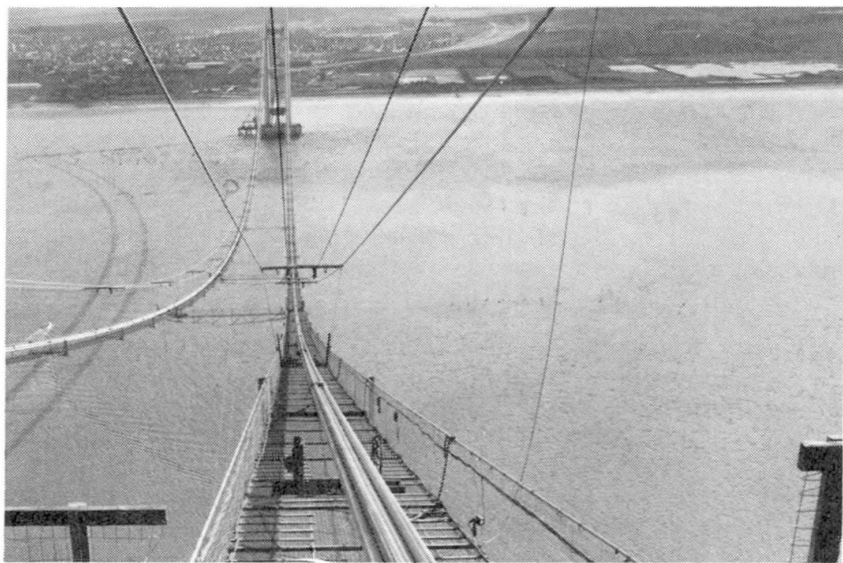
Each cable comprises 14,948 parallel galvanised drawn 5mm diameter wires, divided into 37 strands each of 404 wires.

Mainspan cable part way through spinning process.
