Combined frame-strut earthquake resistant bridge

Autor(en): **Mitrofanov, Ju.M. / Popov, O.A.**

Zeitschrift: **IABSE reports = Rapports AIPC = IVBH Berichte**

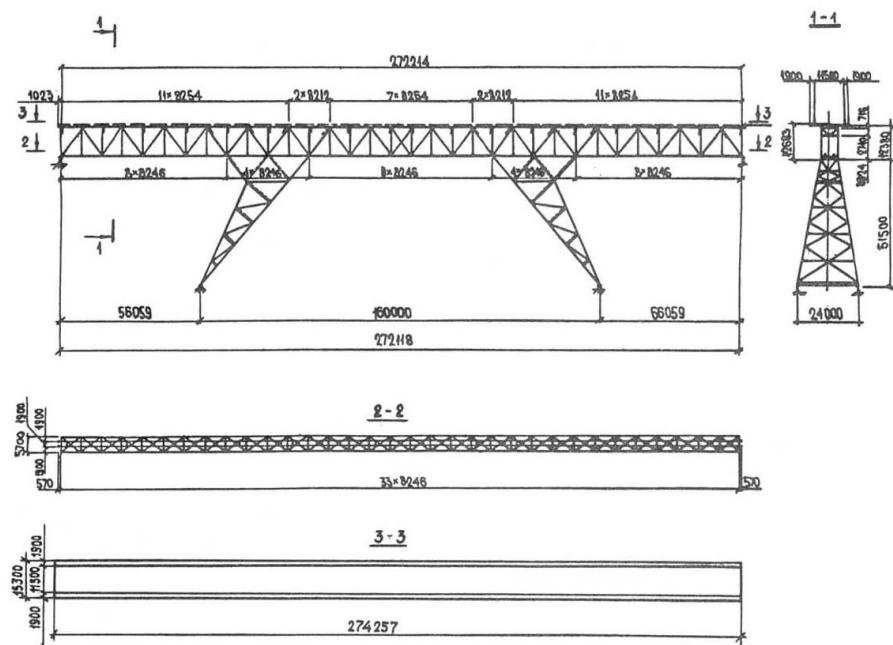
Fig. 1 Diagram of superstructure

The welded superstructure (Fig.1) uses high strength bolts for erection joints. The structure material - steels 10XCHD, 12 XTYAM of grade C-40, 15 XCHD (C-35), 16D (C-23). The total mass of metal is 3276 t.

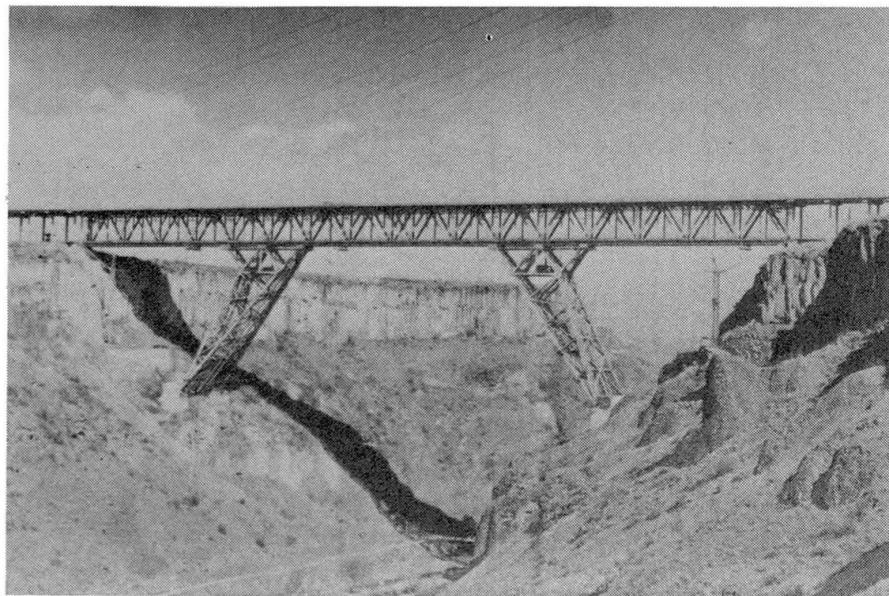
Fig. 2 General view of bridge

The bends, measured in the course of tests, made 80% relative to the design ratings, and the axial stresses in the main girder elements - 70-85%. The bridge was normally operated within 10 years, and during the disastrous earthquake of 1988 the superstructure (Fig.2) suffered no damage.
