Survey of statical conditions of churches in Rome

Survey of Statical Conditions of Churches in Rome

In this context, the writers have been commissioned by the Ministry of Public Works to undertake surveys and investigations on the statical conditions of three main basilicae in the heart of Rome: St. Augustine's, St. John of the Florentines' and the Gesù.

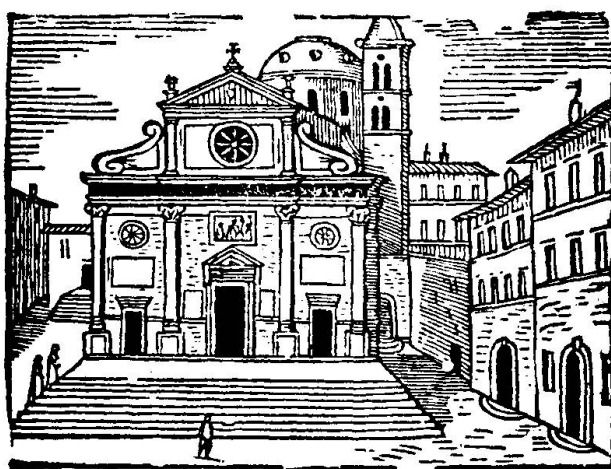
In 18th century, the structure was in bad shape, with severe cracks in the central part, including the drum

sustaining the dome. Then, L. Vanvitelli completely renovated it, consolidating all foundations, dismantling the whole dome and replacing the old bell-tower (both still appearing in the engraving).

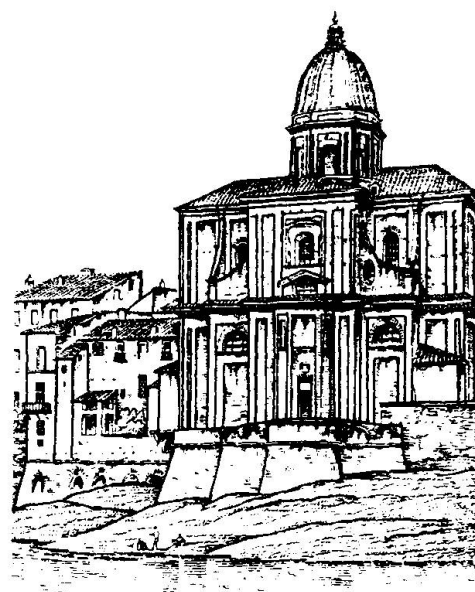
St John of the Florentines' was built by the state of Florence in the beginnings of the 16th Century and completed in the following, involving several of the most important architects of the time. It lies on the Tiber left bank, opposite the Vatican. A large foundation plate was built into the river bed, then without embankments (see the engraving), giving the church a length appropriate to its importance.

Subsequent architects chose different layouts among centric and longitudinal plans, while construction was going on. Finally, the longitudinal scheme prevailed with A. da Sangallo. Some older structures were incorporated such as those of a chapel; but they are not on the same plate as the church and may suffer differential settlements, also due to the high changes in water level of the nearby river.

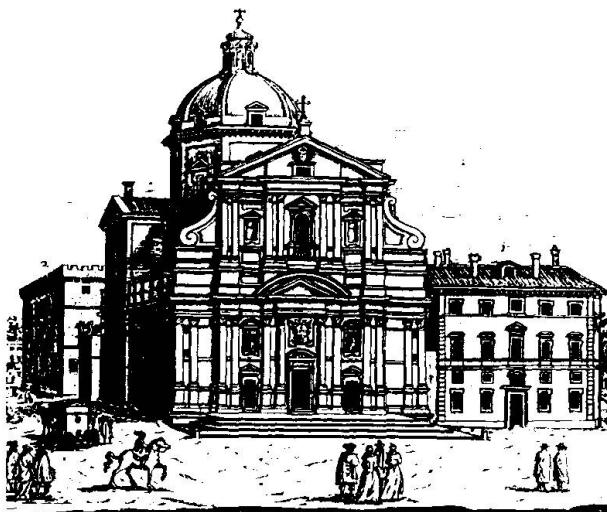
The Gesù (the Holy Name of Jesus'), Mother-Church of the Society of Jesus, is perhaps the most important Renaissance church in Rome. A small chapel, S. Maria della Strada, assigned to the Society on the site, was soon demolished, yielding place to the new majestic architecture. Several designs were examined,

including Michelangelo's, implying various positions, before the actual one by G. Della Porta was agreed upon, its façade rising in front of the *Papal Street* and chancel in the place of the former chapel.

The dome is low, not to impose upon the view of the façade; it had masonry ribs also on the inner face, that were demolished in the 17th century for frescoing the ceiling (a report says that the masonry of the vault was *good and strong*, needing no ribs!).
