Heated bridge deck construction and operation in Lincoln, Nebraska

Autor(en): **Cress, Milo D.**

SUMMARY

The construction and operation of a hydronic bridge/pavement deck heating system are described in this paper. The system is installed in the deck of a 367 m-long by 3.7 m-wide viaduct in Lincoln, Nebraska, USA. The system was monitored and performance evaluated for 12 months following installation.

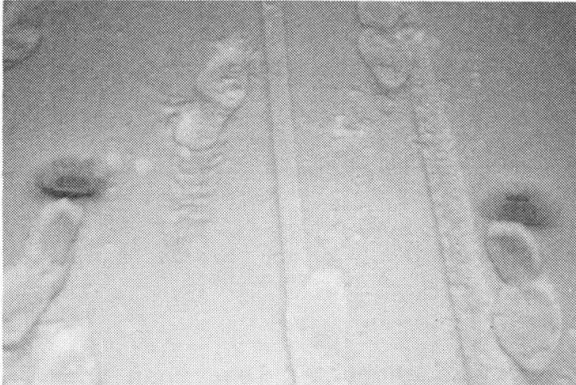
Fig. 9 Moisture Sensors with Snow

Light drizzle with very light snow flakes began early in the morning on December 30, 1994. This continued through most of the day. At 1200 hours the deck was wet, except at the control moisture sensors. Each sensor and about a 50-mm region around each sensor remained dry. Heat from sensors was evaporating moisture. At 1630 hours sensors had some ice accumulation that bridged the sensing elements. At 2330 hours snowfall was very light and about 20 mm of snow had accumulated on the deck. Sensors had no ice and were dry with adjacent snow accumulation (Fig. 9). At 0800 hours on December 31, about 32 mm of snow had accumulated on the deck and sensor location was slightly marked by dark spots on the snow (Fig. 10). Snow accumulation had formed a cap over each sensor and each sensor remained dry. The system did not start automatically because of this "igloo" effect. During investigation of the sensors, snow fell on the sensors, was melted, and the system started at 0955 hours on December 31. Gas and electric meter readings were 8 393 m³ and 2 276 kWh, respectively. At 1840 hours, gas and electric meter readings were 8 996 m³ and 2 320 kWh, respectively. Snow had been melted on about 40 percent of the deck and some spots on the deck were dry. At 1200 hours on January 1, 1995, about 38 mm of snow had accumulated on unheated streets and sidewalks. Gas and electric meter readings were 10 191 m³ and 2 402 kWh, respectively. The deck was about 95 percent cleared with significant dry areas. The boiler was cycling on and off. At 1600 hours the gas and electric meter readings were 10 432 m³ and 2 420 kWh, respectively. The deck was 99 percent clear and the boiler was cycling on and off (Fig. 11). At 1830 hours gas and electric meter readings were 10 516 m³ and 2 421 kWh, respectively. Pump motors were running and the boiler was not operating. The system was manually turned off at 2330 hours and motors stopped. Subsequent

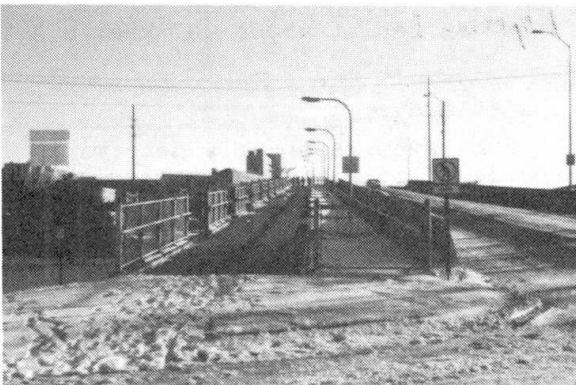
Fig. 11 Advanced Snow Melt
