Zeitschrift: IABSE structures = Constructions AIPC = IVBH Bauwerke
Band: 12 (1988)
Heft: C-44: Structures in Finland

Artikel: Lietvesi Bridge, Puumala (Finland)
Autor: Hyvönen, J.
DOI: <https://doi.org/10.5169/seals-20905>

5. Lietvesi Bridge, Puumala (Finland)

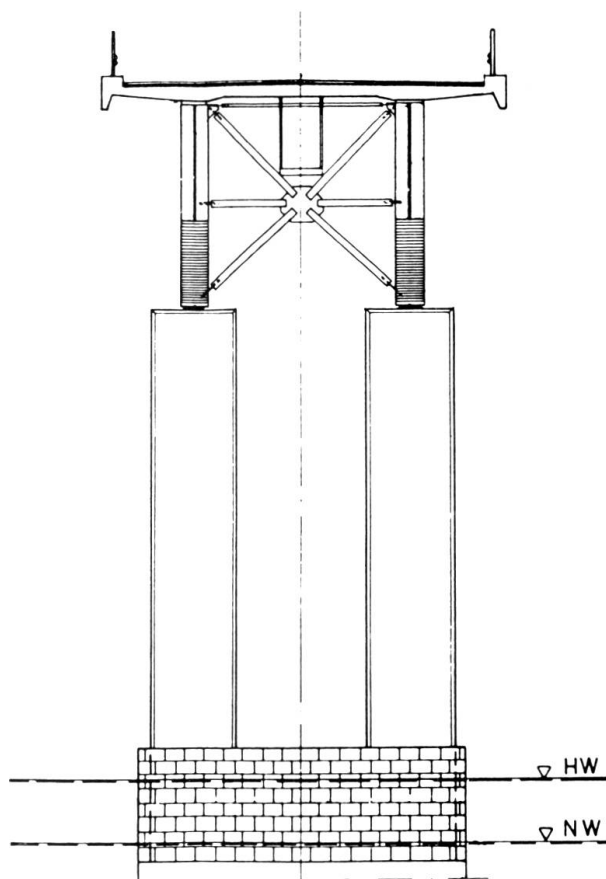
Fig. 1 Bridge cross-section

The main girders were manufactured according to Finnish Standards SFS 255 fine grained steel Fe 355E (corresp. TStE 355/DIN 17102). A total of 800 tons were used for the bridge. The main girder chords are 800 mm wide at their largest point, and their maximum thickness is 120 mm. The web thickness varies from 16 to 24 mm. At the piers, the lower chord is «bent», using a 10 meters radius. The cross and lateral frames are K-frames. Their members are made of square tubes steel grade Fe 520 according to Finnish Standard SFS 200 (St 52-3/DIN 17100). For the frames 40 tons of steel was used.

For the non-tensioned bridge slab 750 m^3 of concrete and 160 tons of reinforced steel were used. The longitudinal slab reinforcement is, at the intermediate supports, about 2% and even in the span about 1% of the concrete cross-sectional area. In this way the crack width has been considerably limited. The price of reinforcing steel is only half the price of structural steel. It is therefore, at the intermediate supports, economical to use it «as the upper chord of the main girder».
