Zeitschrift: IABSE reports = Rapports AIPC = IVBH Berichte
Band: 39 (1982)

Rubrik: Session 3: Rehabilitation and repair of bridges

Rehabilitation and Repair of Bridges

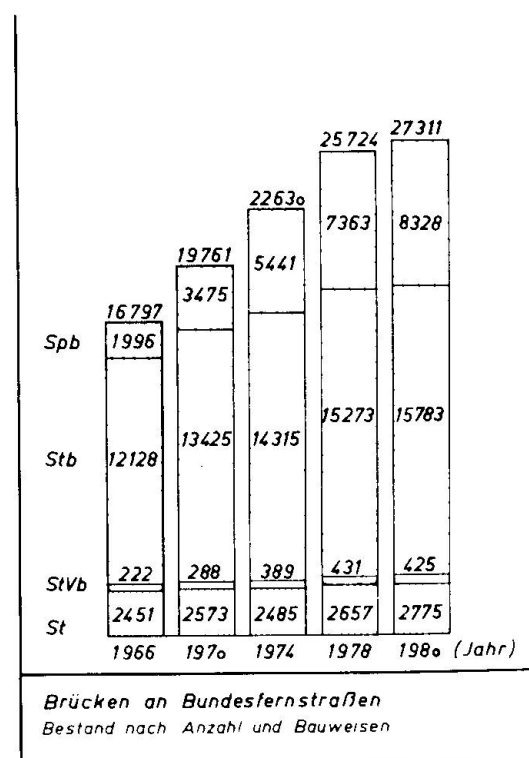
Fig. 1 Bridge statistics/number of bridges

The development of the federal trunk road network and of the bridge stock during the past 15 years is shown in Fig. 1.

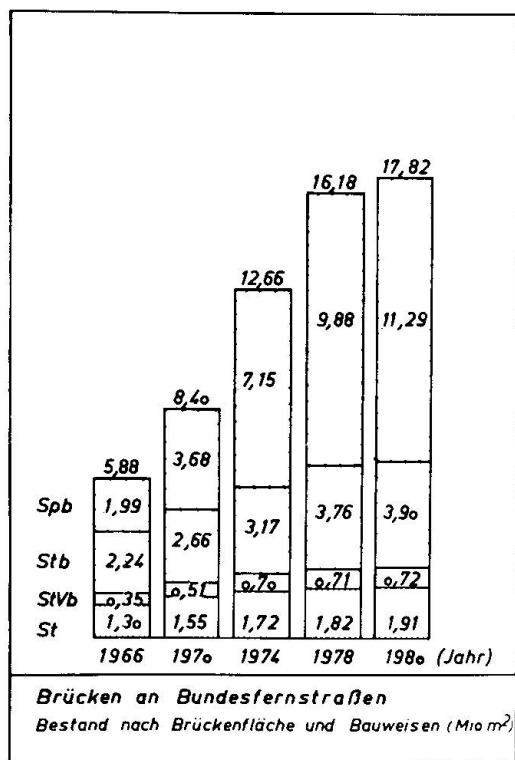
Fig. 2 Bridge statistics/
bridge deck area

Approximately 11,500 bridges with a deck area of almost 12.4 million m² were built on federal trunk roads between 1965 and 1980. Thus, by 1980, the number of bridges carrying or spanning federal trunk roads increased to about 27,000, with their deck area amounting to 18 million m² (Fig. 2).

Almost 90 % of these (i.e. 24,000 bridges) consist of reinforced or prestressed concrete. The percentage of the deck area of these structures (approx. 15 million m²) to the deck area of all bridges on federal trunk roads is approximately 85 %.

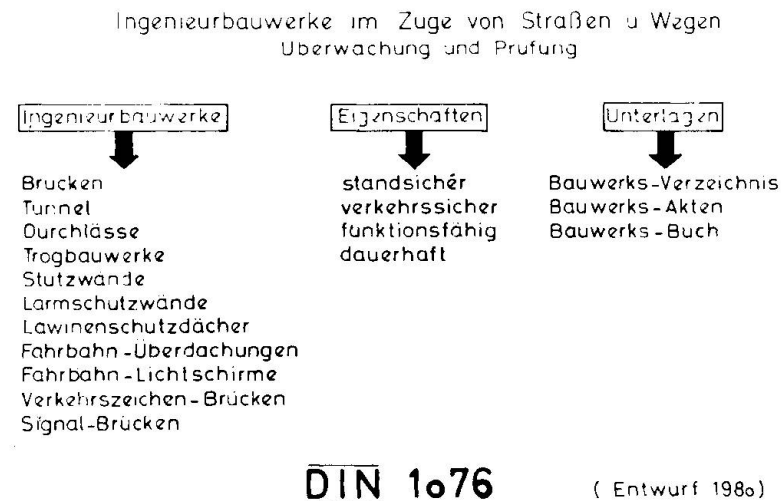
Fig. 3 DIN 1076;
inspection structures/properties/
documents

Fig. 3 contains the most important engineering structures which are inspected in conformance with this standard. Above all, noise barriers and trough constructions have increased considerably during the past years. The properties of the structures to be preserved are listed in the middle of the figure and on the right those documents that are needed for the inspection of the structures.

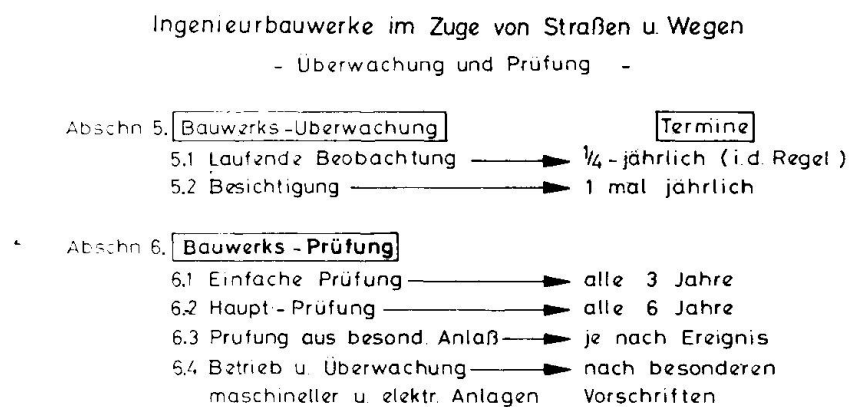
Fig. 4 DIN 1076;
inspection intervals

The next figure (Fig. 4) shows the types of inspection and the times and intervals at which these should take place. The most important inspection is the so-called main inspection, which is carried out every six years, during which the structure is put to the "acid test".

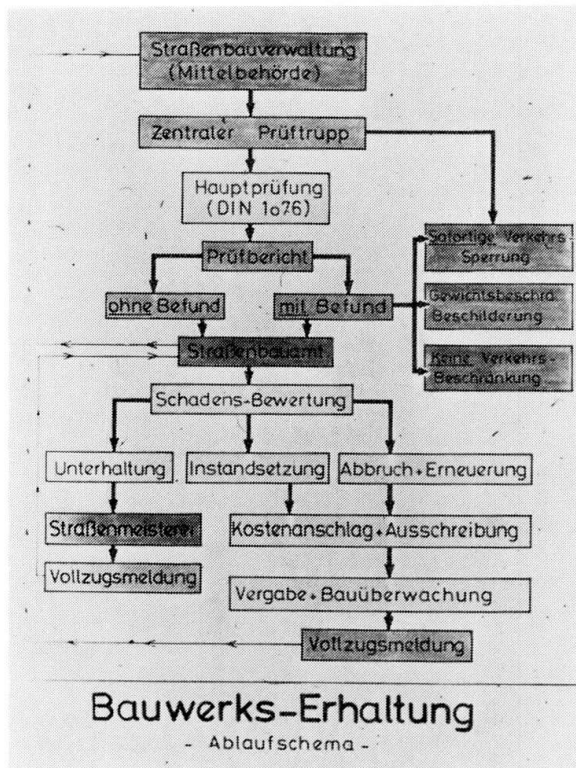
Fig. 9 Preservation of the structure - organization scheme

Fig. 9 shows how the supervision of structures is organized within our highway administration, taking the main inspection as an example. The main inspection is generally carried out by special inspection parties. Depending on the kind and the significance of the defects detected, the test results will set off different activities, which range from minor maintenance measures by the responsible road or motorway maintenance depot to the immediate closure of the bridge.

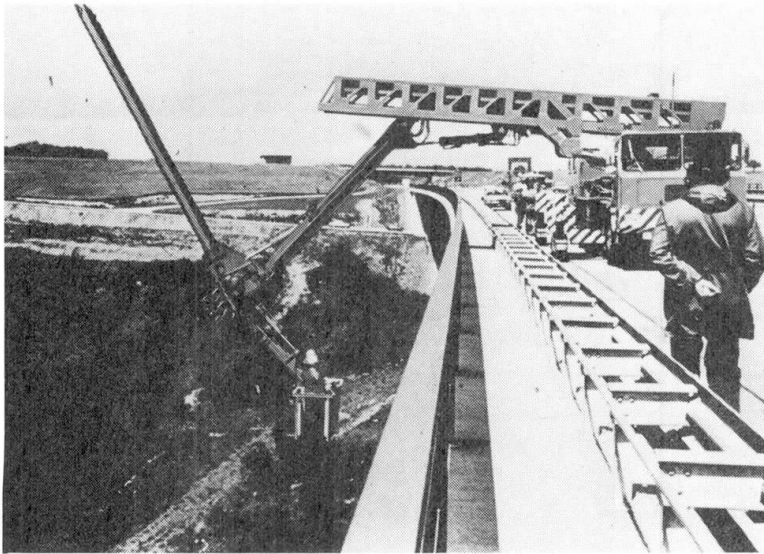
Fig. 10 Bridge inspection equipment Ruthmann double telescope with elevator and three joints US 260

- Figure 10 shows a double telescope with elevator and three joints with a working and inspection bucket for two men. The extension under the bridge is 9.10 m, the lifting height 28 m. Such equipment is particularly suitable for the local inspection of bearings, drainage installations, etc.
- For wide motorway bridges, inspection equipment with working platforms of up to 16 m extension under the bridge are necessary. Figure 11 shows such equipment in action. There can be no doubt that such platforms give much better access to underbridge areas and make it possible to do minor repair work.
- Other equipment, such as inspection trains from the German Federal Railways or an inspection ship from the Waterways and Shipping Administration, can be used for the necessary inspection of road bridges over electrified railway lines and across canals.

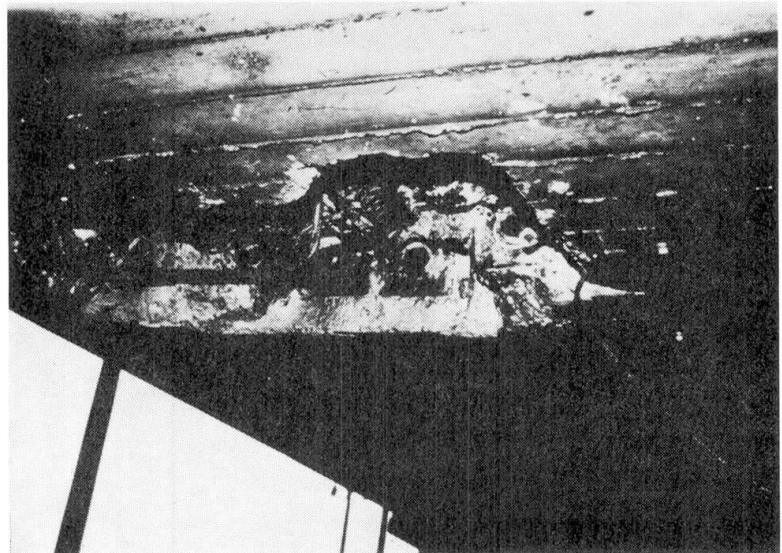
Fig. 14 Underside view of hollow box in the region of coupling joint - laid open (flyover Prinzenallee)

The costs of the repair and reinforcement work are not inconsiderable in these cases. In a particular case, e.g. the fly-over Prinzenallee in Düsseldorf, they amounted to about 5.5 million DM (Figure 14).

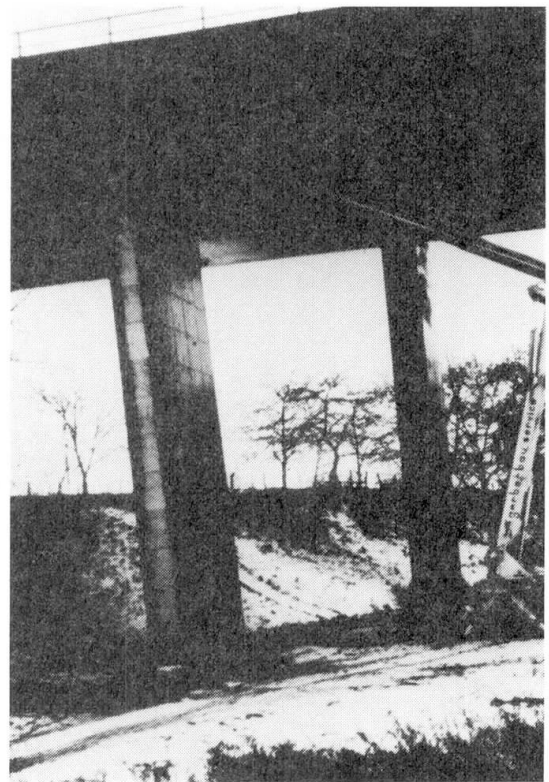
Fig. 19 Damage to the pier due to
rolled off bearing (valley
bridge Blockheide)

Owing to the failure of a roller bearing the superstructure sagged by 27 cm which caused an eccentric load on the pier and entailed heavy damage to the super- and substructures (Figure 19).

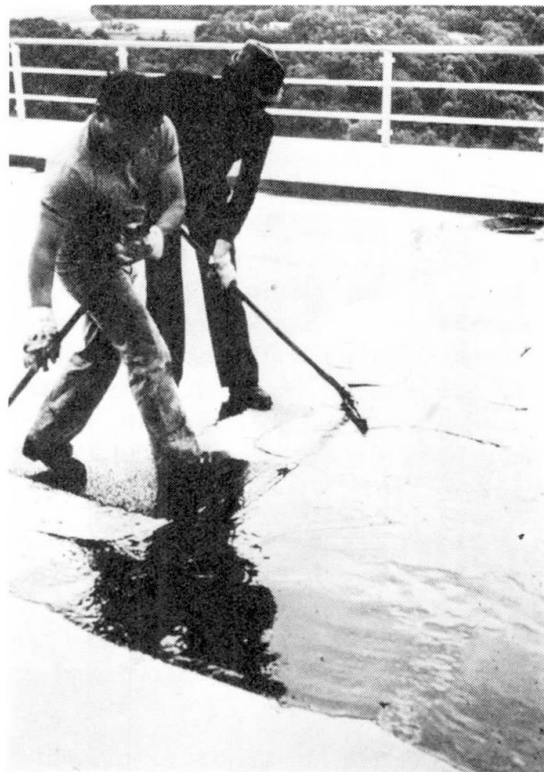
Fig. 21 Spreading of the bitumen epoxy resin waterproofing by hand (bridge over the Kocher valley at Geislingen)

- In the case of damage to the concrete deck slab due to chloride, both the pavement and the waterproofing must first be removed. In case of surface contamination the concrete is either treated mechanically or by high-pressure water. If required, deteriorated concrete should be removed. In case of contamination to greater depths, contaminated concrete is completely removed and replaced by new concrete with resin applied as a bonding agent. After that a bituminous waterproofing or an elastic plastic coating is applied by spraying. The advantage of the spraying method is that subsequently occurring cracks can be bridged and the structure thus be permanently protected.

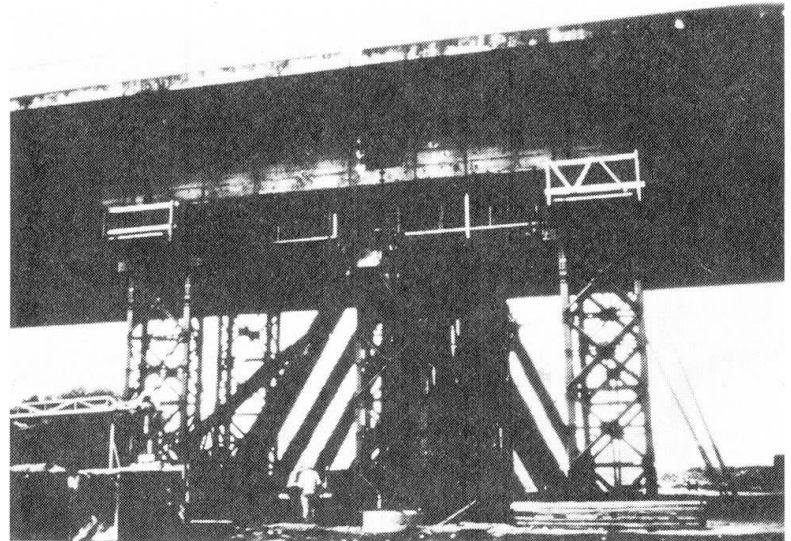
Fig. 27 Erecting tower for the replacement of the bearing (bridge over the river Main at Hochheim

(d) Replacement of bearings (Figure 27)

- exceeding the limits of foreseen movement (rolling off the bearing plate),
- fracture of the rolls,
- overstressing and failure of elastomeric bearings,
- failure of neoprene pot bearings due to fracture of the sealing ring or insufficient lubrication or sliding surface area.

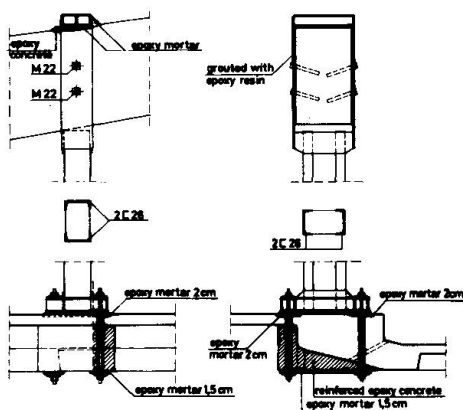
Fig.3 Suspender rehabilitation

During the detailed surveying vertical cracks almost on all suspenders were observed. In view of the vital significance of these members, possible causes of deterioration, the actual state and the necessity of interventions were analysed in detail. The results of the examination of concrete showed that the required

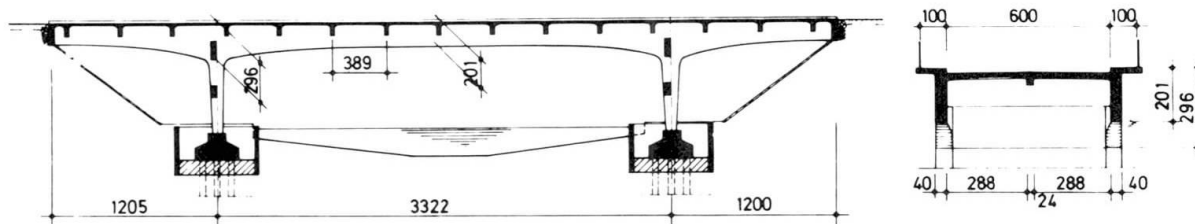
Fig.7 Bridge "C", general arrangement

Bridge C (Fig.7), across the channel, is a reinforced concrete skew frame with cantilevers. It was reconstructed during World War II on the modified foundations of a destroyed, similar bridge from 1939. The bridge conception, with comparatively large cantilevers and considerable deflections at the ends, with a small width of the carriageway, with steep bridge approaches in sharp horizontal curvatures and without transition slabs, does not correspond to the contemporary principles of bridge construction and to the conditions of today's traffic.

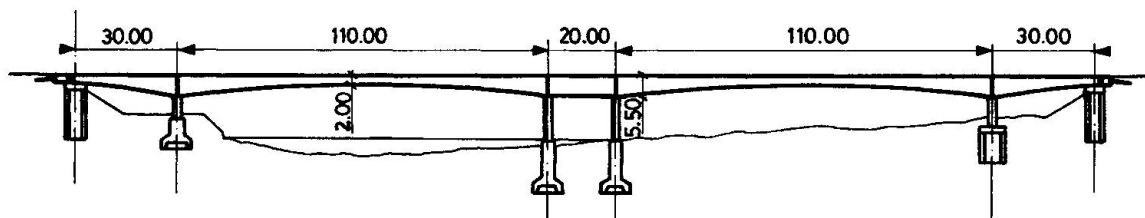
Fig. 1 - Longitudinal section

The deck includes two identical box girders of rectangular section and variable height secured by the upper slab forming a road pavement. The height of the girders varies from 5.5 m on the piers to 2 m at the key of the 110 m spans. The thickness of the webs is constant and equal to 0.3 m.

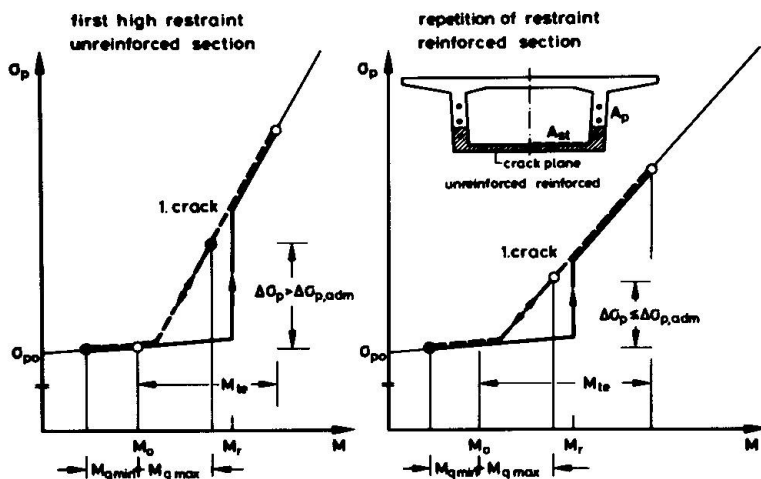
Fig. 1 Efficiency of bonded steel plate strengthening with respect to fatigue stresses in prestressing steel of joint

The efficiency of the bonded steel plate reinforcement with respect to fatigue stresses in the prestressing steel is shown by Fig. 1. The base moment M_0 is superimposed by the moment M_{te} of the first high thermal restraint. Thereby, the cracking moment M_r is transgressed. The moments due to traffic loads cause a fatigue stress range $\Delta\sigma_p$ which exceeds the stress range in the uncracked section. After strengthening of the section the slope of the steel stress-moment-curve will be diminished. Thus, by choice of a suitable cross-section of steel plate the stress range may be reduced to the admissible value as predetermined by acceptance tests.

The repair of cracks in joints by epoxy resin injection alone is not a sufficient countermeasure because the highly probable repetition of thermal restraint may cause either new cracks or the opening of injected cracks. Therefore, besides crack injection also additional reinforcement - provided for by the bonded steel plates - is necessary to reduce the amplitude of fatigue stresses and the crack widths as well.

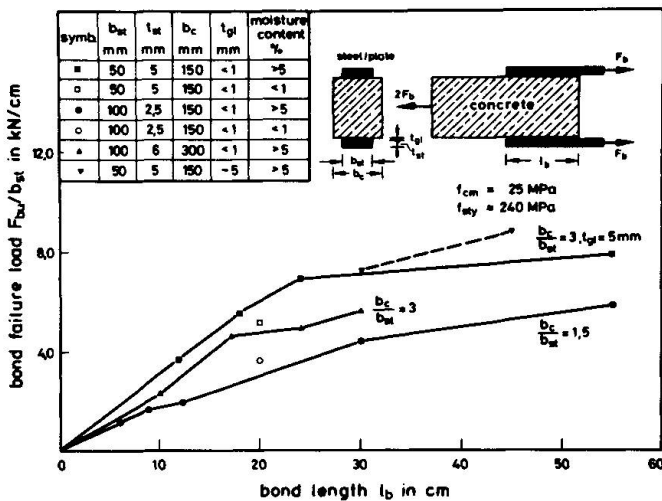
Fig. 3 Bond failure load as a function of bond length and of b_c/b_{st}

From the first part of research, Fig. 3 shows the influence of the bond length on the bond failure load per unit width of the steel plate (short time tests). The most important influence is exercised by the bond length. Up to a bond length of 30 cm the bond failure load shows an approximately linear increase. Beyond this length the increase becomes small with the tendency to approach a limit value of the bond strength. A thickness of steel plate of 5 to 10 mm and a geometry ratio $b_c/b_{st} \approx 3$ seem to be optimal. Several epoxy glues, especially formulated for this application, were tested without showing significant differences in strength. With a suitable glue and adequate preparation and fabrication of the bonding

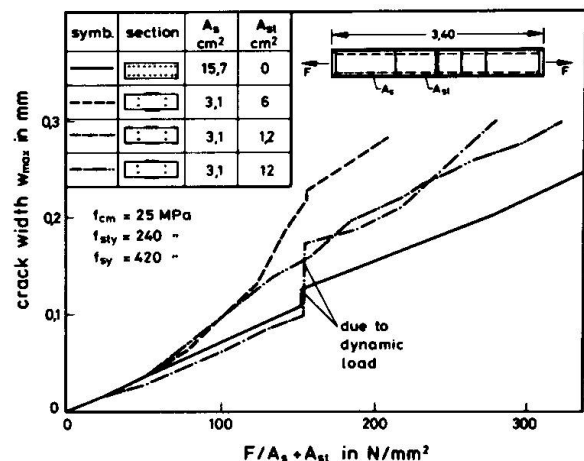
Fig. 4 Width of largest crack, depending on load and strengthening ratio

In the second part of the research work the composite action of reinforced concrete members strengthened with bonded steel plates was studied. At the onset of cracking the bottom slab of a box girder will be approximately subjected to axial tension. Thus, the specimens with a cross-section of 15 cm/50 cm and the length of 3,40 m had to simulate this situation. They were reinforced with 4 deformed bars of 10 mm diameter (grade 420/500). The cross-section of the steel plate was chosen to be twice and four times of the reinforcement's cross-section. The tests showed that the combined yield force of the two steel materials could be activated prior to bond failure. Up to failure the deformation and cracking of the strengthened specimens corresponded to r/c-specimens reinforced with same total steel area but as deformed bars. Fig. 4 shows typical results [2]. On basis of the test results rules for design and for the practical execution of the strengthening with bonded steel plate were developed. An alternating force during the hardening of the glue does not harm bond provided certain limits are not exceeded. This finding is of great practical consequence for the repair of bridges whose traffic flow must be kept up during repair.

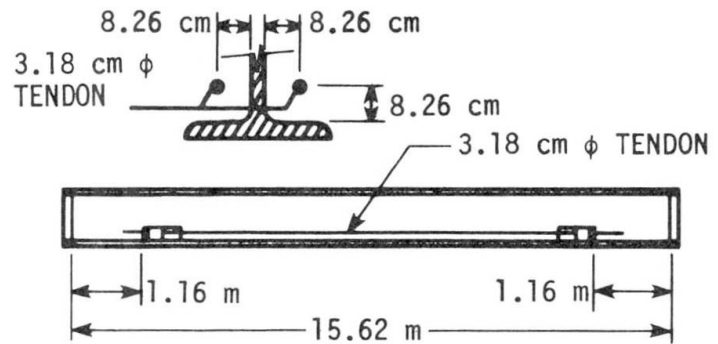
(a) POST-TENSIONING BRACKET AND TENDON IN POSITION

(b) TENDON LOCATION

Fig. 1. Post-tensioning details - Bridge 1.

Details of the post-tensioning system employed are shown in Figure 1. Due to uncertainty about the type of steel in some of the bridges to be strengthened, the connections were bolted. Figure 1a illustrates one of the 8 brackets, fabricated from 1.91 cm thick structural angle, bolted in position. The position of the 3.18 cm ϕ post-tensioning tendons is shown in Figure 1b.

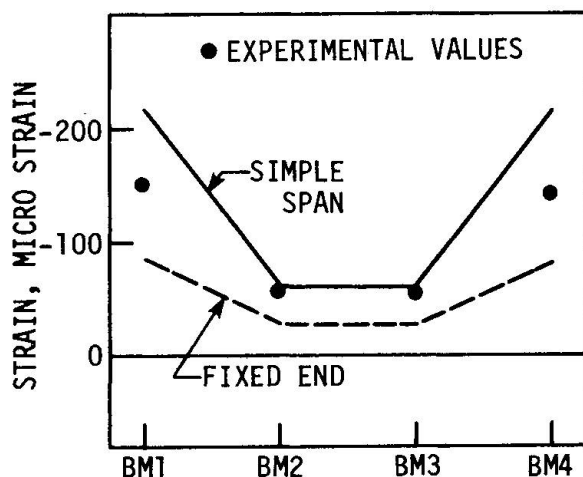
Fig. 3. Midspan, bottom flange strains resulting from post-tensioning: Bridge #1.

The desired post-tensioning force for each bridge was based upon the results of Phase I of the study. Thus, subjecting each exterior stringer to a force of 818.5 kN was supposed to cause a strain reduction in the lower flange of 218 $\mu\epsilon$. This was based upon the assumption that the bridge was simply supported. However when the 818.5 kN force was applied in the field, a strain reduction of only 147 $\mu\epsilon$ was obtained due to restraint of the ends of the stringers. Figure 3 compares the midspan strains measured with theoretical strains assuming the stringer to be completely restrained against rotation and completely free to rotate. Note that the measured strains are essentially midway between the fixed and the free condition. Thus, although the desired strain reduction was not obtained, it should be noted that the end restraint also reduces the effect live load has on the bridge.

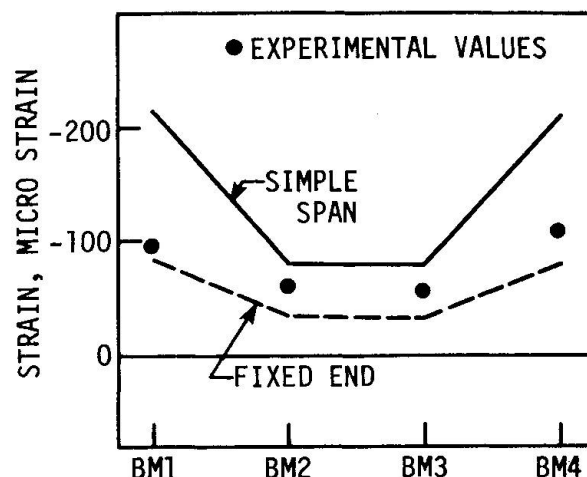
Fig. 4. Midspan, bottom flange strains resulting from post-tensioning: Bridge #2.

As in Bridge #1, the force applied to each exterior stringer (1361.2 kN) was determined assuming the stringers to be simply supported. The 1361.2 kN force was to cause a strain reduction in the lower flange of 212 $\mu\epsilon$. When the desired force was applied in the field, a reduction of only 102 $\mu\epsilon$ was obtained because of end restraint. Figure 4 compares the midspan strains measured with the theoretical strains assuming the stringers to be first completely restrained against rotation and second completely free to rotate. As may be seen, the strains in the exterior stringers approach the fixed end condition.

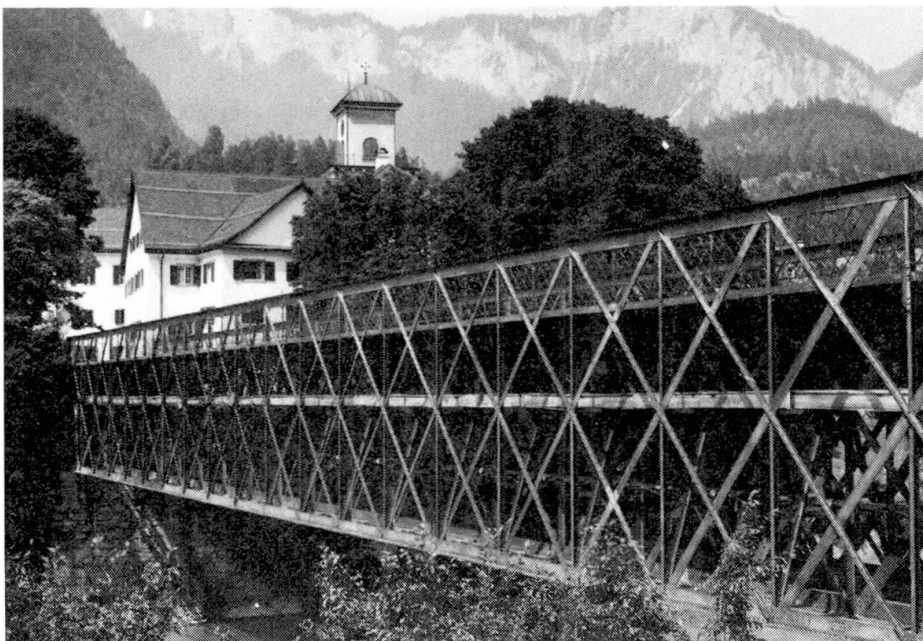
Fig. 1 Seitenansicht der Eisenbrücke Reichenau

Vier 69,6 m weit gespannte Fachwerkträger bilden die Hauptelemente der Brücke. Die zwei 7 m hohen Aussenträger dienen gleichzeitig als Seitenabschluss des Verkehrsraumes, während die um 1,75 m weniger hohen Innenträger die Fahrbahnabdeckung unmittelbar tragen (Fig. 1). Fachwerkartige Querscheiben, in 3,48 m Abständen angeordnet, verbinden die vier Hauptträger zu einem Trägerrost; sie dienen zudem der Lagerung eines axialen Längsträgers und von zwei Saumträgern, welche neben den Innenträgern die Stützung für die 5,4 m breite Fahrbahn (Strasse 3 m, Gehwege je 1,2 m) gewährleisten. Die Schotterabdeckung, später mit einem Bitumenbelag versehen, ruhte auf Zores-Eisen, die wegen der fehlenden Abdichtung mit der Zeit stark verrosteten und in den dreissiger Jahren ausgetauscht werden mussten.

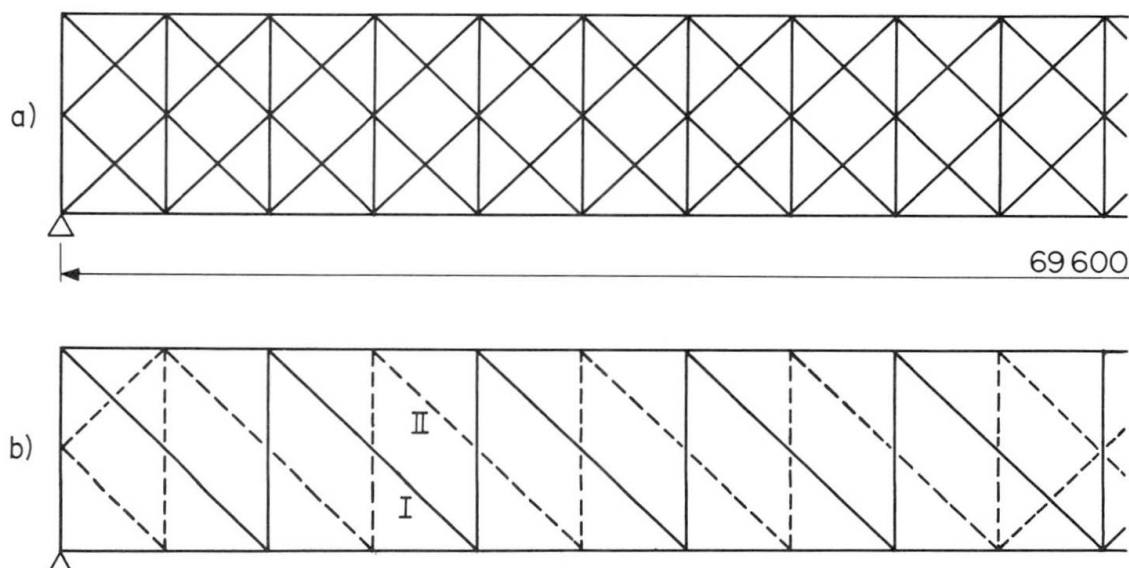
Fig. 3 Ausfachtung im unterkritischen a) und im überkritischen b) Knickbereich

Fig. 3a zeigt die Ausfachtung der Aussenträger, mit vier Streben in jedem Vertikalschnitt. Die Stabkräfte wurden elektronisch bestimmt, wobei einerseits die Biegesteifigkeit der durchgehenden Gurte und der Endpfosten, andererseits die Exzentrizitäten infolge der veränderlichen Anzahl Lamellen berücksichtigt wurden. Dagegen betrachtet man die Strebenanschlüsse als gelenkig und führt deren Kreuzungspunkte nicht als gemeinsame Knoten ein.

Zu Beginn des Knickvorganges nehmen aber die Druckstreben ihre Traglasten weiterhin auf, so dass nur die darüber hinausgehenden Querkräfte (entsprechend 1,8 - 1,4 als Sicherheitsmass) einem überkritischen Tragsystem zuzuweisen sind: es handelt sich um ein doppeltes Ständerfachwerk (Fig. 3b) mit den gleichen Zugdiagonalen wie in der unterkritischen Ausfachung (Fig. 3a) und mit den Druckpfosten, die im primären System nur wenig beansprucht sind und daher genügende Tragreserven besitzen. Auch hier wirken sich die neuen K-Verbände bezüglich des Knickens der Ständer aus der Ebene günstig aus. Was die Zugstreben anbelangt, so genügen sowohl die Querschnittsflächen als auch die Nietanschlüsse. Da die Ausfachung II nach Fig. 3b als K-Feld endet, musste die entsprechende Druckstrebe leicht verstärkt werden.
