## Ship Collisions with Danish Lighthouses

**Aksel MIKKELSEN**  
Civil Engineer  
Administration of Navigation  
and Hydrography  
Copenhagen, Denmark

Since 1972, fourteen small lighthouses have been built in the Great Belt at water depths ranging between 8 and 17 m. Many of them have since then been exposed to ship collisions. Two of them, situated closely to the planned site of the Great Belt Bridge, have for instance been run into three and four times, respectively. The conclusion of the collision cases must be said to be negligence.

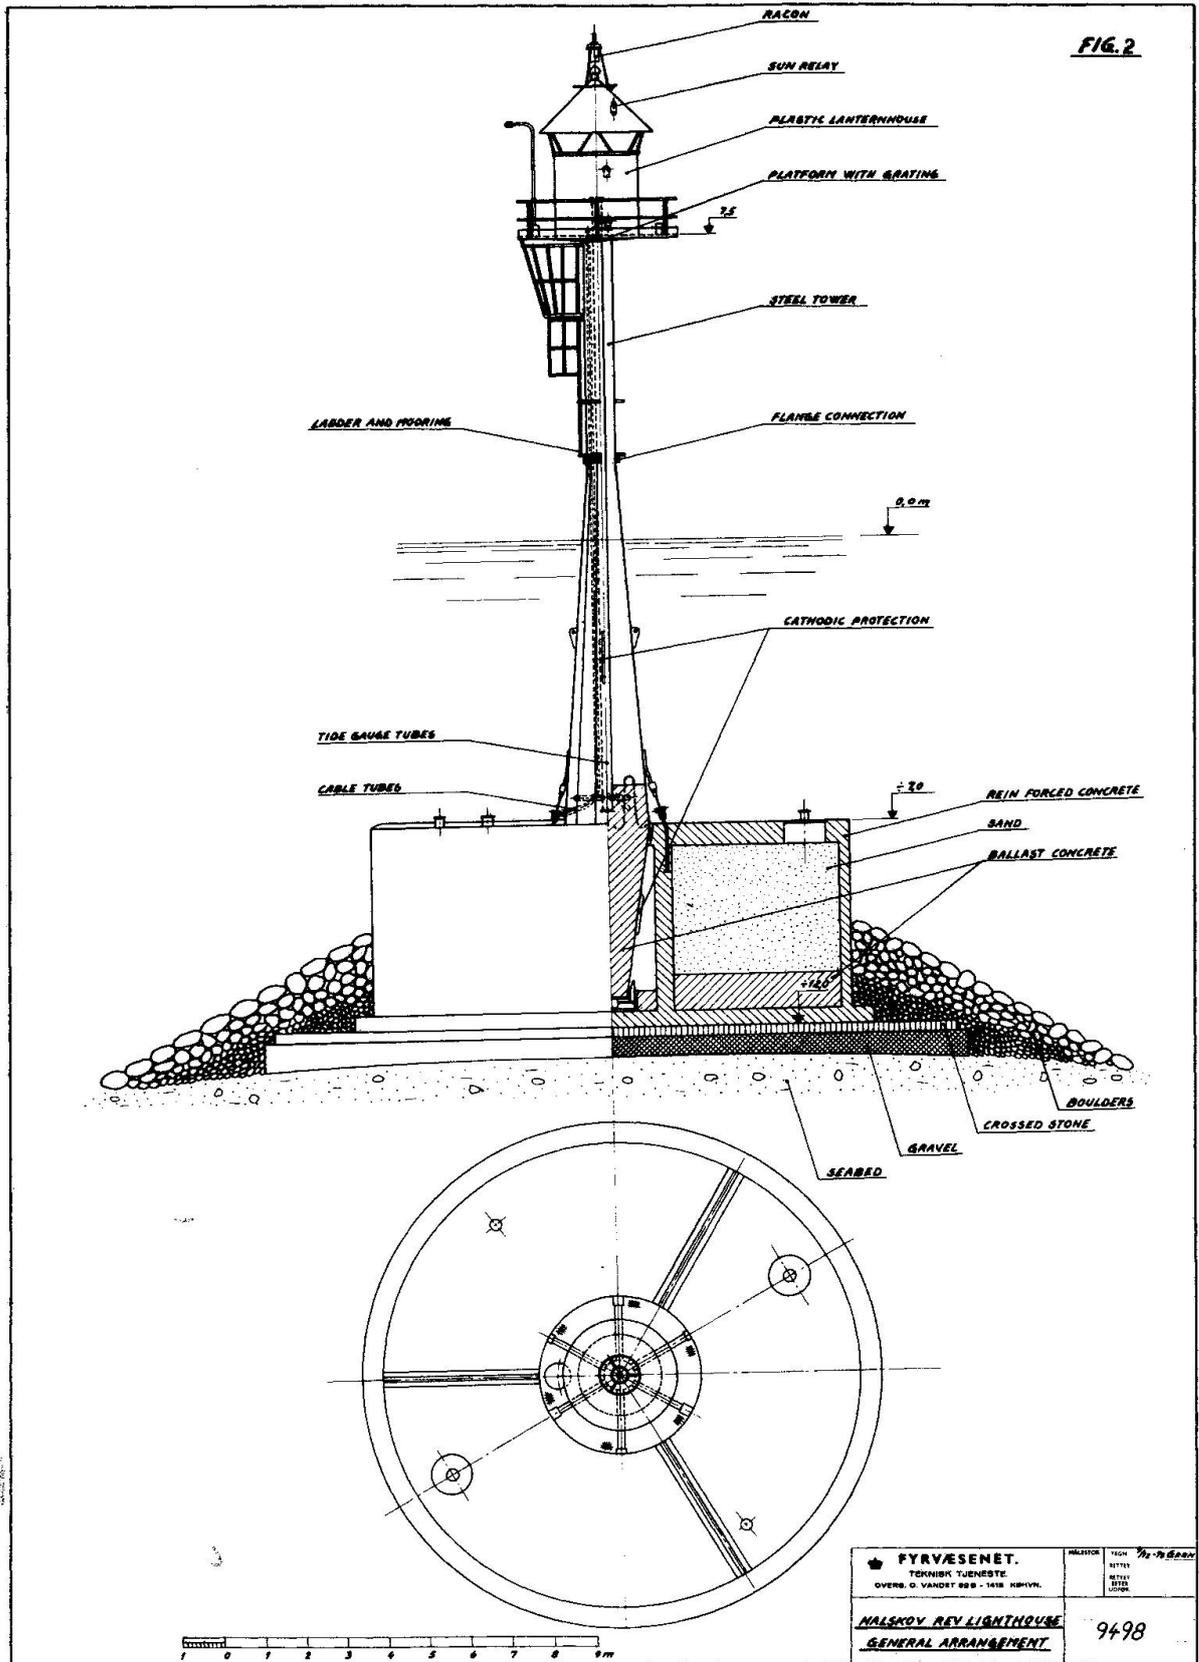
**Fig. 2** Lighthouse. General arrangement

The lighthouses have been designed in such a way that if they are run into, damages to the ship should be as insignificant as possible, as this would be less costly, less dangerous to the crew, and reduce the risk of oil pollution.

## 2. LIGHTHOUSE CONSTRUCTION AND EQUIPMENT (FIG. 2)
