Artikel: Ship collisions with Danish lighthouses

Ship Collisions with Danish Lighthouses

In the period between 1972 and 1977, fourteen small lighthouses were built along the so-called 'deep water route' of the Great Belt, more or less to replace lightbuoys.

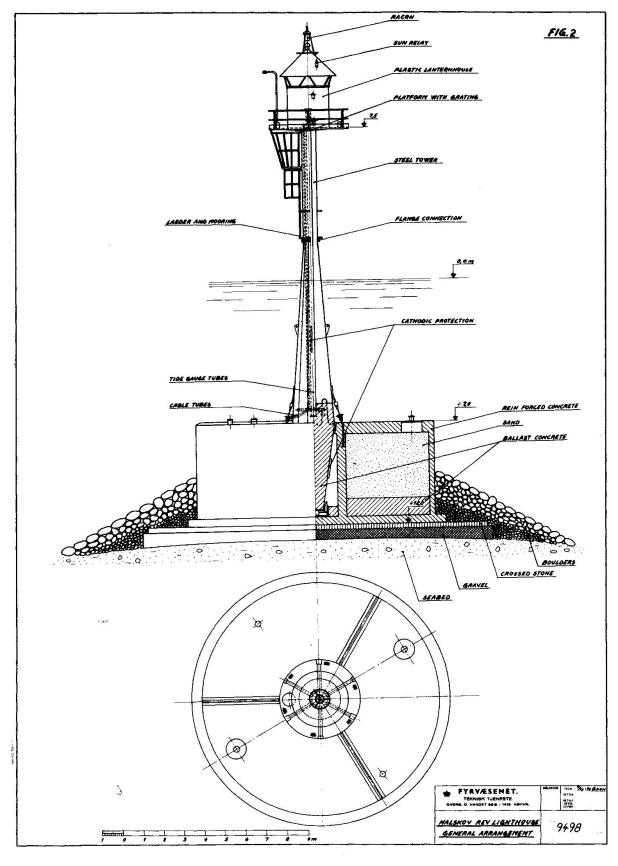
Fig. 2 Lighthouse. General arrangement

The lighthouses have been designed in such a way that if they are run into, damages to the ship should be as insignificant as possible, as this would be less costly, less dangerous to the crew, and reduce the risk of oil pollution.

2. LIGHTHOUSE CONSTRUCTION AND EQUIPMENT (FIG. 2)
