Artikel: Health and safety in the Humber bridge construction, 1973-1981
Autor: Sparkes, Michael
DOI: <https://doi.org/10.5169/seals-34081>

Health and Safety in the Humber Bridge Construction, 1973 – 1981

Michael SPARKES

THE HUMBER BRIDGE

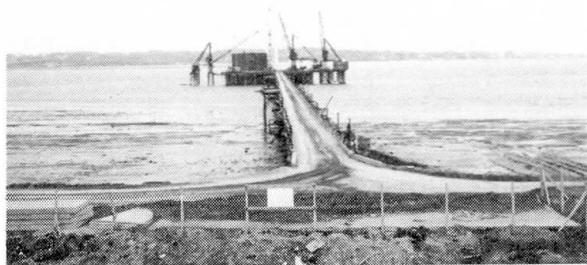
Construction of caissons at the end of the 500 m jetty.

hard clay. The construction of the caissons involved building a temporary jetty 500 metres long out into the river, capable of carrying heavy traffic. The caisson work involved the use of divers inside and outside the caissons to inspect progress during the sinking operation. Careful thought had to be given, in addition to the hazards involved in the diving operation, to the conventional problems of safe access and safe place of work. This involved the establishment of rigid rules for working over water where conventional safe working platforms could not be established, such as the provision of safety lines to which harnesses could be attached, the use of life jackets at all working positions where men were liable to fall into the water, and at all times when travelling by water and working from small craft. It also included the provision of adequate illumination for work which was done at night time. The accidents which occurred during this phase included several incidents of men falling into the water, usually when travelling from ship to shore or vice versa. There was one fatal accident during this phase also:- a small work boat fouled the mooring cable of a pontoon and was overturned by the fast current, which swamped the boat. Four of the men on board were saved, but the skipper of the boat was trapped in his cabin and drowned. This accident occurred as darkness approached. Thus rendering unsuccessful the helicopter search for the skipper's body.

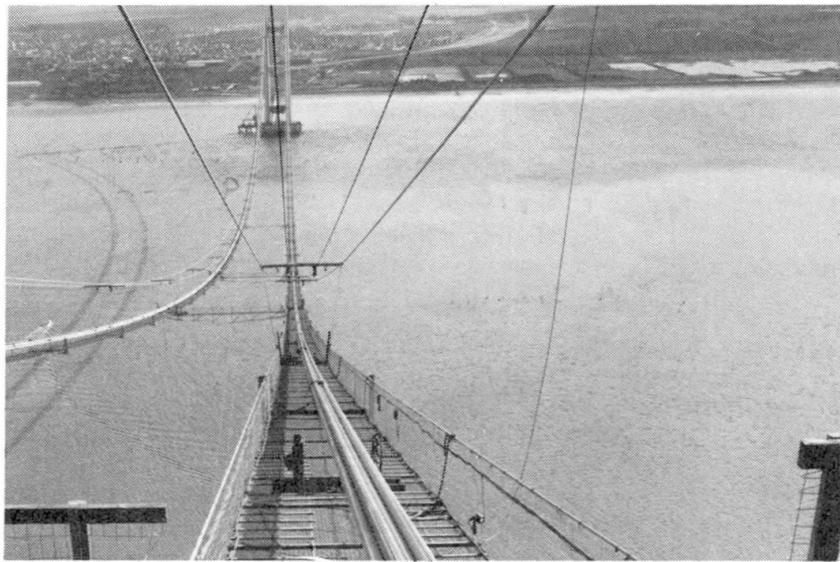
Mainspan cable part way through spinning process.

Each cable comprises 14,948 parallel galvanised drawn 5mm diameter wires, divided into 37 strands each of 404 wires.
