Health and Safety in the Humber Bridge Construction, 1973 – 1981

Michael SPARKES
Principal Inspector
Health and Safety Executive
Sheffield, England

THE HUMBER BRIDGE

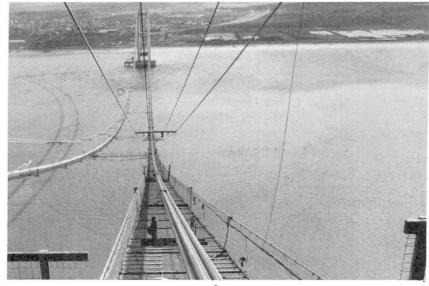
Each cable comprises 14,948 parallel galvanised drawn 5mm diameter wires, divided into 37 strands each of 404 wires.

Mainspan cable part way trough spinning process.

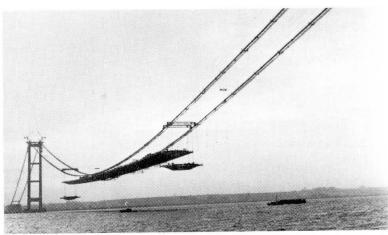
Erection of the main span during february 1980. Each box is 18.1 m long by 28.5 m wide (including the footpaths along each side). And weighed approximately 140 tons.

After each box was lifted into place and pinned in position on to the correct hanger, the lifting carriage had then to be moved up the cable to its new lifting position by hauling it on its rollers along the cable. The 4 main lifting winches at ground level were used for this purpose, being attached directly to the lifting carriage by tag lines. During the final move of the Northern sidespan carriage the tag lines failed and the carriage fell from the cable through the suspended deck 120 metres below, causing damage to the suspended boxes and severely injuring 2 men on the catwalk. The hangers, cables, pins and boxes did not fail and remained suspended with no damage, although the temporary connection between the 2 box sections affected was broken, allowing the boxes to tilt to an alarming angle. The cause of the accident is believed to be the failure of the several Crosby clamps attaching the haul line to a tag line on the carriage. It would appear that they were not tightened sufficiently to withstand the strain of hauling the 25 ton load up the cable and over the cable clamp on the steepest part of the cable and one side pulled out causing the carriage to roll back down the cable and fall off, dragging the second carriage with it. The winch operators immediately below heard the noise above and ran before the falling debris smashed down on to the 4 winches.
