Zeitschrift: IABSE reports = Rapports AIPC = IVBH Berichte
Band: 46 (1983)

Techniques for Testing, Analyzing and Rehabilitation of Terra-Cotta

Sven E. THOMASEN

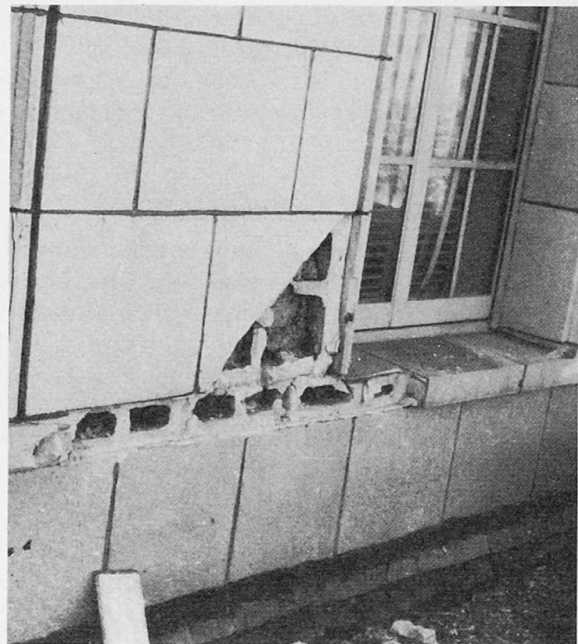
Fig. 4: Inspection opening

Inspection openings, as seen in Figure 4, are the best method to verify the location and the condition of the wall supports, and especially, to detect corrosion of the embedded metal anchors.
