Zeitschrift: IABSE reports = Rapports AIPC = IVBH Berichte
Band: 60 (1990)

Artikel: Epoxy bonded steel plate method for repairing deteriorated slabs
Autor: Sonoda, Keiichiro / Matsui, Shigeyuki / Hayqashi, Hidenao
DOI: <https://doi.org/10.5169/seals-46572>

Epoxy Bonded Steel Plate Method for Repairing Deteriorated Slabs

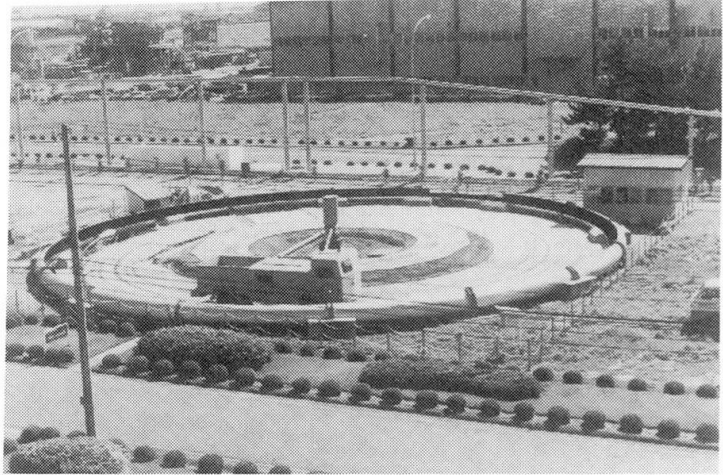
Photo.1 Test View

The tests slabs supported by a twin girder bridge spanning over 3.6m have 8cm thick, main re-bars in 10cm pitch and distribution re-bars in 15cm pitch, which were modeled to an existing RC deck slab on a typical highway road bridge in Japan. A full size truck cyclically running on six composite girder bridges arranged on a circular test road was used, as shown in Photo. 1. Three steps of tests were carried out. The first was static tests by a central patch load on the slabs. The second was fatigue loading tests before repairing, in order to give some degrees of deterioration to the slabs. The third was fatigue loading tests after repairing. Through those steps, the mechanical behavior of repaired and non-repaired slabs was examined, in particular on cracking pattern, debonding of steel plate, degradation of stiffness and so on. The six test slabs named No.1 to No.6 have the same sizes and reinforcements. The load intensity of truck rear wheel in running was set to 51kN for slabs Nos.1, 3 and 5 and to 42kN for slabs Nos.2, 4 and 6. Slabs Nos.1,2,3 and 4 were repaired after a finite number of loading cycles. Slabs Nos. 5 and 6 remained non-repaired for monitoring. The higher load intensity of rear wheel applied were corresponding to about 1.5 times as large as an equivalent design load specified by the Japanese code [1].

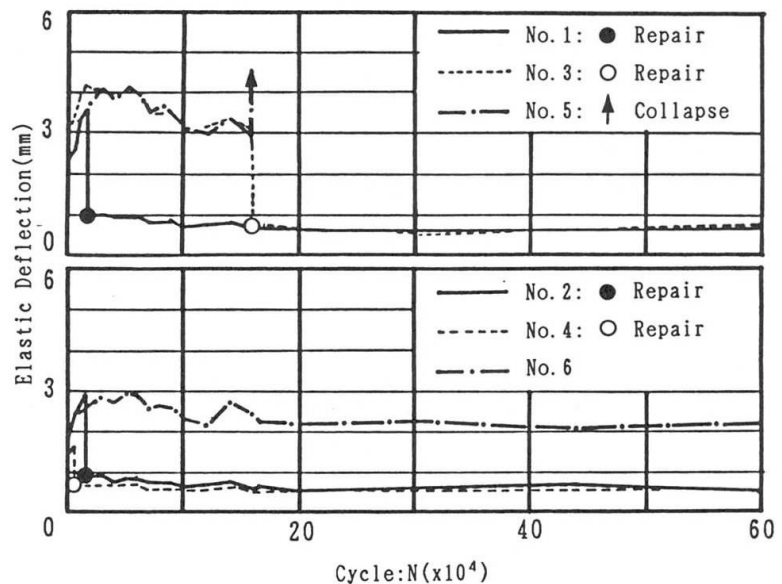
Fig.1 Relationship between Loading Cycle and Elastic Deflection at Center

Figure 1 shows variations of elastic deflection under the central rear wheel load, which mean the degradation of stiffness of slab. Non-repaired slab No.5 collapsed at about 160000 cycles, and slabs Nos. 1 and 3 with the same loading condition as No.5 were repaired at 17000 and 160000 cycles, respectively. While, slabs Nos.2 and 4 subjected to a lighter loading condition were repaired at earlier stages of 5000 and 17000 cycles, respectively. All test slabs except No.5 did not collapse until 600000 cycles when the tests ceased.
