Zeitschrift: IABSE reports = Rapports AIPC = IVBH Berichte
Band: 60 (1990)

Artikel: Epoxy bonded steel plate method for repairing deteriorated slabs
Autor: Sonoda, Keiichiro / Matsui, Shigeyuki / Hayqashi, Hidenao
DOI: <https://doi.org/10.5169/seals-46572>

Epoxy Bonded Steel Plate Method for Repairing Deteriorated Slabs

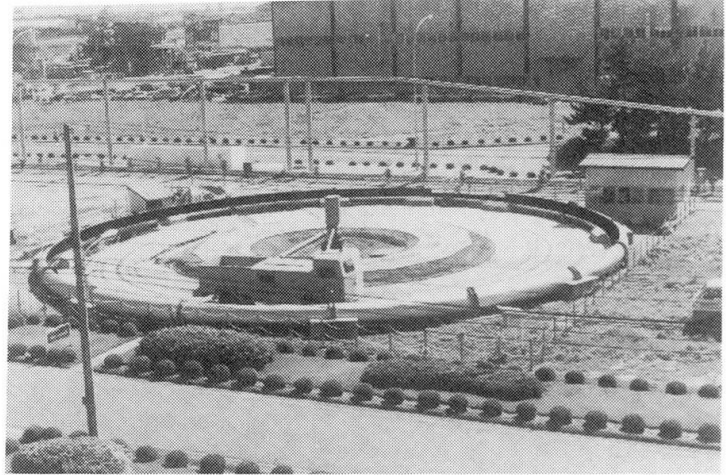
Photo.1 Test View

The tests slabs supported by a twin girder bridge spanning over 3.6m have 8cm thick, main re-bars in 10cm pitch and distribution re-bars in 15cm pitch, which were modeled to an existing RC deck slab on a typical highway road bridge in Japan. A full size truck cyclically running on six composite girder bridges arranged on a circular test road was used, as shown in Photo. 1. Three steps of tests were carried out. The first was static tests by a central patch load on the slabs. The second was fatigue loading tests before repairing, in order to give some degrees of deterioration to the slabs. The third was fatigue loading tests after repairing. Through those steps, the mechanical behavior of repaired and non-repaired slabs was examined, in particular on cracking pattern, debonding of steel plate, degradation of stiffness and so on. The six test slabs named No.1 to No.6 have the same sizes and reinforcements. The load intensity of truck rear wheel in running was set to 51kN for slabs Nos.1, 3 and 5 and to 42kN for slabs Nos.2, 4 and 6. Slabs Nos.1,2,3 and 4 were repaired after a finite number of loading cycles. Slabs Nos. 5 and 6 remained non-repaired for monitoring. The higher load intensity of rear wheel applied were corresponding to about 1.5 times as large as an equivalent design load specified by the Japanese code [1].
