Zeitschrift: IABSE reports = Rapports AIPC = IVBH Berichte
Band: 67 (1993)

Artikel: Safe capacity of suspension bridge cables
Autor: Sluszkza, Peter / Kendall, Martin
DOI: <https://doi.org/10.5169/seals-51399>

Safe Capacity of Suspension Bridge Cables
Sécurité de la capacité portante des câbles de ponts suspendus
Sichere Traglast von Hängebrückenseilen

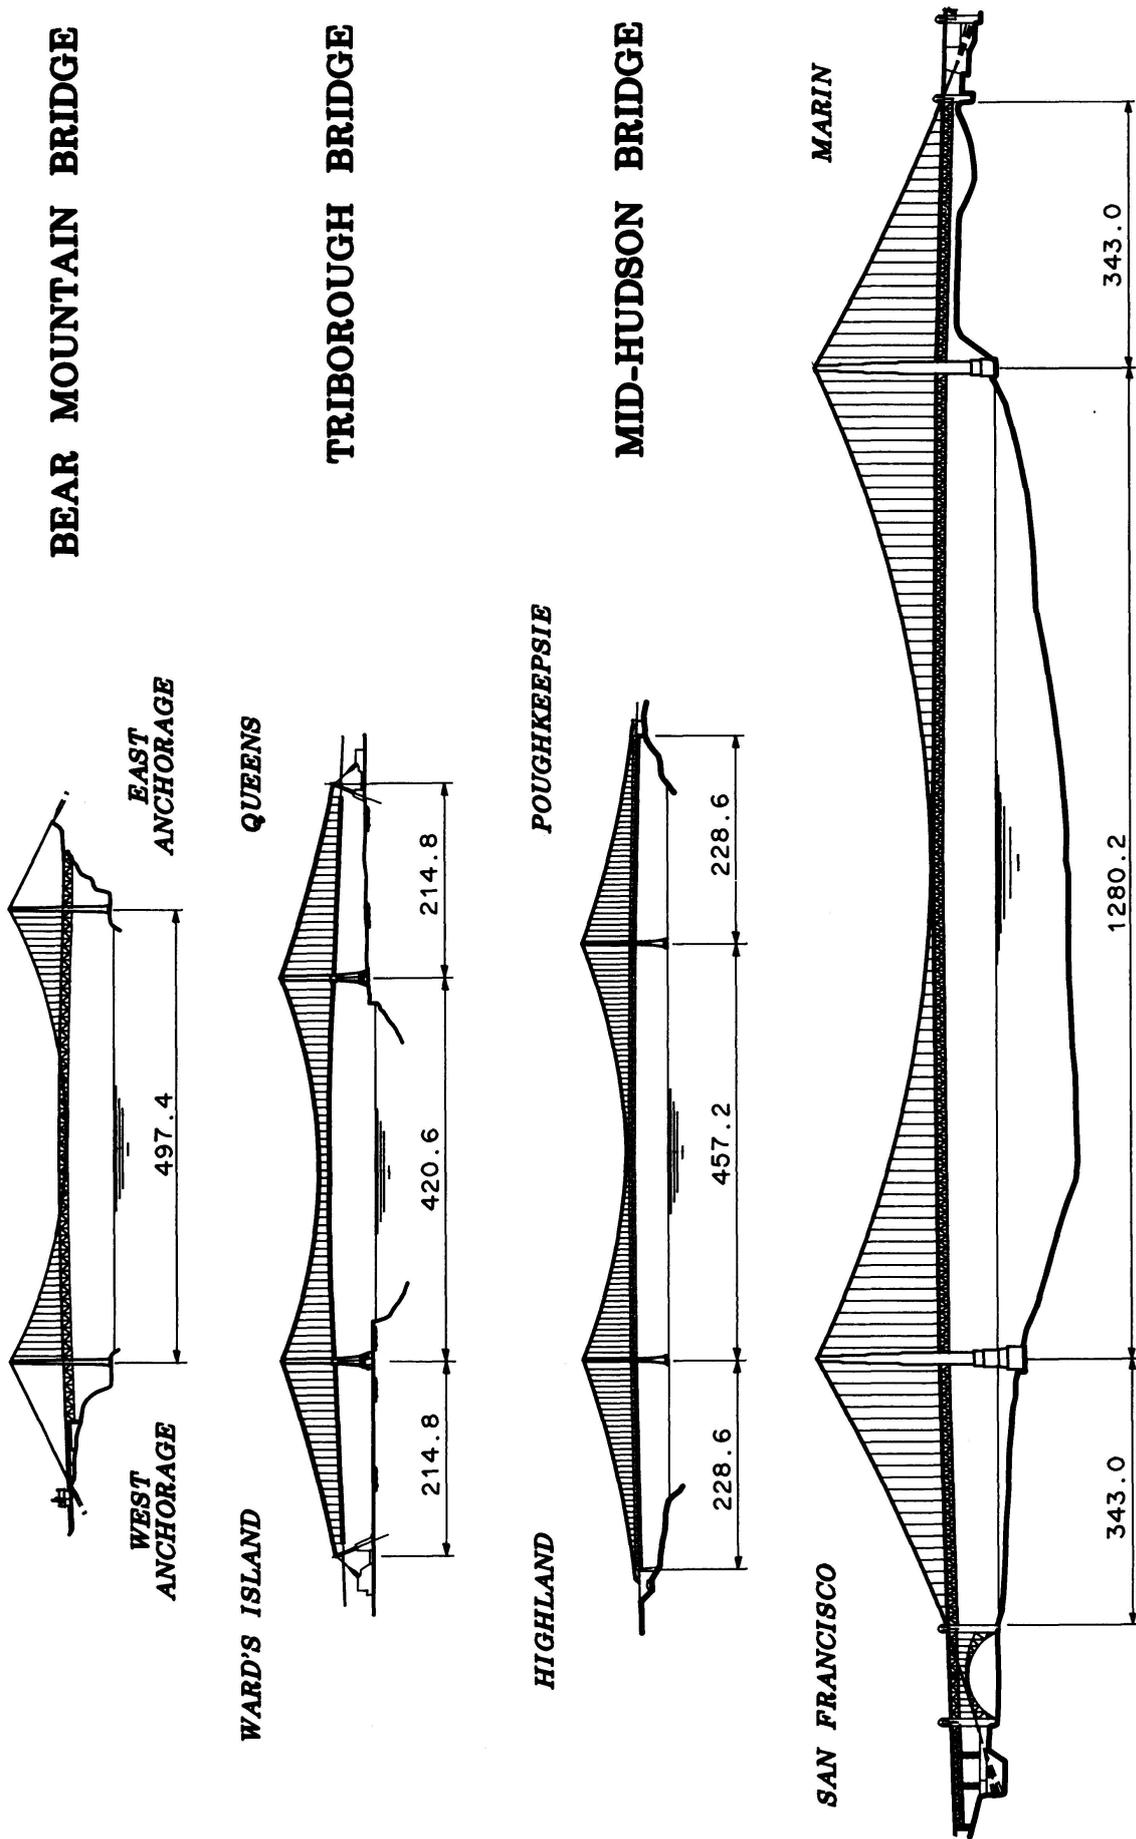
Figure 1

THE GOLDEN GATE BRIDGE

1.6 The size of the spans and cables, with the exception of the Golden Gate Bridge are all roughly comparable. The make-up, size of cable, and spans are listed in Table 1 and the bridges are illustrated in Figure 1.
