Artikel: Damage detection and repair control of marble elements
Autor: Tommaso, Angelo di / Pascale, Giovanni / Cianfrone, Francesco
DOI: <https://doi.org/10.5169/seals-53301>

Damage Detection and Repair Control of Marble Elements

This paper presents an experimental study carried out using the microseismic method on blocks of marble in which defects such as cracks and cavities were created artificially. The purpose is to evaluate the ability of the method to detect internal defects in stone blocks, and to judge the effectiveness of resin repairs.

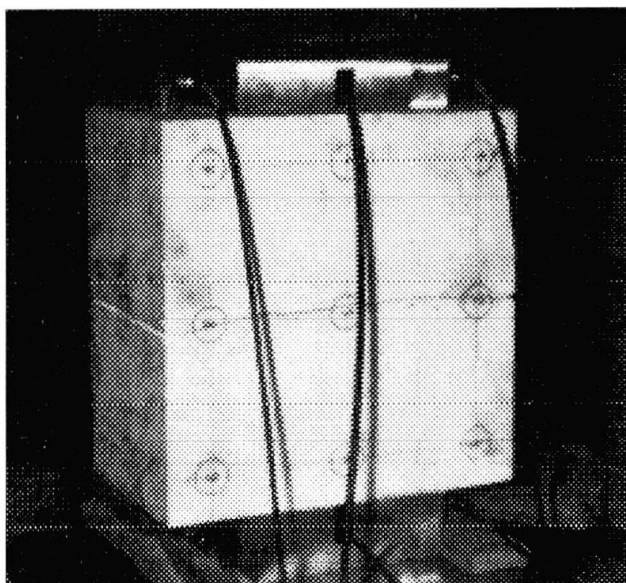
The block was cracked horizontally, rotating it at 90°, and a splitting test was performed; the sample was then replaced in its initial position (see fig. 2). The same pressure was then applied once again, and the measurements taken along the same trajectories.

Fig. 2 Marble block with glued probes

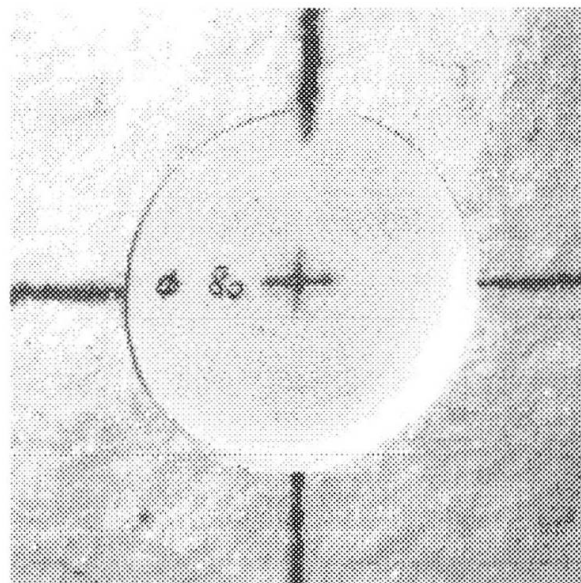
Without moving the lower part of the block, a circular cavity 20 cm in diameter was then created in the upper part by milling (see fig. 3). After replacing the block in its initial position, the pressure of 12 N/mm^2 was applied again, taking into account the reduction of the compressed area, and the measurements were repeated.

Fig. 3 Milling a circular cavity

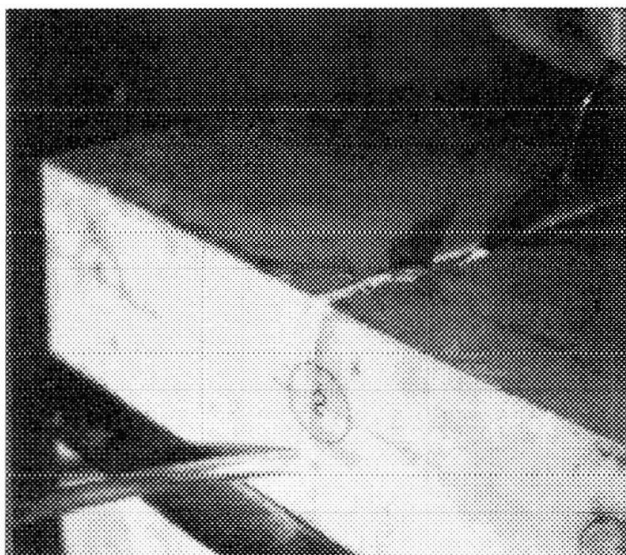
Fig. 4 Preparing the block for repair

Finally, the crack and the cavity were sealed by applying a technique used for repairing damaged stone elements, consisting of the injection of epoxy resin after spackling the edges (see figs. 4 and 5). Once this procedure was completed, the measurements were repeated in the same conditions.

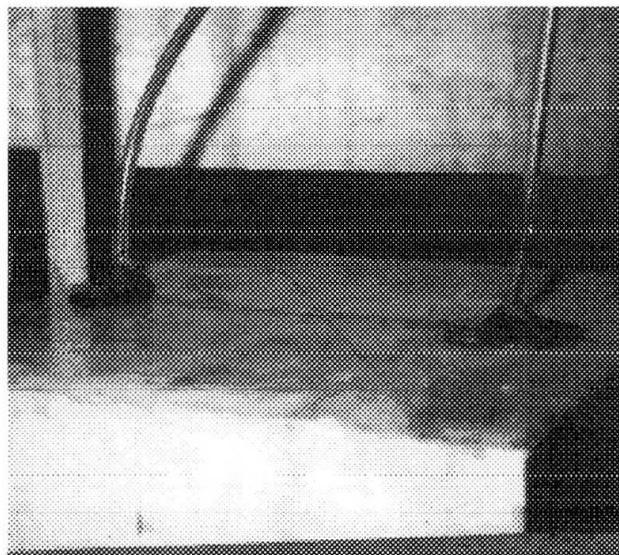
Fig. 5 Epoxy resin injection

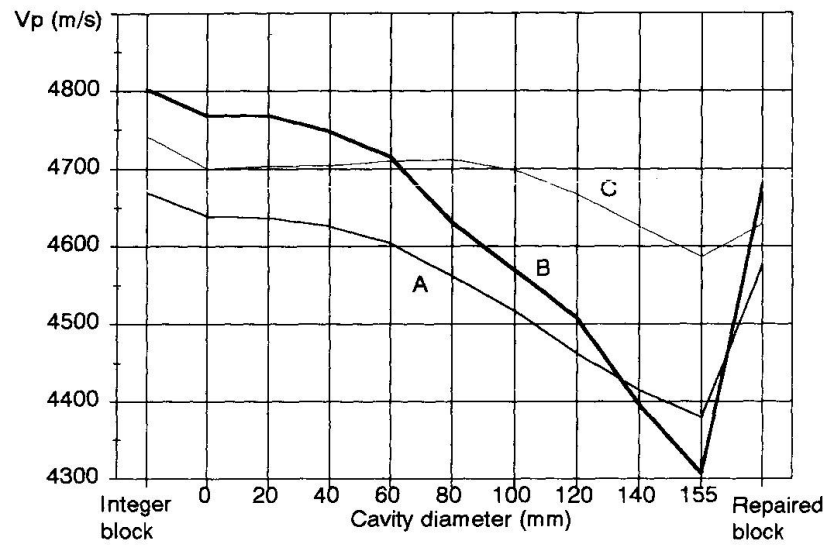
The results obtained are shown in tables 1 and 2, and in graphic form in figures 6 and 7. In the latter, the data regarding the measurements taken along equivalent paths have been grouped together and averaged.

Along the path A, the velocity in the cracked block is slightly lower than that in the integer block, and the attenuation slightly greater. This is due to the applied pressure, which creates good contact between the edges of the crack. In the presence of the cavity, the velocity decreases as the diameter increases, more so for diameters greater than 60 mm. The total increase is approximately 10%. The attenuation increases progressively, with a total increase of approximately 10 dB. After repair, the velocity returns to a value quite similar to that of the integer block, while this is not the case for attenuation, which remains very near to that found with the largest cavity surface area.

The paths B show a similar velocity pattern to that of the path A. For attenuation, the pattern shows a certain anomaly, due to the formation of a vertical crack.

The paths C do not intersect the cavity until the diameter exceeds 100 mm. Beyond this value, the velocity graph shows a limited decrease. Attenuation instead shows the defect from the very beginning, increasing progressively.

Fig. 6 Pulse velocity along different paths

The graphs in figures 6 and 7 show a different response by the two parameters *velocity* and *attenuation* according to the presence and size of the internal cavity. The cavity reflects a part of the energy, and thus causes an increase in attenuation even if the defect is not directly on the line joining the two probes. The transit time, and thus the apparent velocity, show instead a change only if the joining path crosses the defect. Variations in attenuation may therefore indicate the presence of defects, while in order to determine the position and dimensions it is more appropriate to perform a series of velocity tests.

Another purpose of the study was to examine the ability of the method to determine whether a resin filling has been successful. When this technique is used to repair internal cracks or cavities in blocks of stone or marble, it may occur that the filling is incomplete and air bubbles remain, or that the resin separates from the edges of the hole while hardening. In the case in question, the filling was performed correctly, as was subsequently verified by dividing the two parts of the block along the adhesive surface. By examining the graphs in figure 6, we note that in the repaired block the velocity returns very close to the values of the integer block.

This would not have been the case if internal cavities were still present, due to a faulty filling. The *pulse velocity* parameter is therefore capable of indicating that the material is once again continuous. The graphs in Figure 7 indicate instead that the filling, even when performed correctly, does not return the attenuation to the value found in the integer block, probably because the resin, which has a different acoustic impedance from that of marble, still causes a considerable part of the energy emitted to be reflected. The *attenuation* parameter therefore is not useful to this purpose.

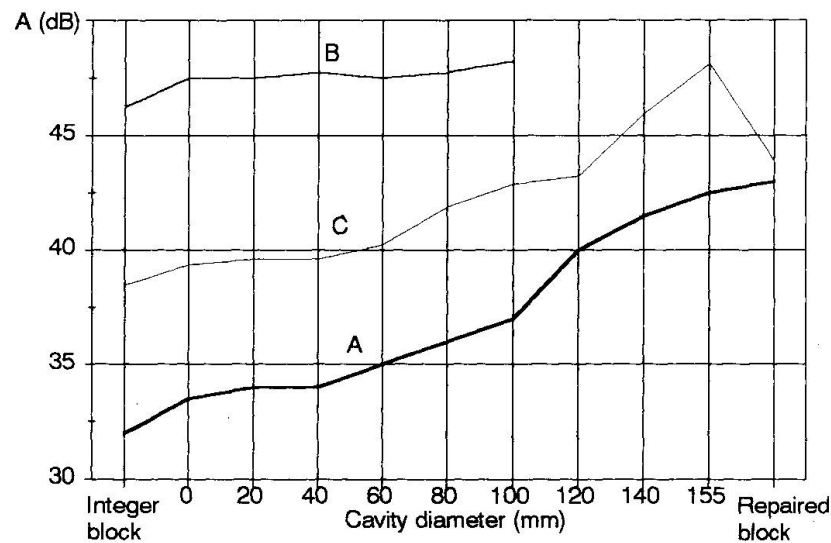
Fig. 7 Attenuation along different paths

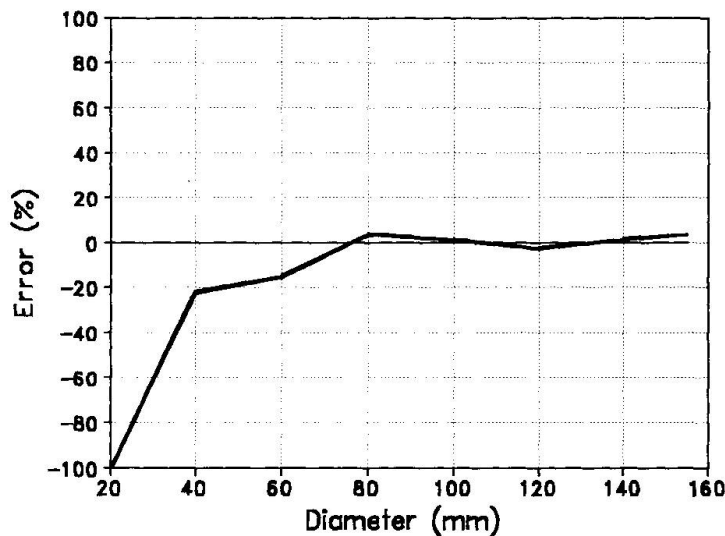
Based on changes in the transit time along the trajectory E2-R2, the known diameters are compared to the calculated diameters using the above formula. The graph in figure 8 indicates that the estimate becomes reliable beyond 80 mm in diameter.

Fig. 8 Error in the evaluation of the diameter
