Zeitschrift: IABSE reports = Rapports AIPC = IVBH Berichte

Artikel: Damage detection and repair control of marble elements

Damage Detection and Repair Control of Marble Elements

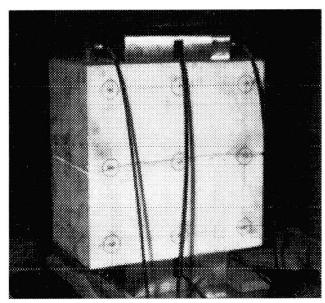
Fig. 2 Marble block with glued probes

The block was cracked horizontally, rotating it at 90°, and a splitting test was performed; the sample was then replaced in its initial position (see fig. 2). The same pressure was then applied once again, and the measurements taken along the same trajectories.

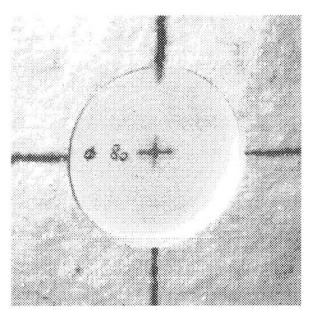
Fig. 3 Milling a circular cavity

cm in diameter was then created in the upper part by milling (see fig. 3). After replacing the block in its initial position, the pressure of 12 N/mm² was applied again, taking into account the reduction of the compressed area, and the measurements were repeated.

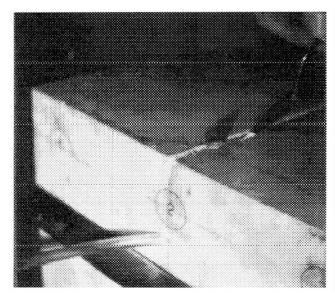
Fig. 4 Preparing the block for repair

Finally, the crack and the cavity were sealed by applying a technique used for repairing damaged stone elements, consisting of the injection of epoxy resin after spackling the edges (see figs. 4 and 5). Once this procedure was completed, the measurements were repeated in the same conditions.

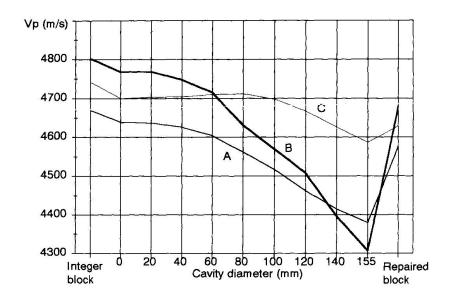
Fig. 6 Pulse velocity along different paths

The results obtained are shown in tables 1 and 2, and in graphic form in figures 6 and 7. In the latter, the data regarding the measurements taken along equivalent paths have been grouped together and averaged.

Along the path A, the velocity in the cracked block is slightly lower than that in the integer block, and the attenuation slightly greater. This is due to the applied pressure, which creates good contact between the edges of the crack. In the presence of the cavity, the velocity decreases as the diameter increases, more so for diameters greater than 60 mm. The total increase is approximately 10%. The attenuation increases progressively, with a total increase of approximately 10 dB. After repair, the velocity returns to a value quite similar to that of the integer block, while this is not the case for attenuation, which remains very near to that found with the largest cavity surface area.

The paths B show a similar velocity pattern to that of the path A. For attenuation, the pattern shows a certain anomaly, due to the formation of a vertical crack.

The paths C do not intersect the cavity until the diameter exceeds 100 mm. Beyond this value, the velocity graph shows a limited decrease. Attenuation instead shows the defect from the very beginning, increasing progressively.

The graphs in figures 6 and 7 show a different response by the two parameters *velocity* and *attenuation* according to the presence and size of the internal cavity. The cavity reflects a part of the energy, and thus causes an increase in attenuation even if the defect is not directly on the line joining the two probes. The transit time, and thus the apparent velocity, show instead a change only if the joining path crosses the defect. Variations in attenuation may therefore indicate the presence of defects, while in order to determine the position and dimensions it is more appropriate to perform a series of velocity tests. The following formula is often used to evaluate the size of a defect:

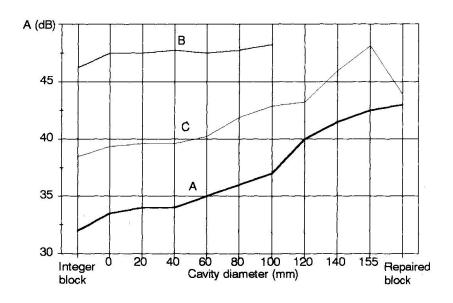
Fig. 7 Attenuation along different paths

cavities were still present, due to a faulty filling. The *pulse velocity* parameter is therefore capable of indicating that the material is once again continuous. The graphs in Figure 7 indicate instead that the filling, even when performed correctly, does not return the attenuation to the value found in the integer block, probably because the resin, which has a different acoustic impedance from that of marble, still causes a considerable part of the energy emitted to be reflected. The *attenuation* parameter therefore is not useful to this purpose.

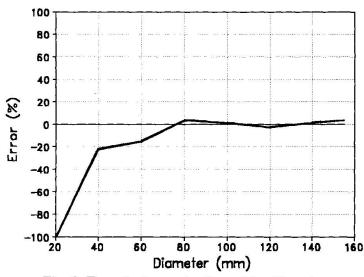
Fig. 8 Error in the evaluation of the diameter

Based on changes in the transit time along the trajectory E2-R2, the known diameters are compared to the calculated diameters using the above formula. The graph in figure 8 indicates that the estimate becomes reliable beyond 80 mm in diameter.
