**Artikel:** Damage detection and repair control of marble elements  
**Autor:** Tommaso, Angelo di / Pascale, Giovanni / Cianfrone, Francesco  
**DOI:** <https://doi.org/10.5169/seals-53301>

## Damage Detection and Repair Control of Marble Elements

This paper presents an experimental study carried out using the microseismic method on blocks of marble in which defects such as cracks and cavities were created artificially. The purpose is to evaluate the ability of the method to detect internal defects in stone blocks, and to judge the effectiveness of resin repairs.

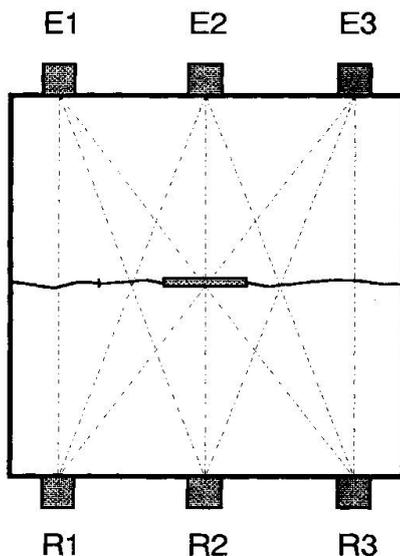
Initially the probes (three emitting and three receiving) were glued to a block in the positions indicated in figure 1.

Fig. 1 Marble block and paths

The probes were glued on the block surface during the experiment in order not to introduce disturbing parameters due to repeated removal and repositioning of probes and thus to avoid variations in coupling points, acoustic coupling between probes and material, electric connections, etc. Using two specially-built commutators, each of the emitting probes was then connected to each of the receivers, and the microseismic parameters were determined (P-wave propagation velocity and attenuation) along the paths indicated in figure 1. An average tension of 12  $\text{N}/\text{mm}^2$  was applied to the sample.

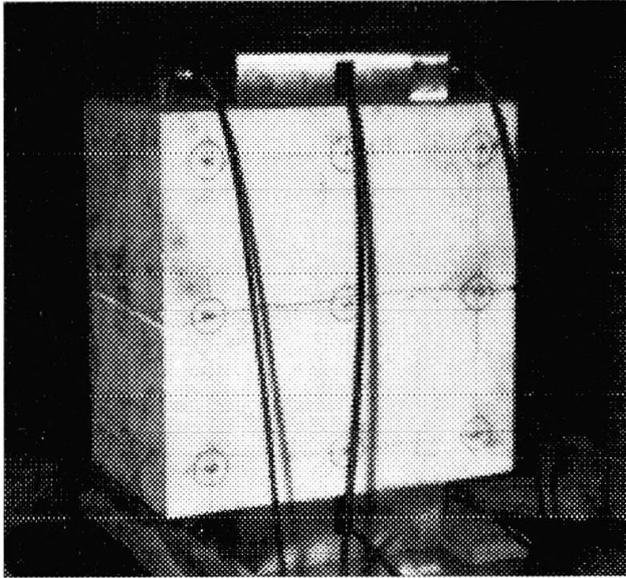
The block was cracked horizontally, rotating it at 90°, and a splitting test was performed; the sample was then replaced in its initial position (see fig. 2). The same pressure was then applied once again, and the measurements taken along the same trajectories.

Fig. 2 Marble block with glued probes

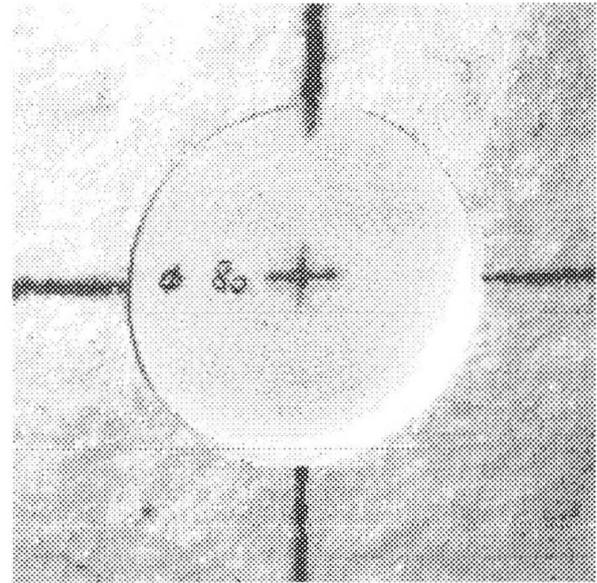
Without moving the lower part of the block, a circular cavity 20 cm in diameter was then created in the upper part by milling (see fig. 3). After replacing the block in its initial position, the pressure of 12  $\text{N}/\text{mm}^2$  was applied again, taking into account the reduction of the compressed area, and the measurements were repeated.

Fig. 3 Milling a circular cavity

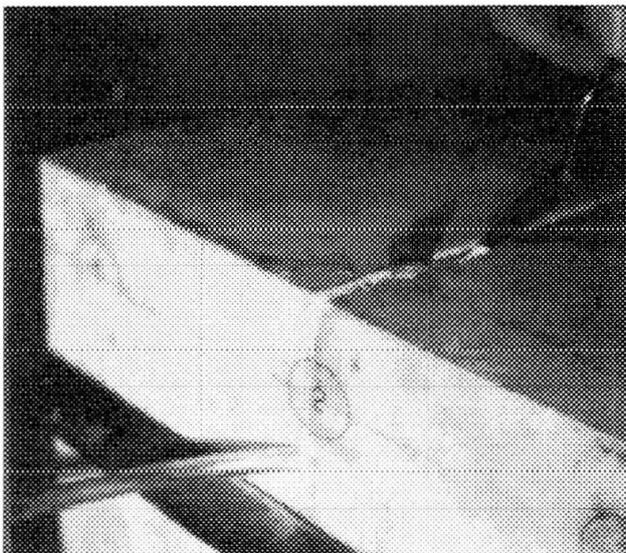
Finally, the crack and the cavity were sealed by applying a technique used for repairing damaged stone elements, consisting of the injection of epoxy resin after spackling the edges (see figs. 4 and 5). Once this procedure was completed, the measurements were repeated in the same conditions.

Fig. 4 Preparing the block for repair

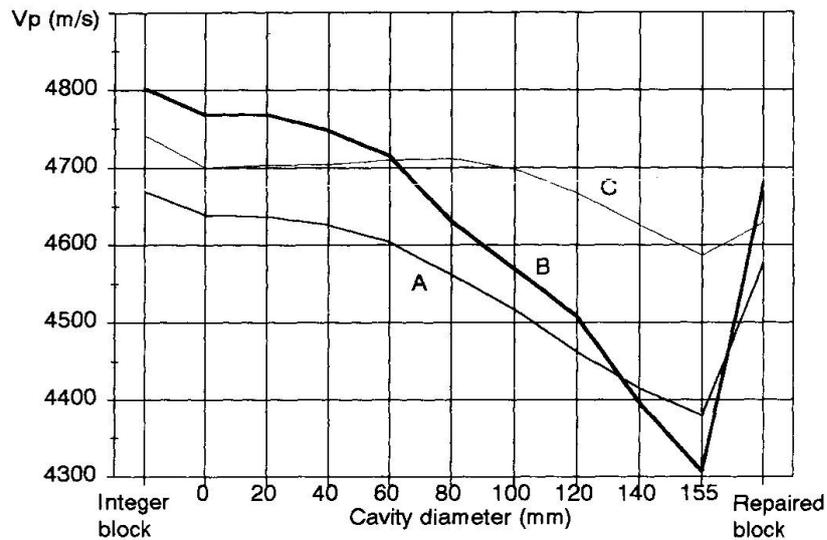
Fig. 6 Pulse velocity along different paths

The results obtained are shown in tables 1 and 2, and in graphic form in figures 6 and 7. In the latter, the data regarding the measurements taken along equivalent paths have been grouped together and averaged.

Along the path A, the velocity in the cracked block is slightly lower than that in the integer block, and the attenuation slightly greater. This is due to the applied pressure, which creates good contact between the edges of the crack. In the presence of the cavity, the velocity decreases as the diameter increases, more so for diameters greater than 60 mm. The total increase is approximately 10%. The attenuation increases progressively, with a total increase of approximately 10 dB. After repair, the velocity returns to a value quite similar to that of the integer block, while this is not the case for attenuation, which remains very near to that found with the largest cavity surface area.

The paths B show a similar velocity pattern to that of the path A. For attenuation, the pattern shows a certain anomaly, due to the formation of a vertical crack.

The paths C do not intersect the cavity until the diameter exceeds 100 mm. Beyond this value, the velocity graph shows a limited decrease. Attenuation instead shows the defect from the very beginning, increasing progressively.

The graphs in figures 6 and 7 show a different response by the two parameters *velocity* and *attenuation* according to the presence and size of the internal cavity. The cavity reflects a part of the energy, and thus causes an increase in attenuation even if the defect is not directly on the line joining the two probes. The transit time, and thus the apparent velocity, show instead a change only if the joining path crosses the defect. Variations in attenuation may therefore indicate the presence of defects, while in order to determine the position and dimensions it is more appropriate to perform a series of velocity tests.

Another purpose of the study was to examine the ability of the method to determine whether a resin filling has been successful. When this technique is used to repair internal cracks or cavities in blocks of stone or marble, it may occur that the filling is incomplete and air bubbles remain, or that the resin separates from the edges of the hole while hardening. In the case in question, the filling was performed correctly, as was subsequently verified by dividing the two parts of the block along the adhesive surface. By examining the graphs in figure 6, we note that in the repaired block the velocity returns very close to the values of the integer block.

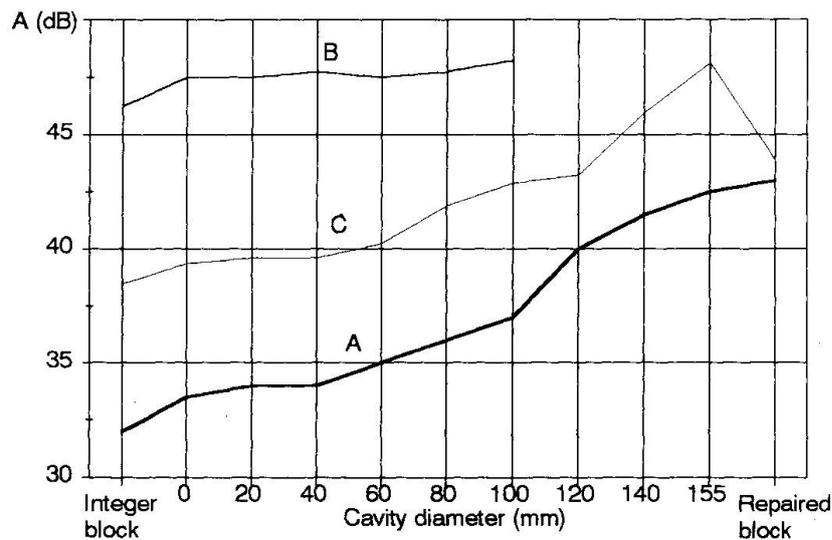
Fig. 7 Attenuation along different paths

cavities were still present, due to a faulty filling. The *pulse velocity* parameter is therefore capable of indicating that the material is once again continuous. The graphs in Figure 7 indicate instead that the filling, even when performed correctly, does not return the attenuation to the value found in the integer block, probably because the resin, which has a different acoustic impedance from that of marble, still causes a considerable part of the energy emitted to be reflected. The *attenuation* parameter therefore is not useful to this purpose.

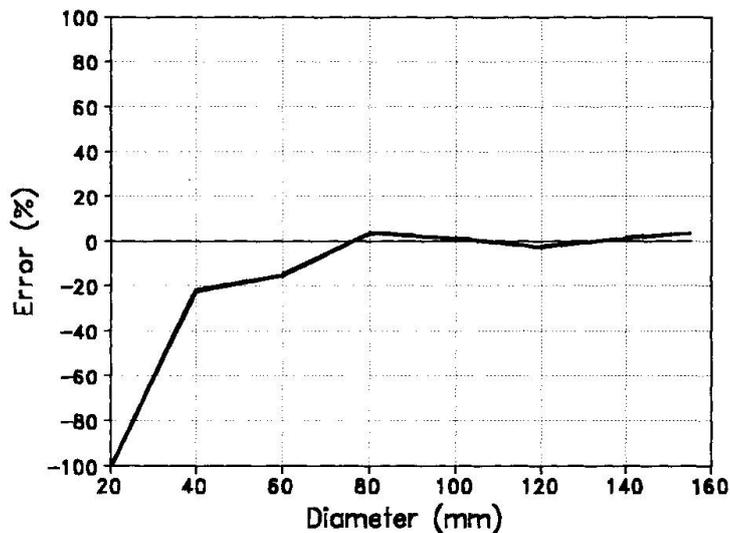
Based on changes in the transit time along the trajectory E2-R2, the known diameters are compared to the calculated diameters using the above formula. The graph in figure 8 indicates that the estimate becomes reliable beyond 80 mm in diameter.

Fig. 8 Error in the evaluation of the diameter
