Zeitschrift: IABSE reports = Rapports AIPC = IVBH Berichte
Band: 70 (1993)

Rubrik: Session 4: Remedial measures

Session 4

Remedial Measures

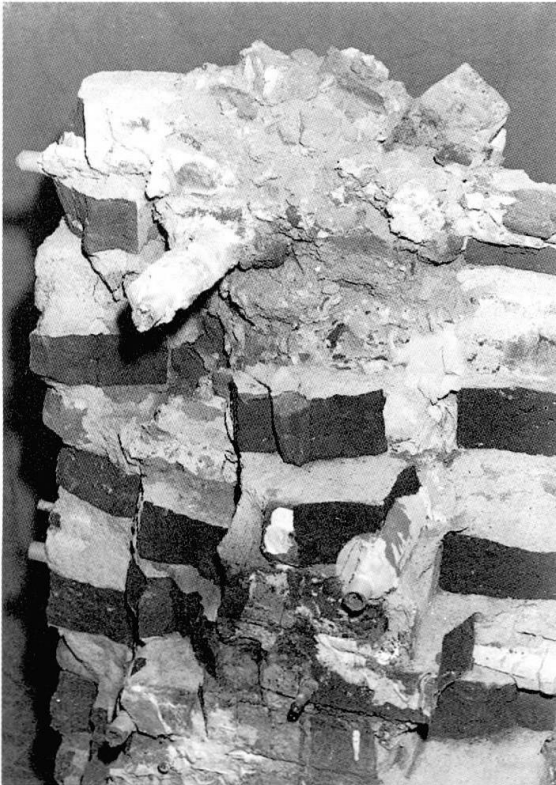
Fig. 4 Inside view of consolidated column with the connectors in place.

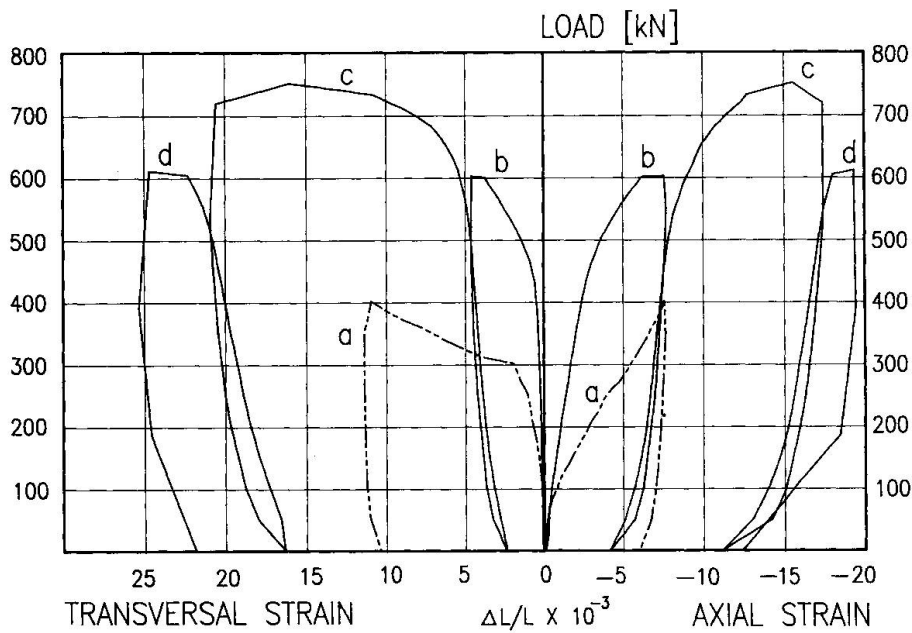
Fig. 7 Load-strain diagram, specimen No. 6

Consolidated specimens were tested until failure by the same procedure employed in the earlier series of tests. Figs. 7 and 8 reproduce the diagrams for two representative specimens. Lines a) refer to the damaging cycle and lines b), c) and d) refer to the subsequent application of the load to the consolidated specimens.

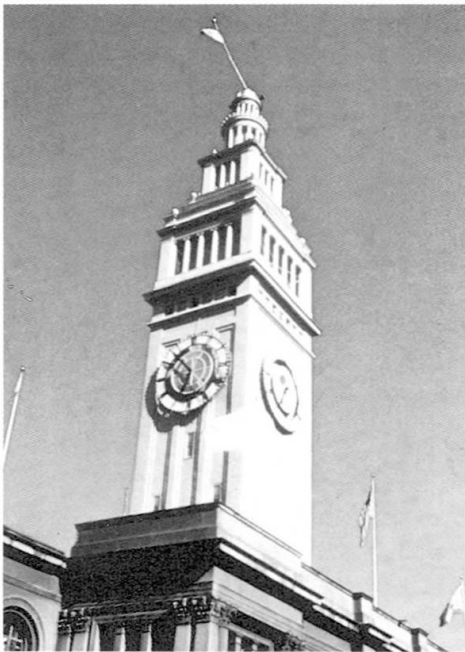
Figure 2. Photograph of Ferry Building tower after Loma Prieta earthquake with bent flagpole.

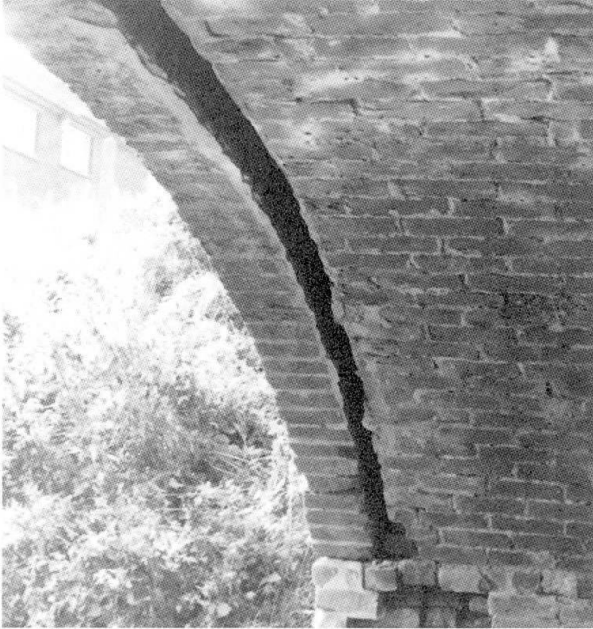
Fig 2 Crack in arch ring

Spandrel walls stiffen the arch ring at its edges. Flexing of the arch ring due to traffic loads will produce shear stresses in the ring where the relatively flexible part with only fill above it is stiffened by the spandrel wall, and these stresses may result in a crack. A severe example of such a crack is shown in figure 2. This type of failure may be assisted by rainwater getting into the structure at the parapet/surface joint and causing particular damage to the arch ring mortar where the spandrel wall meets the ring.

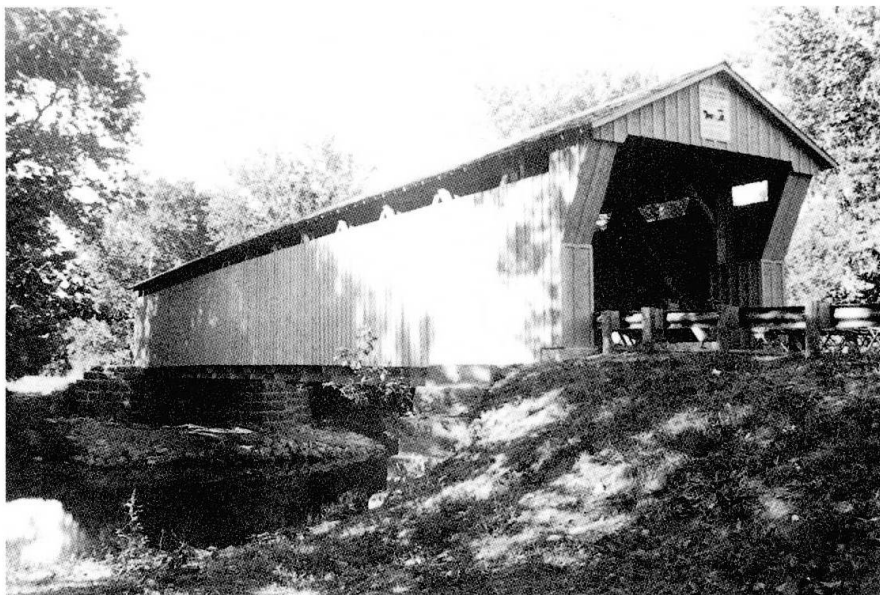
Figure 1.
Rehabilitated 1887
wood truss bridge
at Canal
Winchester, Ohio.

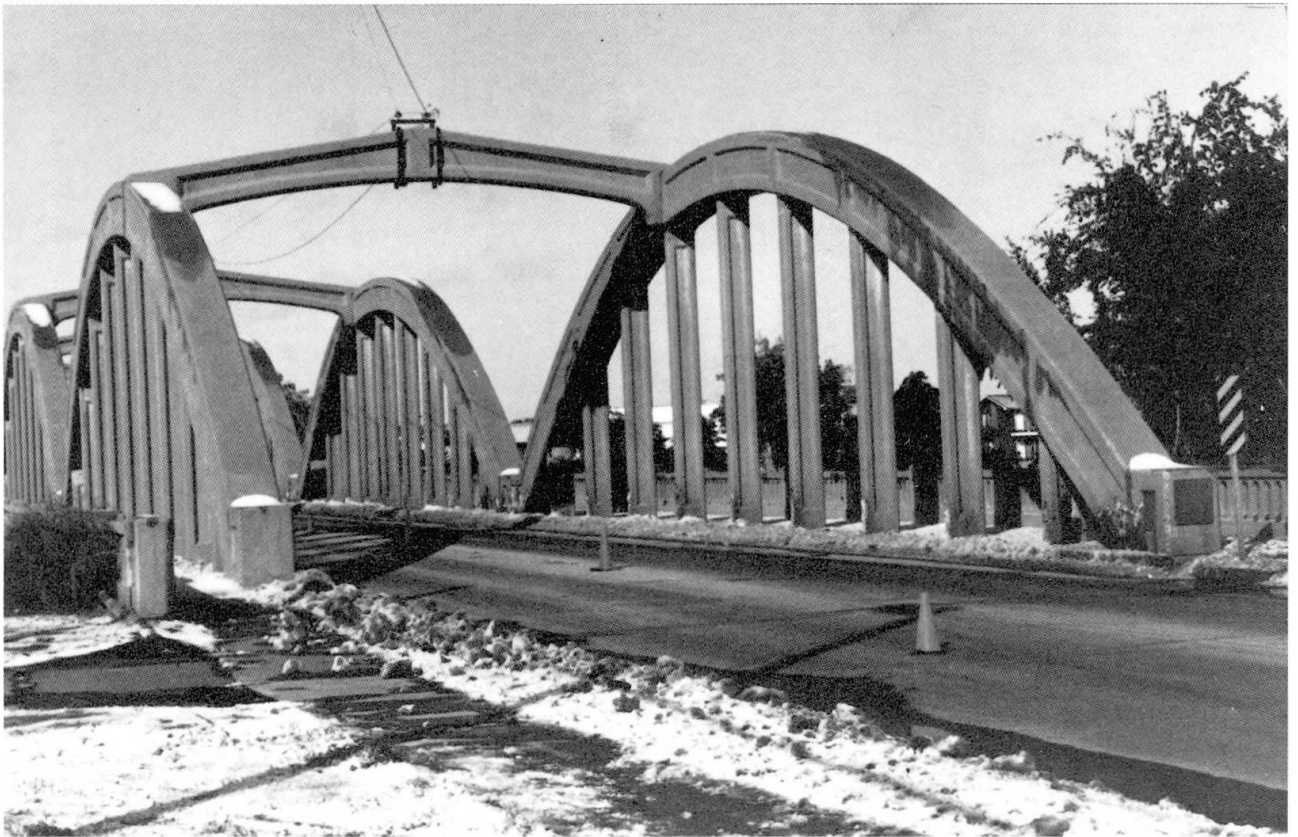
Figure 3. Circa 1930 patented Marsh encased steel through arch span at Wichita, Kansas.

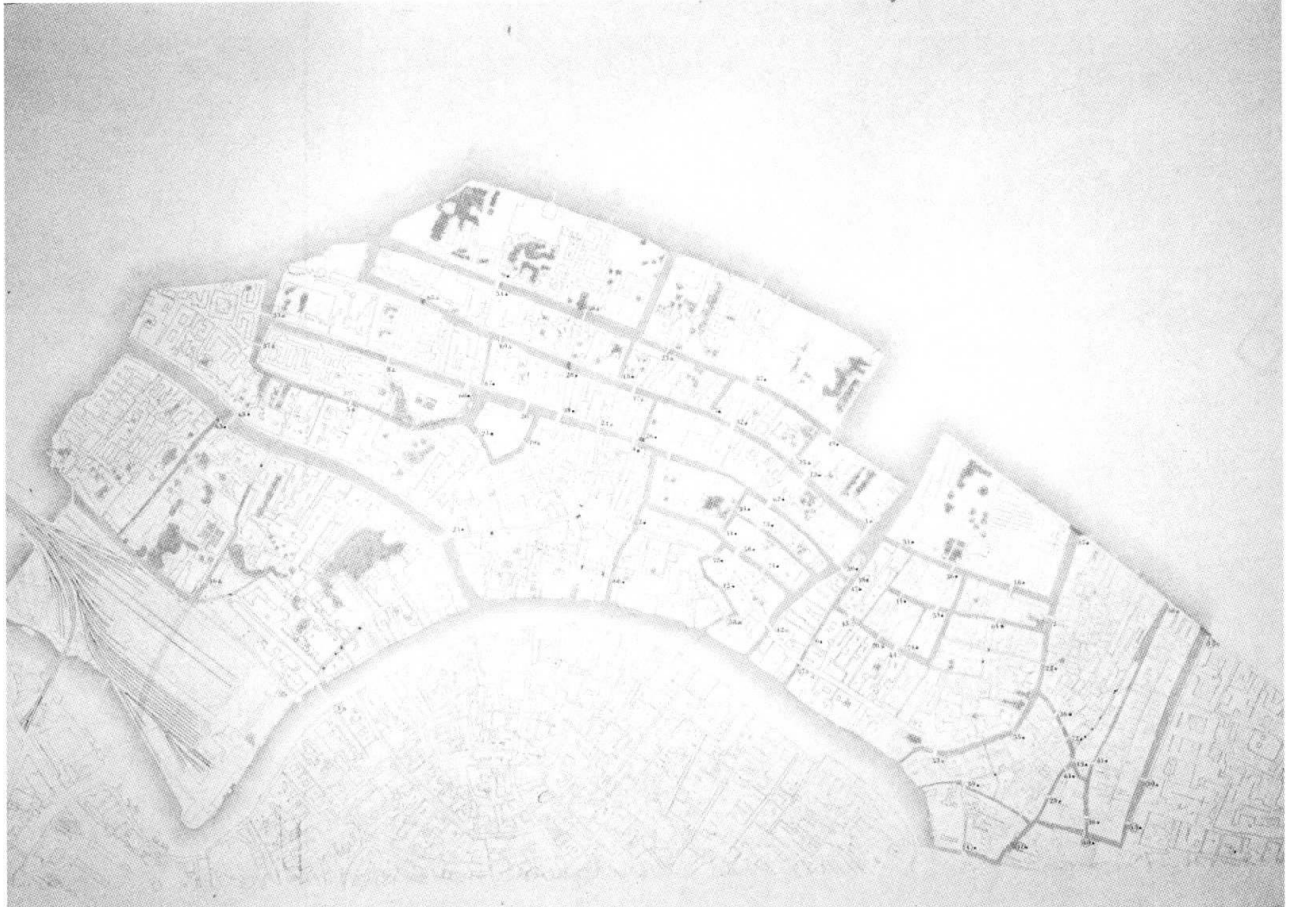
Fig. 7 Example of district map.

Our bridge filing system gives quick information on quantity, type of structure and location. To this purpose we have made use of several instruments, namely: six maps (one for each “sestiere”, as venetian districts are called) (1:2000 scale), synthetical and analytical tables.

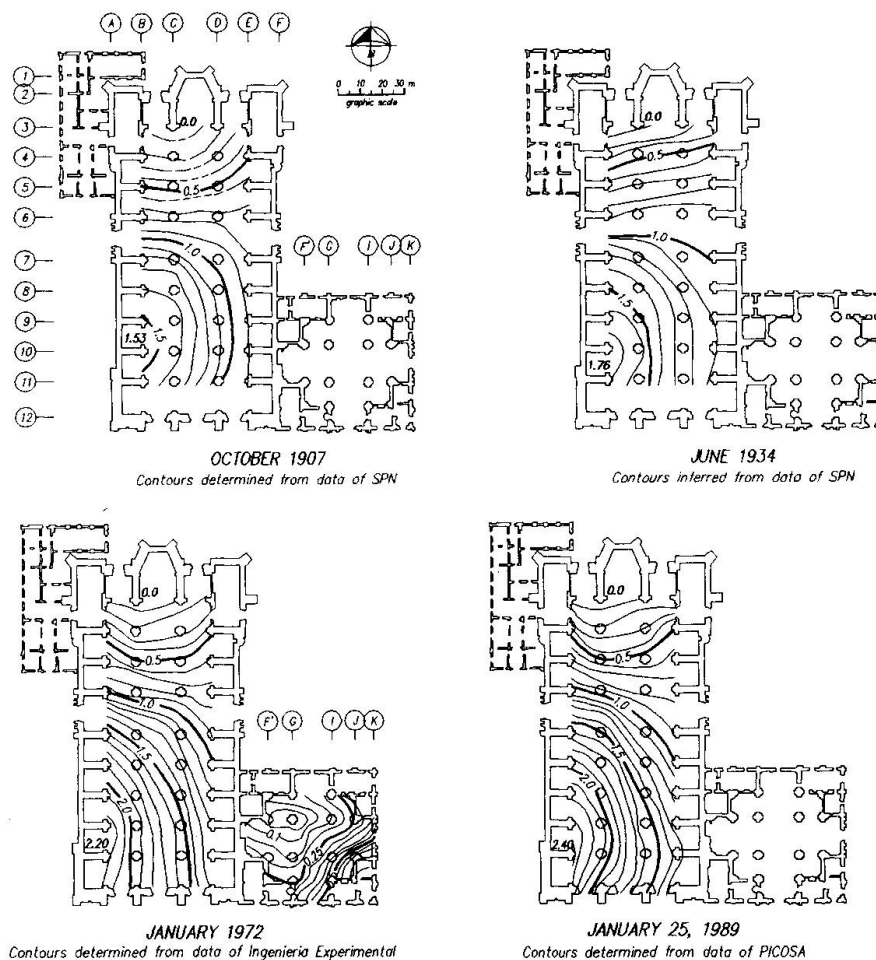
FIG 2 EVOLUTION OF THE DIFFERENTIAL SETTLEMENTS

In April 1989, severe cracking along the building southeast-northwest direction, revealed that alarmingly large settlements were taking place in the Cathedral. A review of all topographic surveys, as well as of all previous actions taken to mitigate the effects of differential settlements followed; the effects of the construction of a subway and a circular drainage tunnel built in front of the Cathedral were also considered. Surveys performed in 1907 revealed the existence of a differential settlement of more than 1.5 m between the apse and the west tower; in 1972, this settlement reached 2.2 m (fig. 2) and exceeded 2.4 m in 1990. Between the two towers, differential settlements are presently 1.25 m. The Sagrario church has tilted easterly and settled more than 90 cm differentially with respect to the Cathedral.

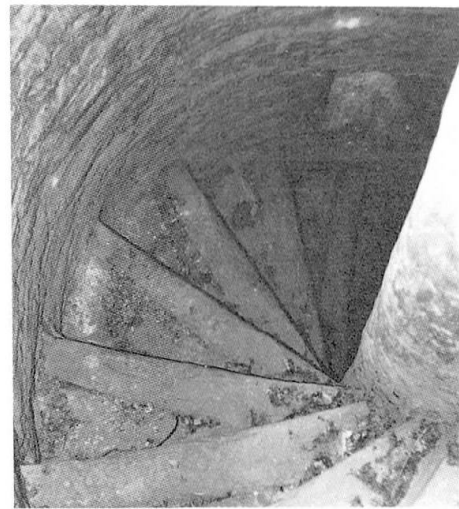
Fig.1

(a) Rotunda-Minaret: Southern view. (b) Masonry close-up: Merely visible horizontal crack. (c) Internal staircase. (d) Balcony and upper cylindrical part

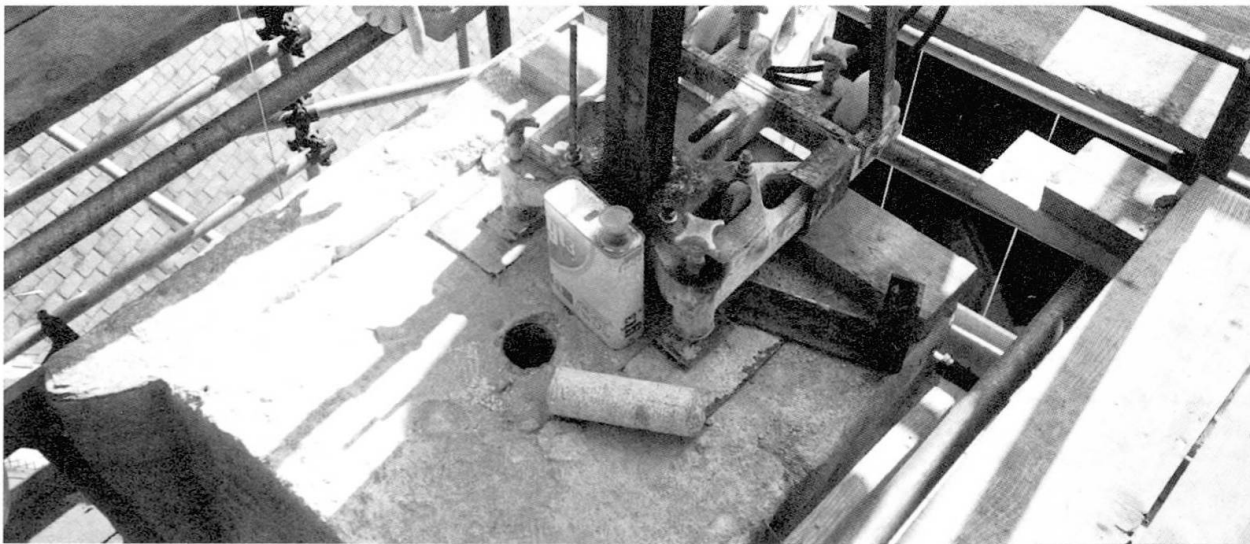
FORAGE DES TIRANTS SUBVERTICAUX

L'intérieur de la gaine PVC a été garni de mousse de polyuréthane pour isolation et maintien du tirant dans l'axe de la gaine.

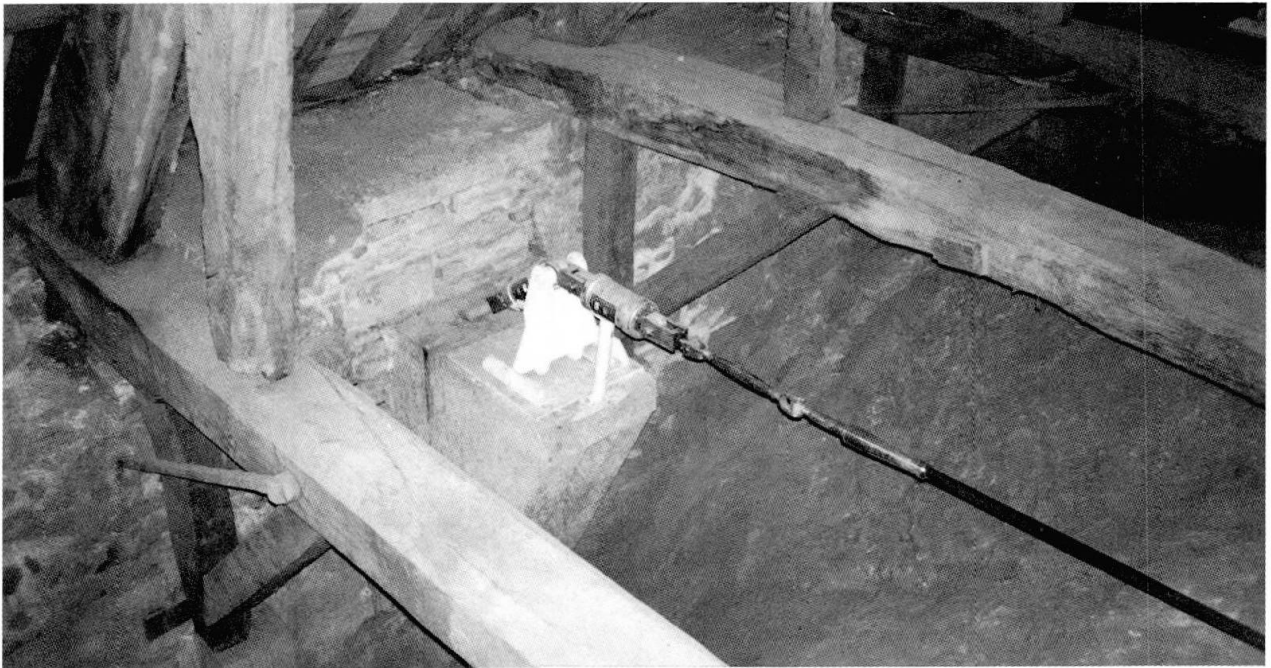
ACCROCHAGE DE TRAPEZE EN COMBLE

- Le tirant de liaison était prévu en acier inoxydable avec enrobage d'un isolant thermique. Mais du fait du coefficient de dilatation très élevé de l'acier inoxydable, seule une isolation par manchon chauffant semblait pouvoir donner une stabilité satisfaisante. Cette formule a été écartée pour des raisons évidentes de maintenance, et la solution a pu être trouvée dans l'emploi de matières composites dérivées de la fibre de carbone (thermiquement stable, incombustible, non magnétique, etc...). Les résultats ont immédiatement marqué une stabilisation de la tension à plus ou moins 6%, de la tension nécessaire.

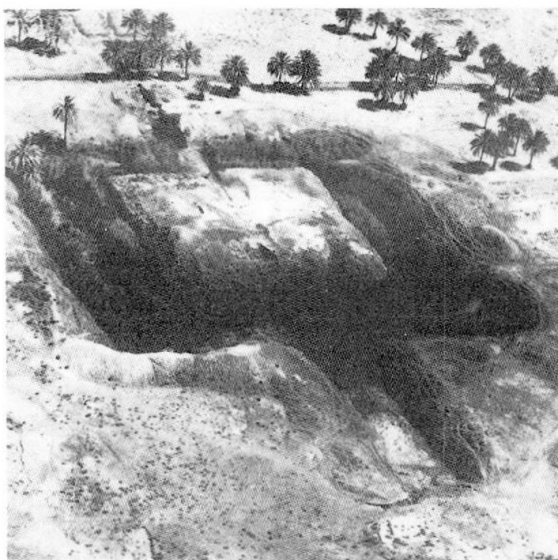
Fig. 5 Archaeological traces of the Tower of Babel /1/

To-day there is only the trace of the Tower of Babel (Fig. 5), a very imperfect echo of the past glory (Fig. 6).

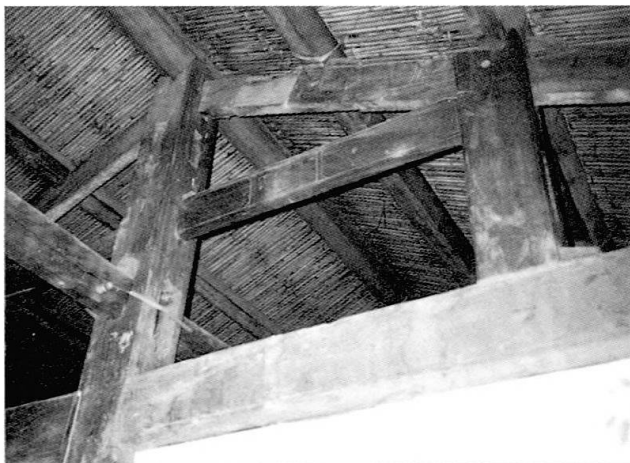
Fig. 3 The wooden Framework

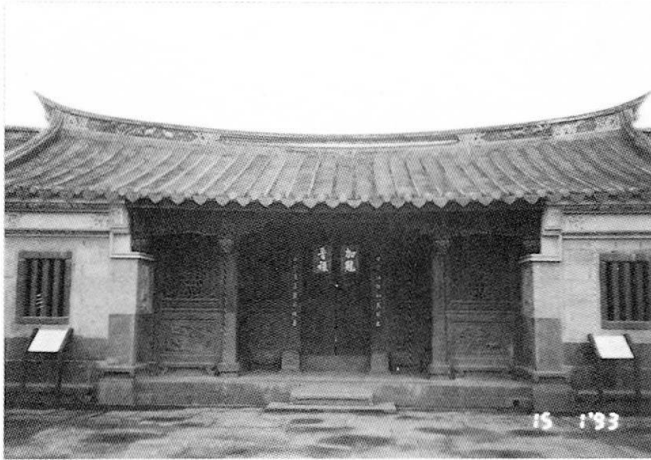
Fig. 5 The bricks and tiles

Three types of bricks laid horizontally in the facade of the lower building are in the southern Fukien style. Those on the rear part of the building are clay bricks. The face brick walls of the side buildings are engraved with tortoiseshell patterns. These probably resulted from a later addition or repair work. The stone slates below the stone waist piece are rather elaborately engraved in the pattern of tables. The entire facade of the dwelling looks neat and handsome. Although its altitude is relatively low, there is a sense of equilibrium (Fig.5).

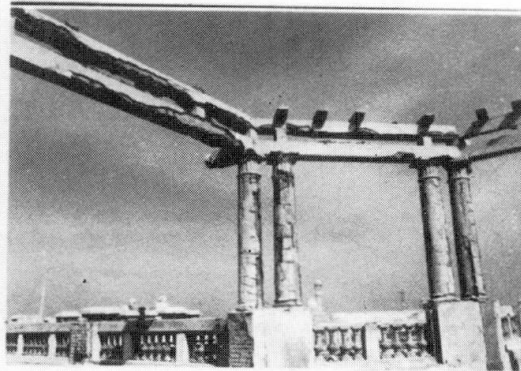
Fig. (2) Photos taken to the Extension Building showing a sample of the damaged parts

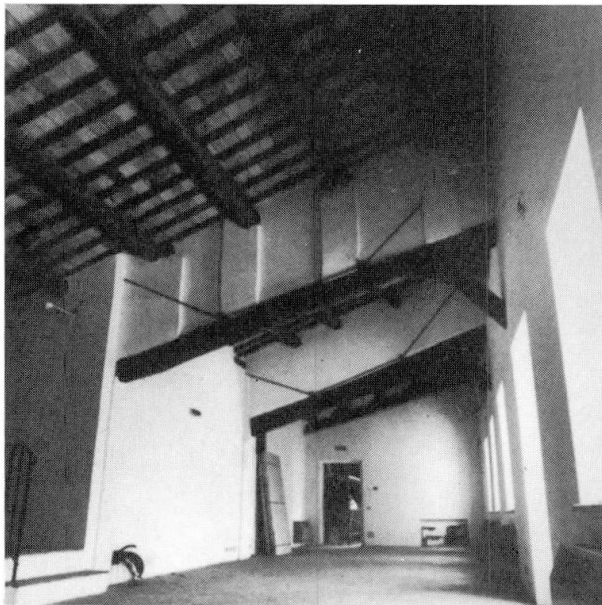
Pic. 6

The increase in bearing capacity was obtained by a steel section placed over the principal beam within the height of, and connected to, the secondary structure.
