Zeitschrift: IABSE reports = Rapports AIPC = IVBH Berichte
Band: 70 (1993)
Rubrik: Keynote lecture

Compatibilité de la thérapie avec le monument

Verträglichkeit Instandstellungsmassnahmen mit dem Monument

Appropriate Measures for the Preservation of Monuments

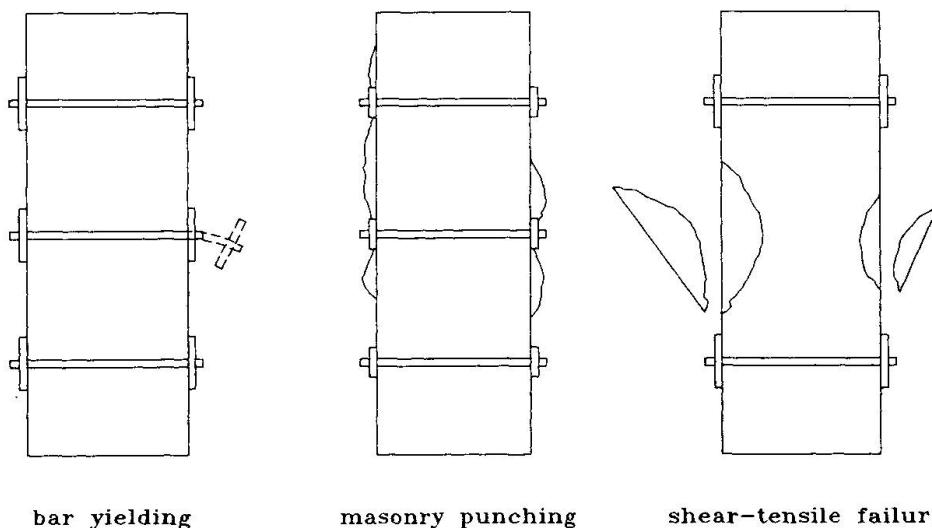
Fig. 1 Possible failure modes. From the left hand side: yielding and fracture of bars; punching of masonry beneath the confining plates; shear-tensile failure in the unconfined region

As already mentioned three fundamental failure modes have been considered, as shown in figure 1. For the purpose of some preliminary estimation of the failure mode to be expected, a bidimensional behaviour was assumed, imposing a perfect confinement in the third direction. These conditions could correspond to those of a wall with width significantly larger than thickness, and have been reproduced in the tests applying much stiffer bars and plates covering the whole side in one of the horizontal directions (see figure 2).

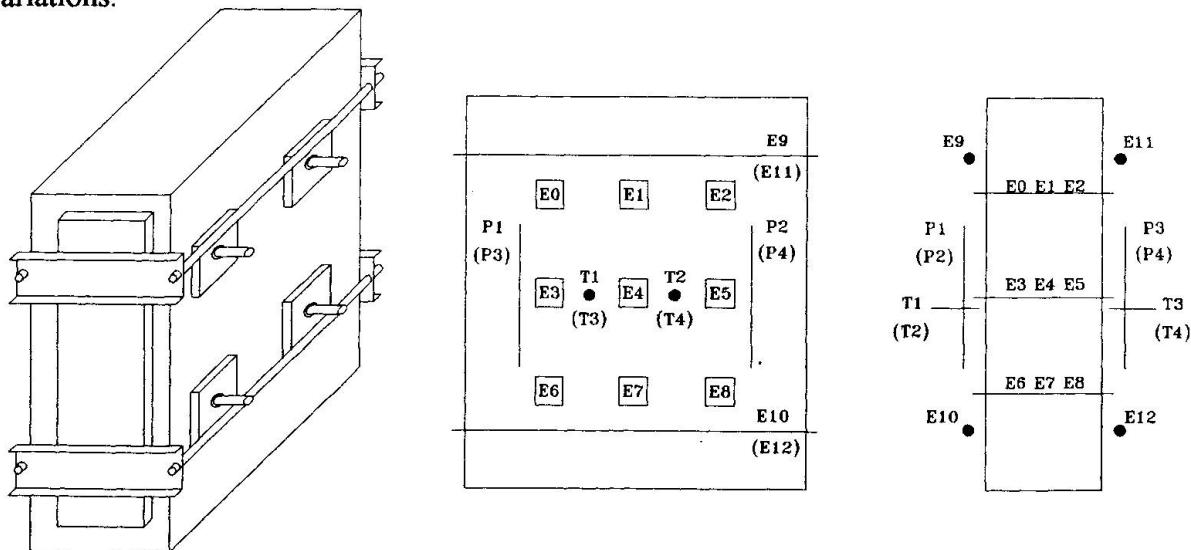
Fig. 2 Test setup (P: linear potentiometers, T: LVDT, E: Strain gauges)

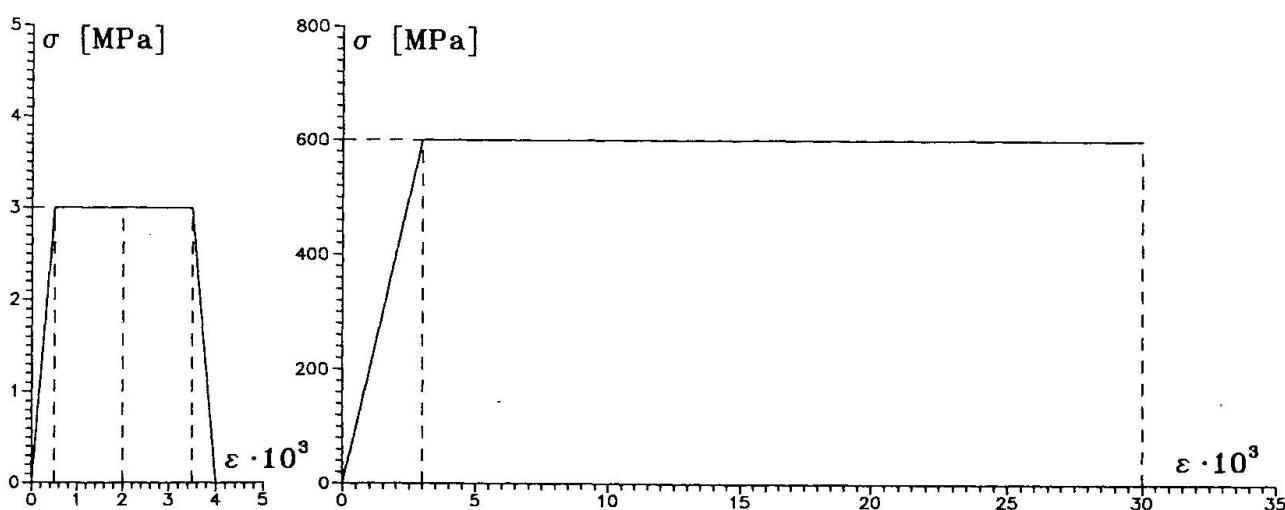
Fig. 3 Assumed material behaviour. Left: masonry; right: steel bar

Assuming the materials behaviour as shown in figure 3, the total energy absorption capacity of the wall can be approximately evaluated as 1400 kN mm, the energy absorption capacity of each reinforcing bar as 140 kN mm. The energy increment should therefore be estimated as 40%, for the case with 4 bars, and 90% for the case with 9 bars, provided that the assumptions mentioned above are applicable and that the final collapse corresponds to a contemporary fracture of all bars. The energy increment could correspond to different combinations of strength and deformation capacity variations.

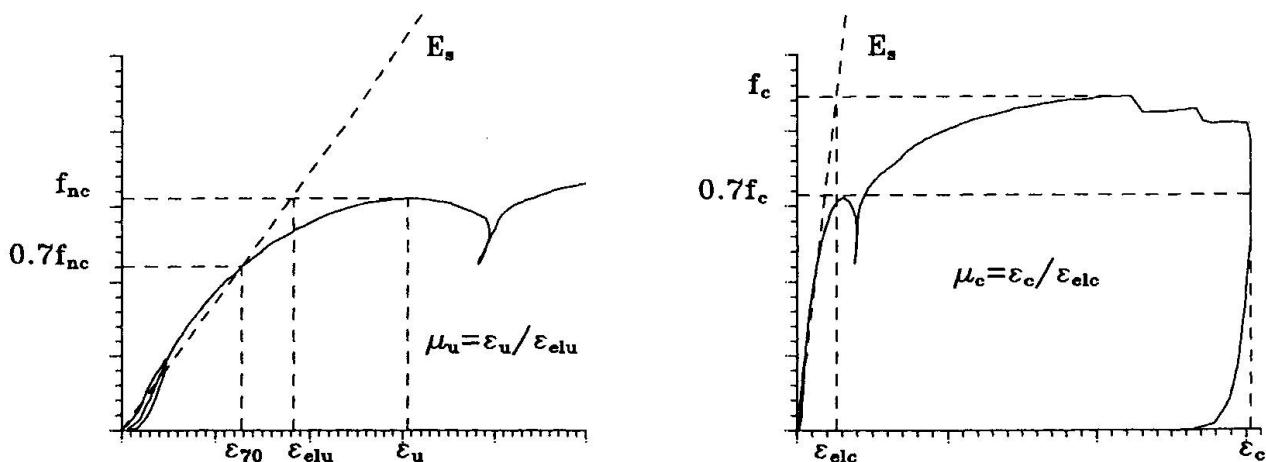
Fig. 4 Typical stress-strain curve obtained from the tests (the definition used for stiffness, equivalent elastic limit and ductility are shown)

The ultimate deformation capacity of the unconfined specimens was equal to 0.24% (average, c.o.v. 0.26), with an equivalent "ductility" (μ_v , defined according to figure 4) of 1.76 (c.o.v. 0.12).

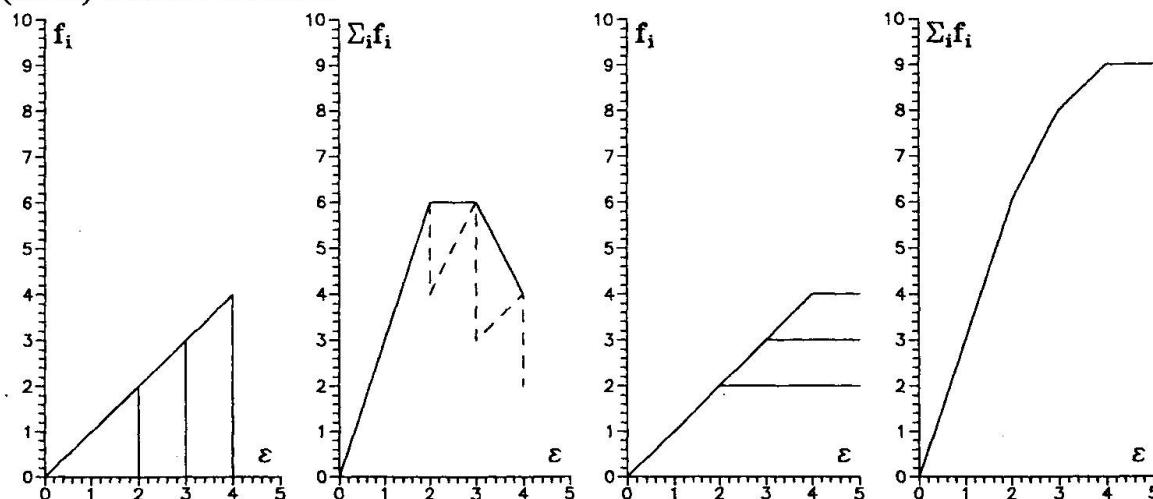
Fig. 5 Comparison of the overall behaviour shown by systems made with materials of different strength working in parallel. Left: elastic-brittle; right: elastic perfectly plastic.

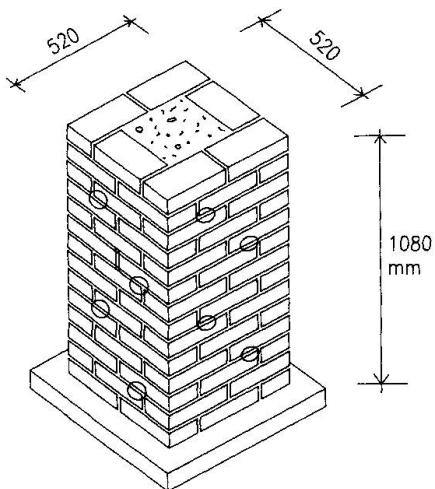
Fig. 1 Test column showing arrangement of connectors

Fig. 1 clearly shows the shape and geometry of the columns. The fill layer was reproduced with rubble taken from the Castello della Venaria. Grain size is described in fig. 2.

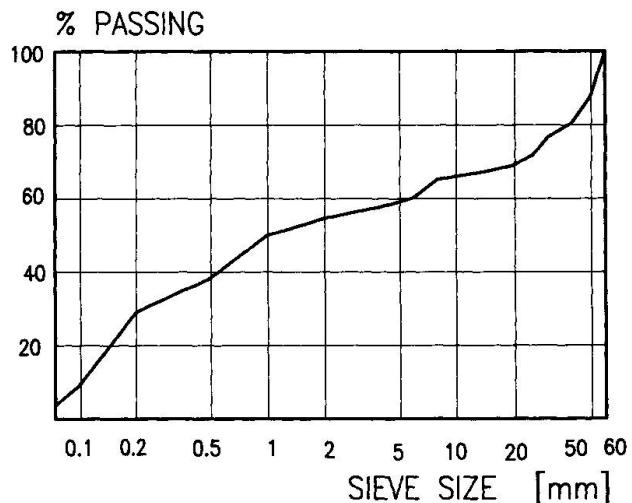
Fig. 2 Grain size of the fill material

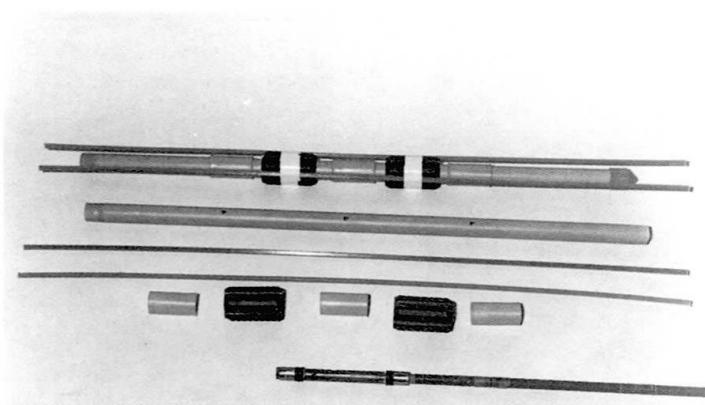
- a pipe with valves, of DURVINIL PVC, 21 mm in diameter and long enough to match the element's size, fitted with three manchette-type 30 mm long polyester elastomer DUR-O-RING valves, with opening pressure < 1 bar;
- two circular cross-section bars with nominal diameter of 5 mm, made of parallel aramidic fibres impregnated with an epoxy-based compound and coated with the same compound with the addition of fine silica sand (grain size between 0.125 and 0.25 mm);
- two (or more) spacers-centering pieces of polypropylene, 37 mm in diameter and 60 mm in length.

Fig. 3 Detailed view of connector

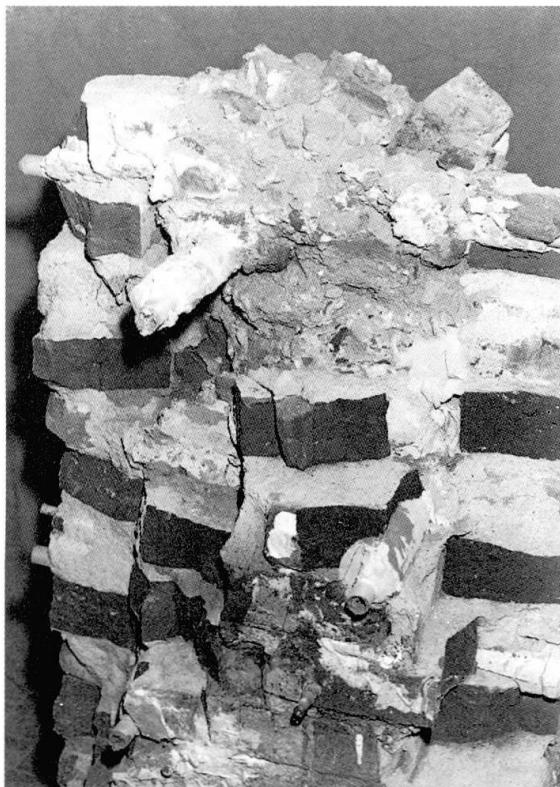
Fig. 4 Inside view of consolidated column with the connectors in place.

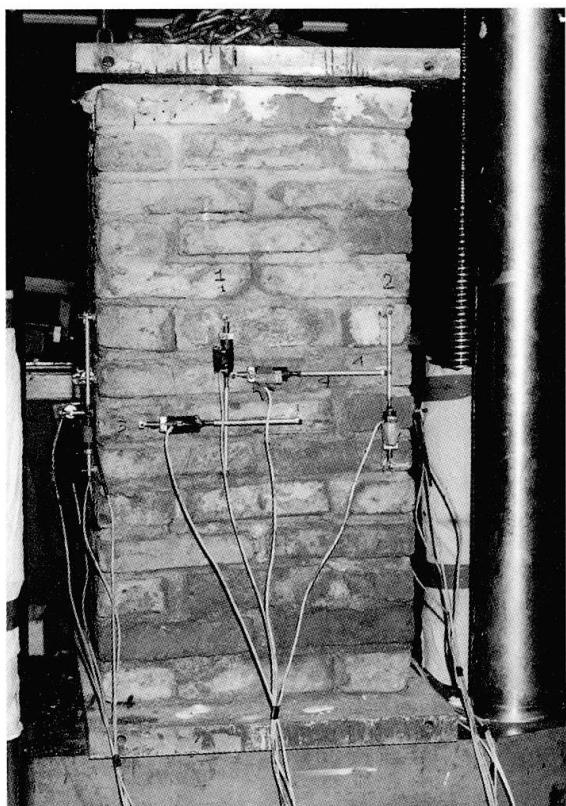
Fig. 5 Arrangement of the strain gauges

After about 30 days of ageing at 20°C temperature and 65% humidity, the specimens were subjected to centred compressive tests up to advanced cracking. For each load level, strains were measured by means of 16 potentiometric transducers on 250 mm gauges, arranged as shown in fig. 5.

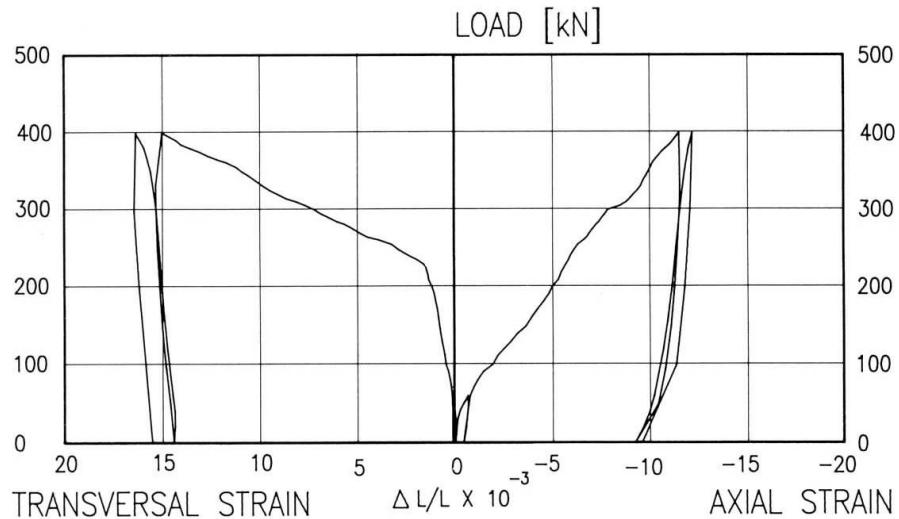
Fig. 6 Load-strain diagram, specimen No. 12

representative specimens. Lines a) refer to the damaging cycle and lines b), c) and d) refer to the subsequent application of the load to the consolidated specimens.

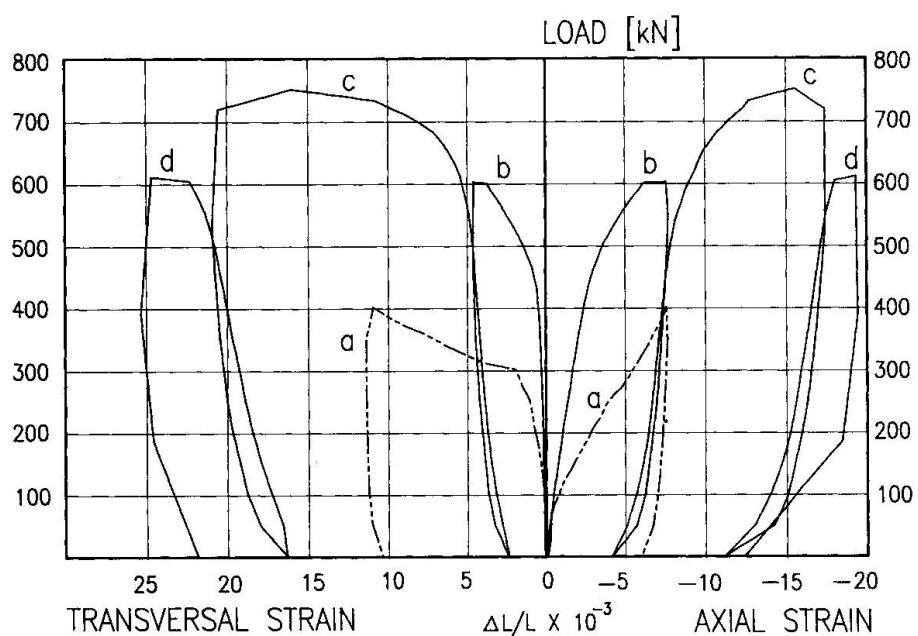
Fig. 7 Load-strain diagram, specimen No. 6

Consolidated specimens were tested until failure by the same procedure employed in the earlier series of tests. Figs. 7 and 8 reproduce the diagrams for two

The slope of the load-strain curves obtained from the consolidated structures can be compared to the load removal curves obtained during the damaging cycle. This means that the stiffness of the structural elements remains substantially unaltered after the intervention.

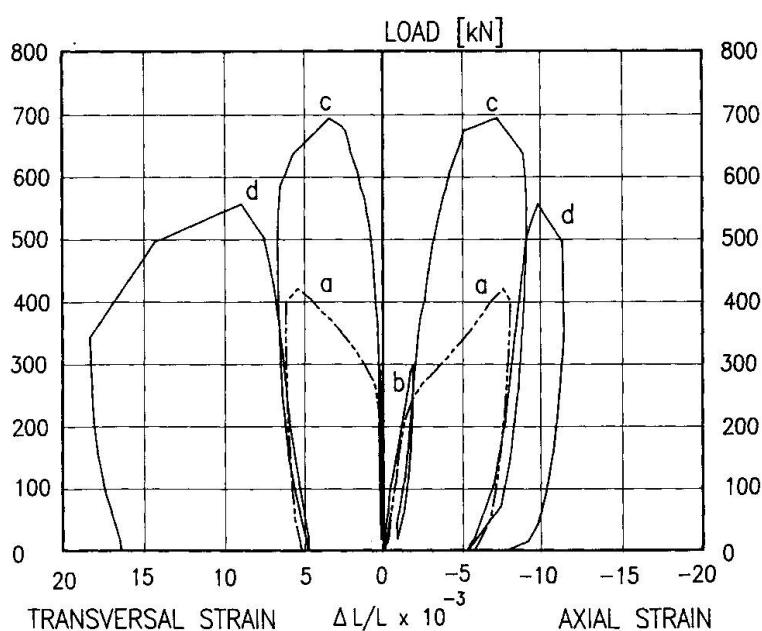
Fig. 8 Load-strain diagram, specimen No. 7

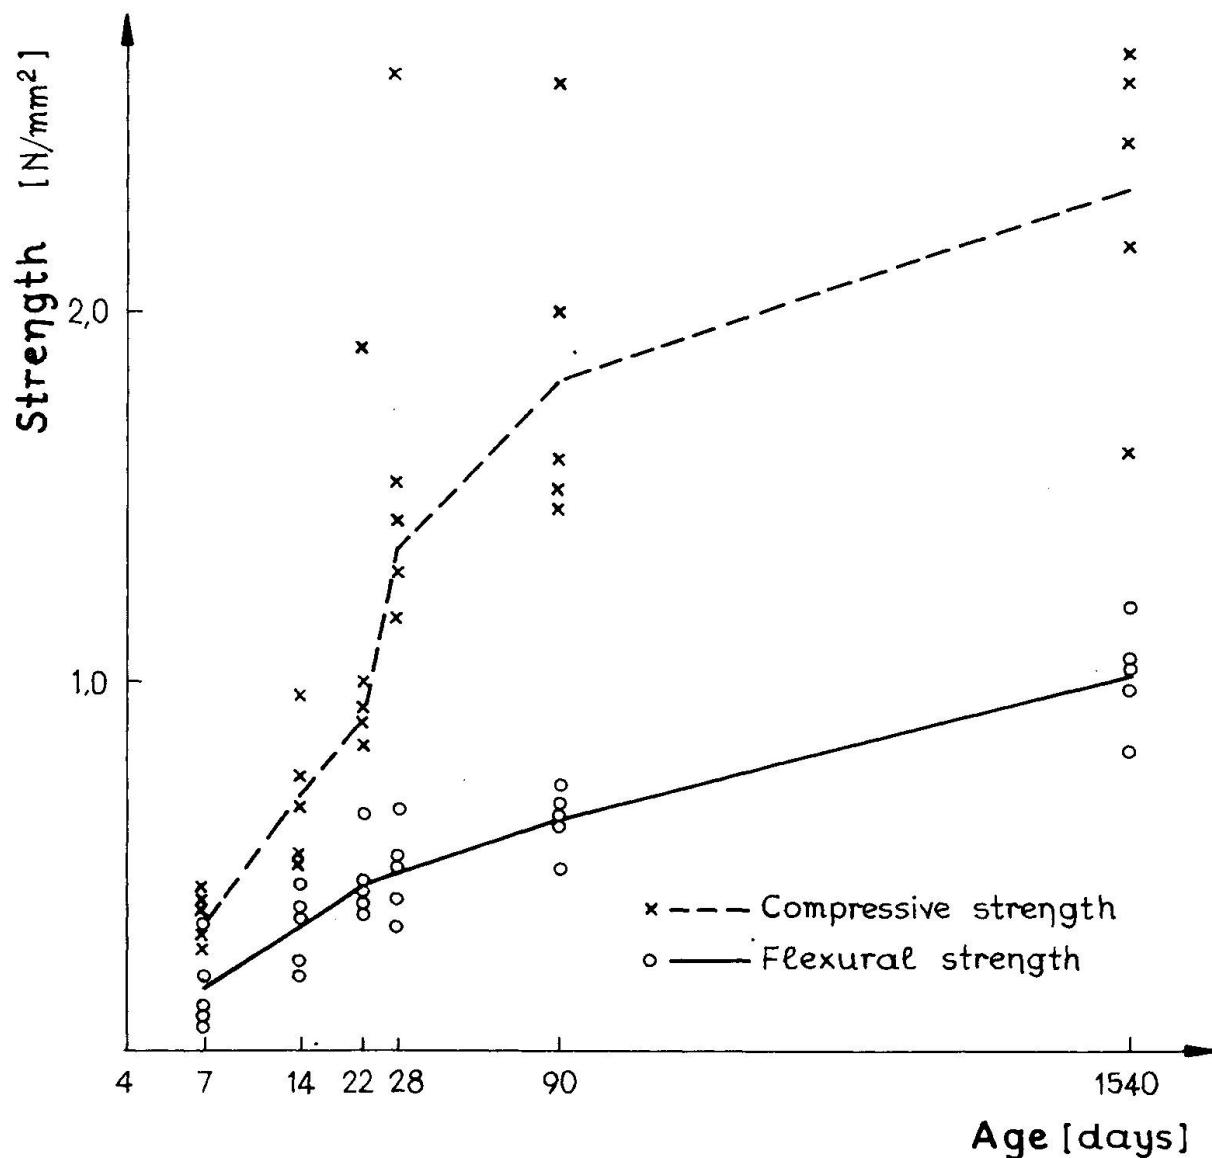
Fig. 1 Strength development of grouts G₃, G₄, G₅, G₆, G₇

The long-time strength of mortars and grouts must be taken into account in the analysis of bearing capacity of under restoration masonry as well as the masonry deformations. Therefore, a slight decrease in mortar strength must be expected after one year. In contrast, grout strength is slightly increased after years. This leads to the suggestion that in order to achieve the required strength for repairing a masonry a higher strength mixture should be designed.

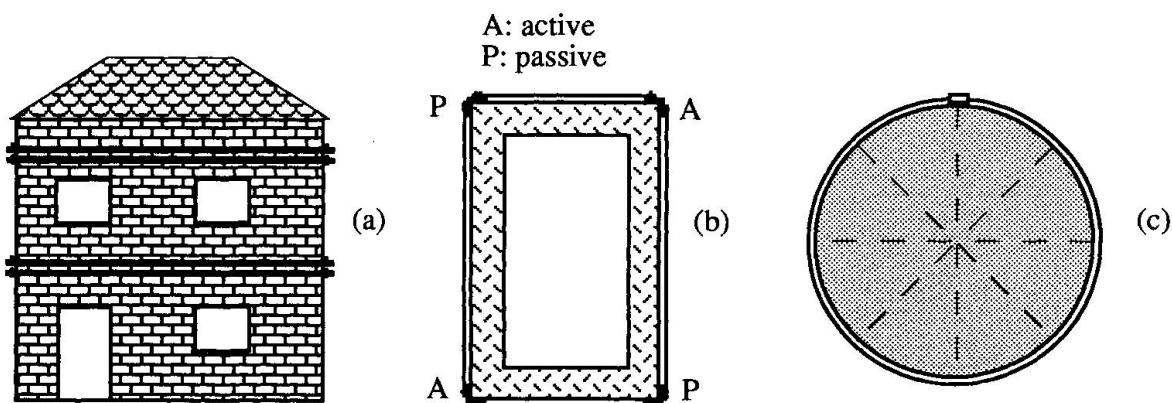
Fig. 1 Application of external FRP ties: (a) elevation; (b) plan view of rectangular structure; and (c) plan view of spherical dome.

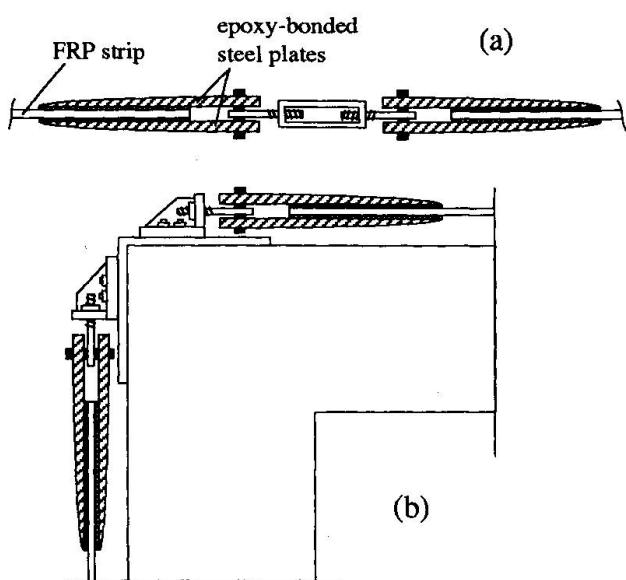
Fig. 2 Conceptual FRP anchorage/attachment for (a) circumferential prestressing of circular domes; and (b) masonry structure corners.

Due to their anisotropic nature, unidirectional composites have relatively low transverse compressive strength (approx. $0.1f_{FRP,t}$) and even lower (interlaminar) shear strength. Furthermore, because of their brittle nature, the materials are sensitive to stress concentrations and hence cannot be pierced or threaded. Finally, their abrasion resistance allows only limited frictional stresses. Thus, conventional anchoring solutions (upset heads, threads, wedges, etc.) are not applicable, and relatively large anchor lengths are required. Strip-like tendons may be better than round ones for external post-tensioning of masonry, because they minimize anchor lengths (due to their large surface area) and simplify the attachment of anchorages on the masonry walls. Proposed concepts for anchorages and their attachment on masonry are illustrated in Fig. 2.

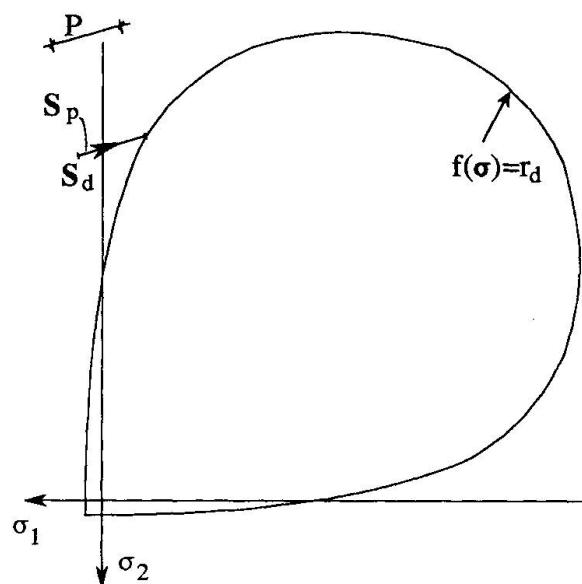
Fig. 3 Illustration of design procedure.

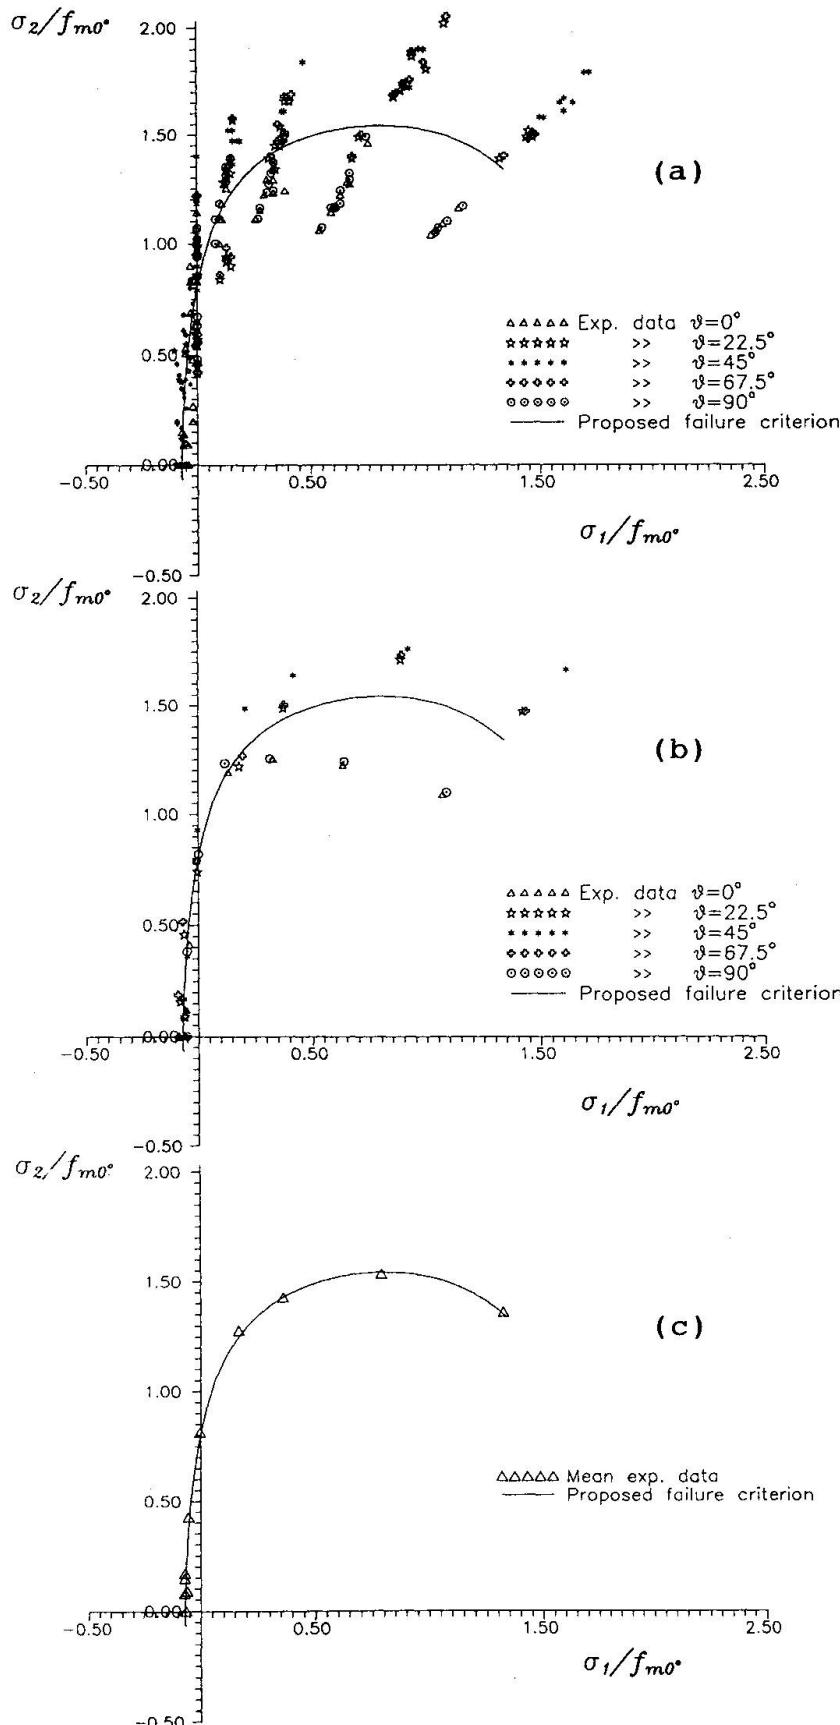
Fig. 1 Test data from [4, 5] and proposed failure criterion. (a) Individual data; (b) average data for each θ value; (c) average data for all θ .

medieval and Renaissance monuments. Despite of its importance, though, it has never been the subject of a systematic experimental investigation, such as those reported for brick masonry under biaxial stresses [4, 5]. In view of this lack of test data the authors had to resort to these latter results on solid brick masonry tested to failure under a variety of biaxial tension-compression and compression-tension principal stress combinations, oriented at various angles θ equal to 0° , 22.5° , 45° , 67.5° and 90° with respect to the bed joints, and to fit a biaxial failure criterion to them after removing the dependence on the angle of θ .

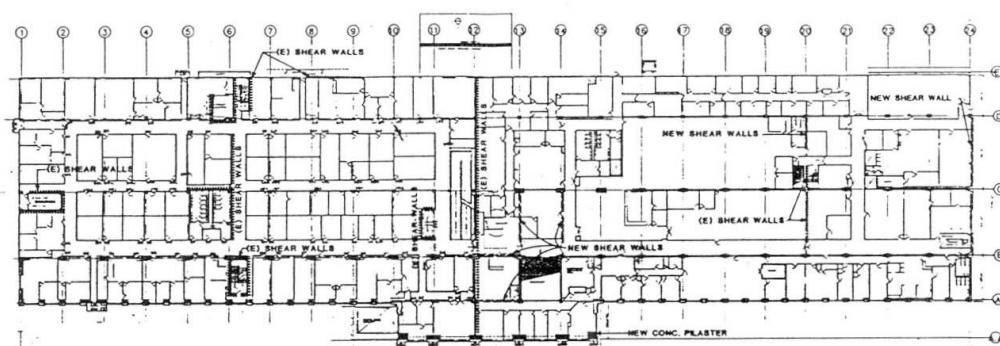
Figure 1. Second Floor of Ferry Building showing existing and recommended locations of shear walls. The tower is between columns 12-13-A-B.

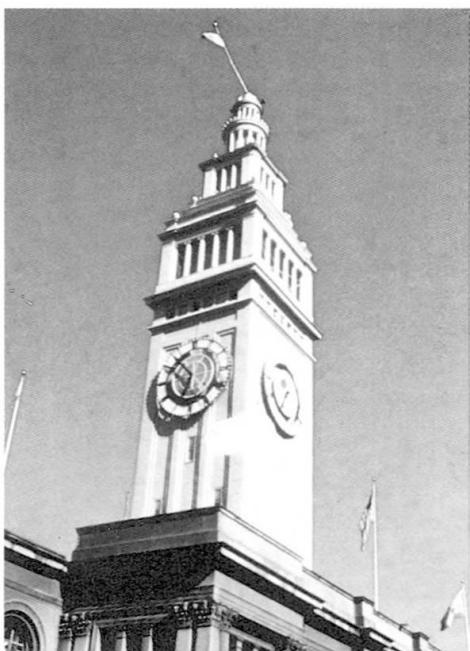
Figure 2. Photograph of Ferry Building tower after Loma Prieta earthquake with bent flagpole.

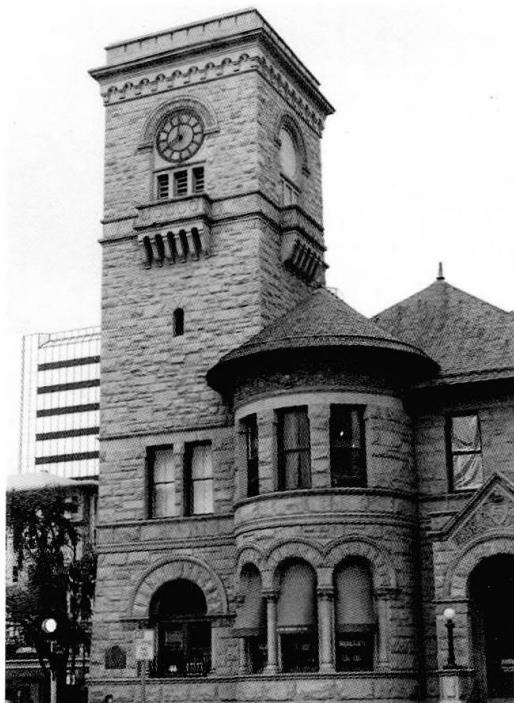
Figure 5. San Jose Museum of Art, formerly the United States Post Office.

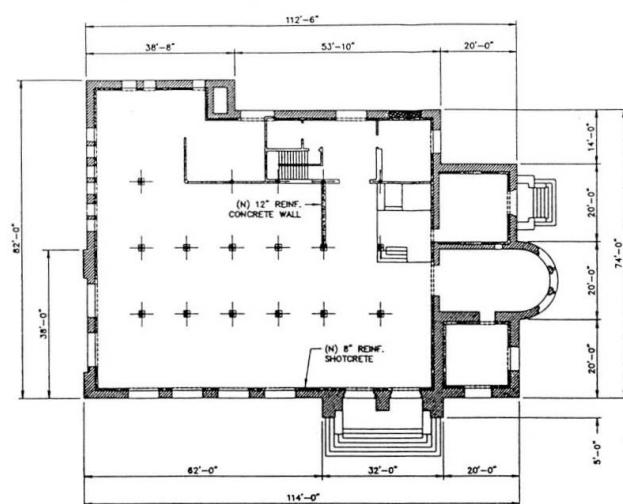
Figure 6. Proposed strengthening of San Jose Museum of Art - First Floor Plan.

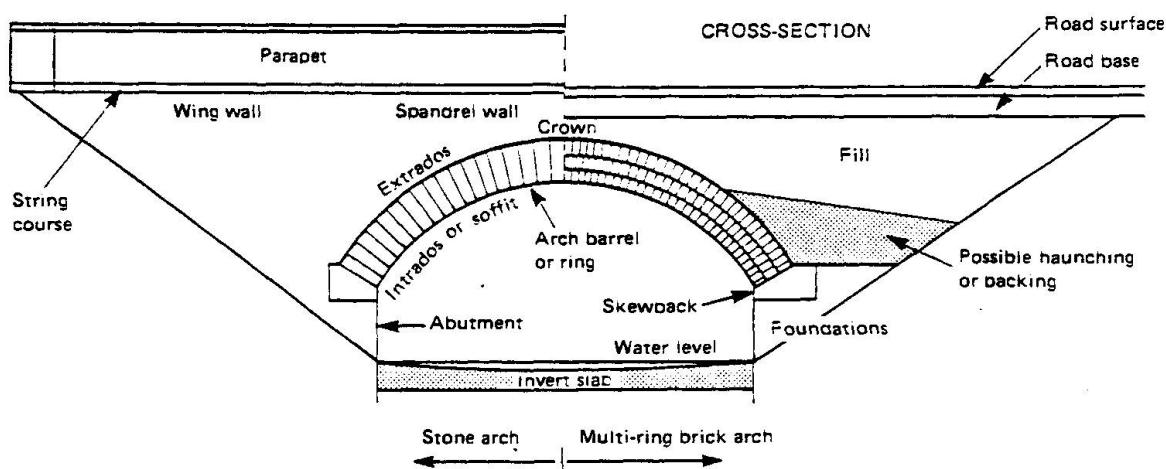
Fig 1 Typical masonry arch bridge construction

Many of them have deteriorated due to the effects of weathering and traffic: some of the traffic they are now required to carry is much heavier than was envisaged when they were built. There are a variety of commonly used repair and strengthening methods used to maintain their function or to increase their load carrying capacity. This paper discusses the common types of deterioration and the effectiveness and cost of some repair and strengthening methods. Typical construction of masonry arch bridges is shown in figure 1.

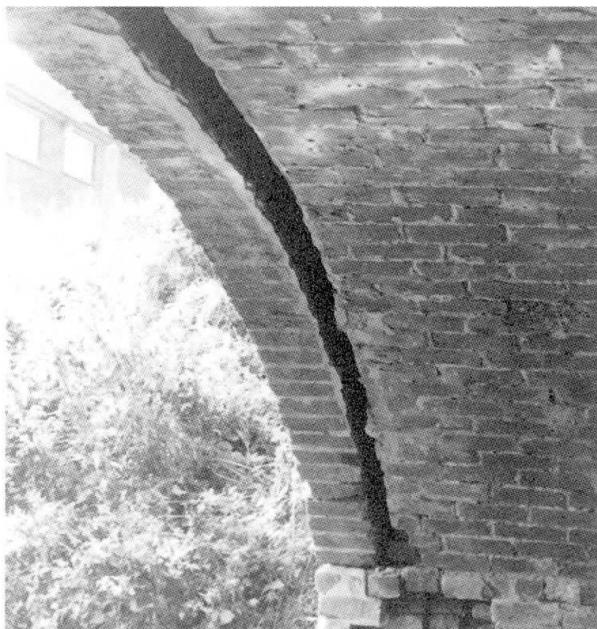
Fig 2 Crack in arch ring

Spandrel walls stiffen the arch ring at its edges. Flexing of the arch ring due to traffic loads will produce shear stresses in the ring where the relatively flexible part with only fill above it is stiffened by the spandrel wall, and these stresses may result in a crack. A severe example of such a crack is shown in figure 2. This type of failure may be assisted by rainwater getting into the structure at the parapet/surface joint and causing particular damage to the arch ring mortar where the spandrel wall meets the ring.

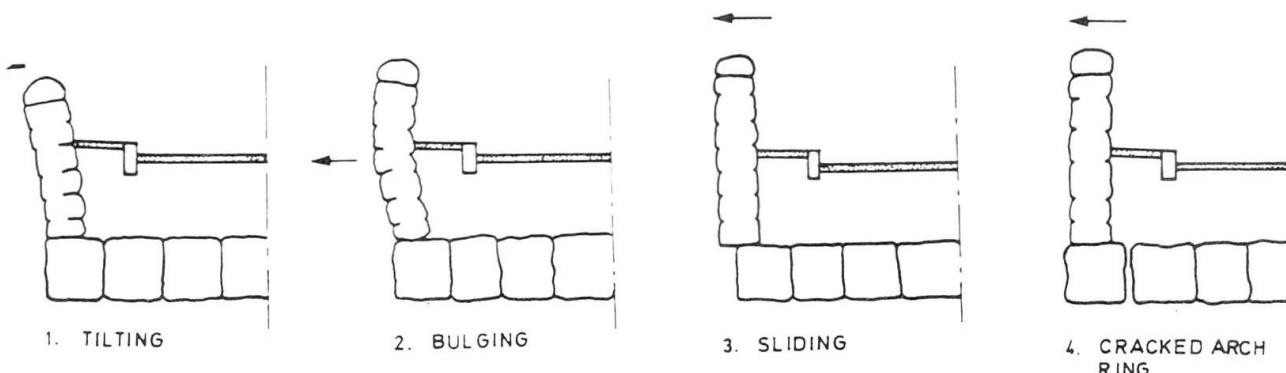
Fig 3 Spandrel wall failures

Spandrel walls probably represent the biggest single problem with masonry arch bridges. They suffer from the normal problems associated with exposed masonry such as weathering and loss of pointing. They are also frequently affected by dead and live load lateral forces generated through the fill or as a result of vehicle impact on the parapet or by freezing of the fill. The effect may be (see figure 3) outward rotation, sliding on the arch ring, cracking of the arch ring, or bulging.

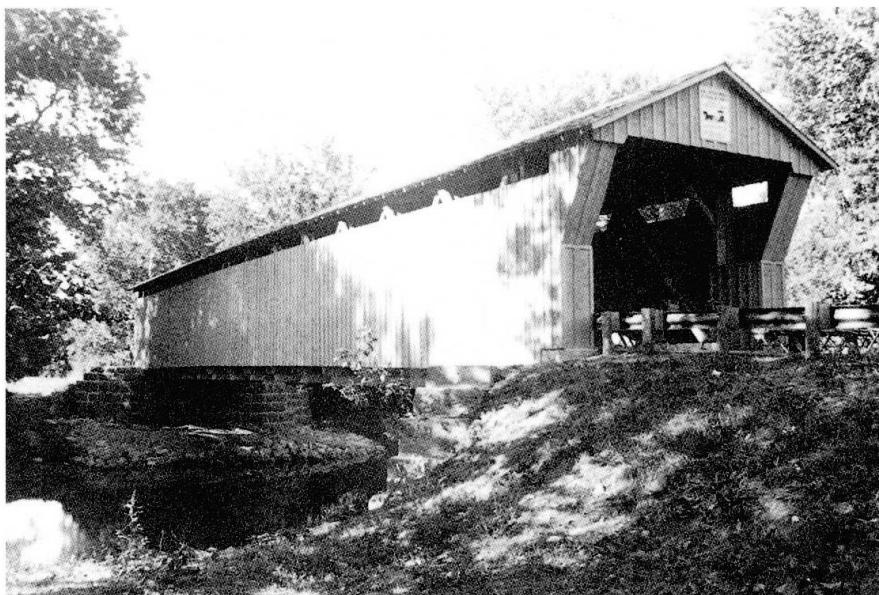
Figure 1.
Rehabilitated 1887
wood truss bridge
at Canal
Winchester, Ohio.

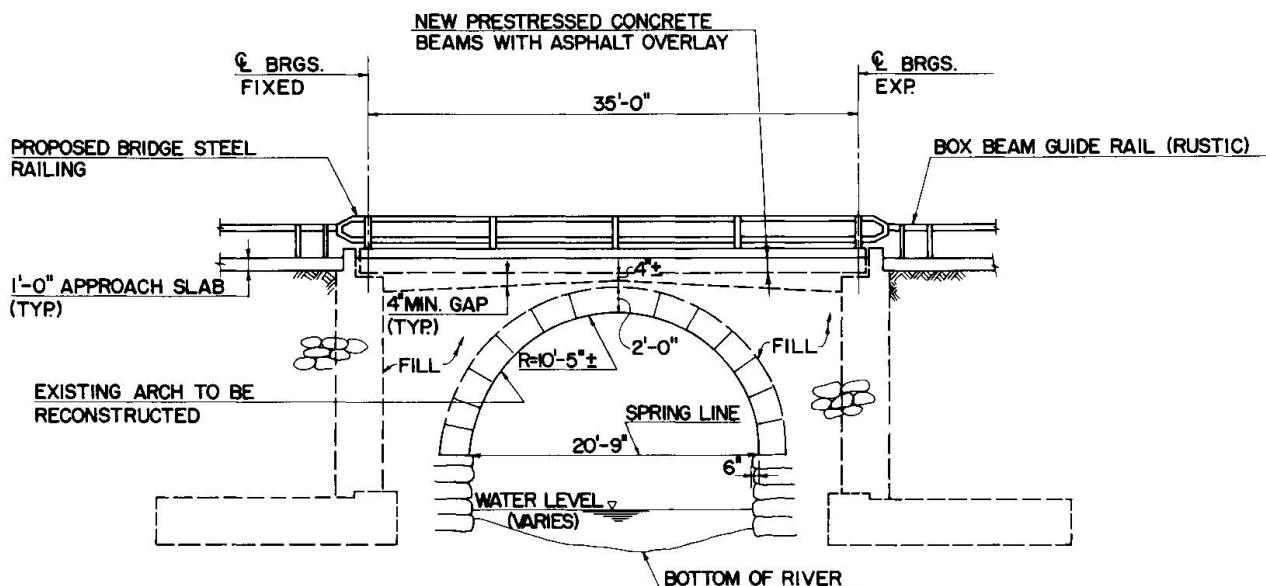
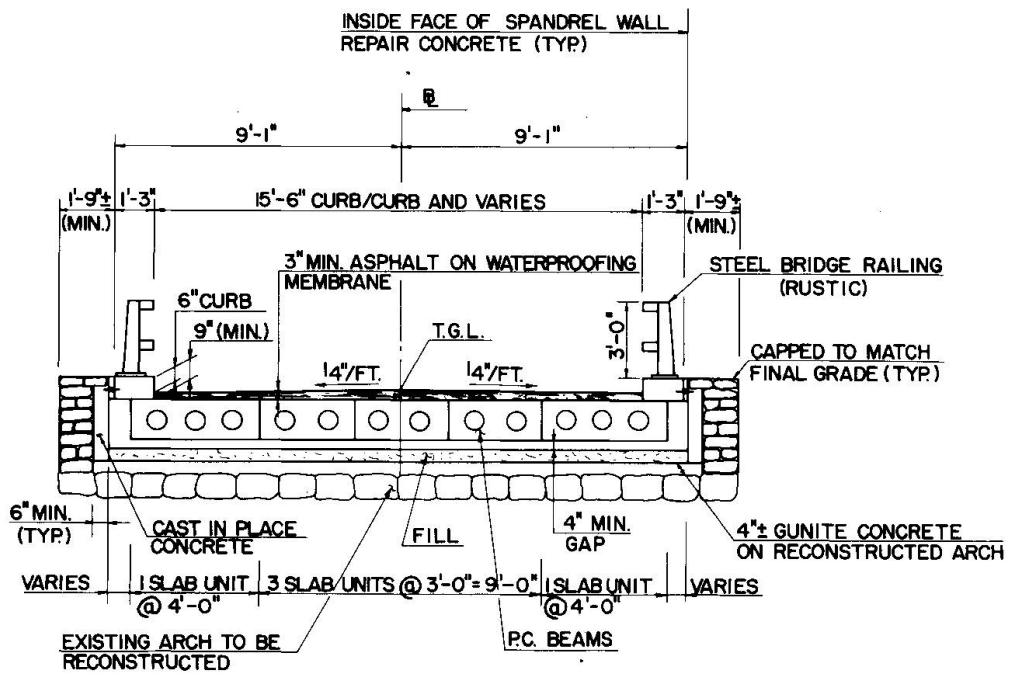
KEELER LANE
BRIDGE RESTORATION
NORTH SALEM, N.Y.

ELEVATION

BRIDGE SECTION

Figure 2. Rehabilitation plans for ca. 1840 Keeler Lane stone arch bridge at North Salem, NY.

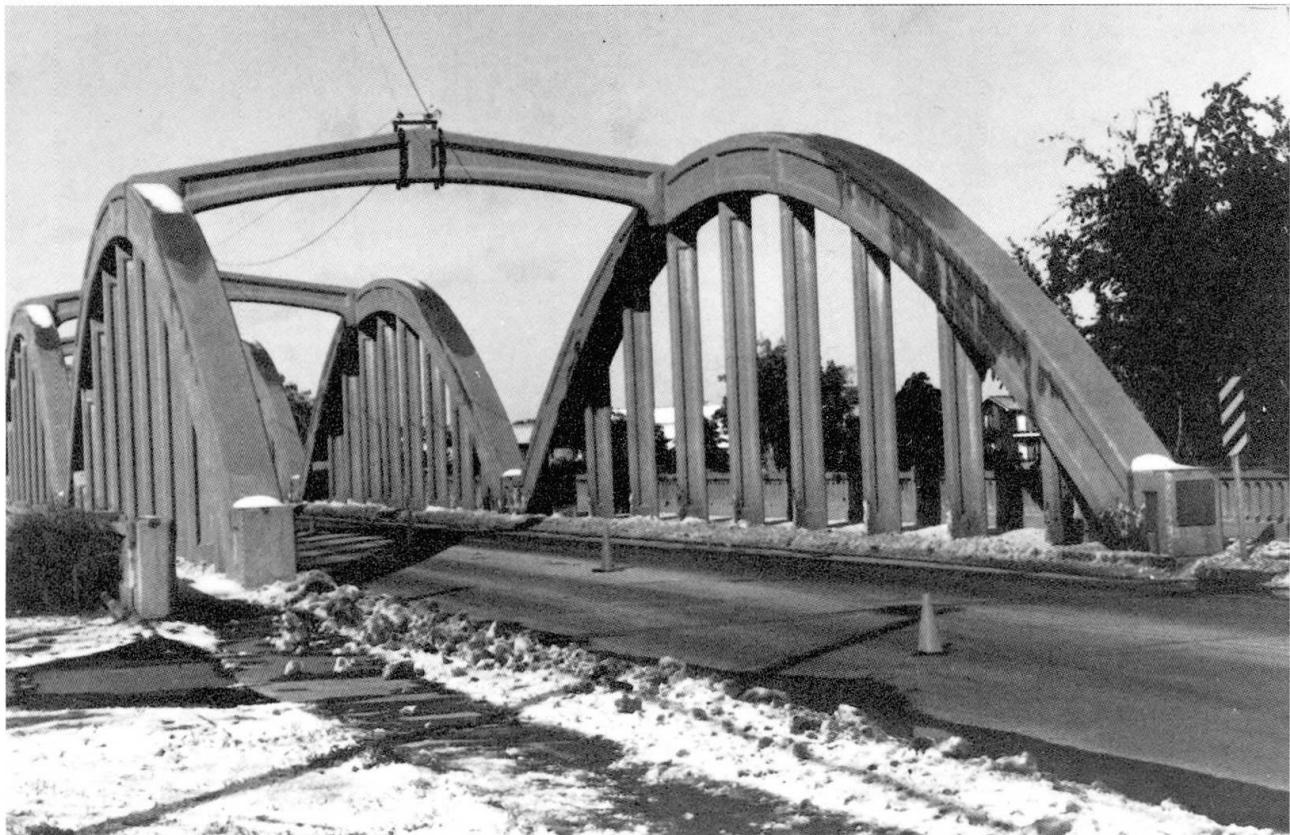
Figure 3. Circa 1930 patented Marsh encased steel through arch span at Wichita, Kansas.

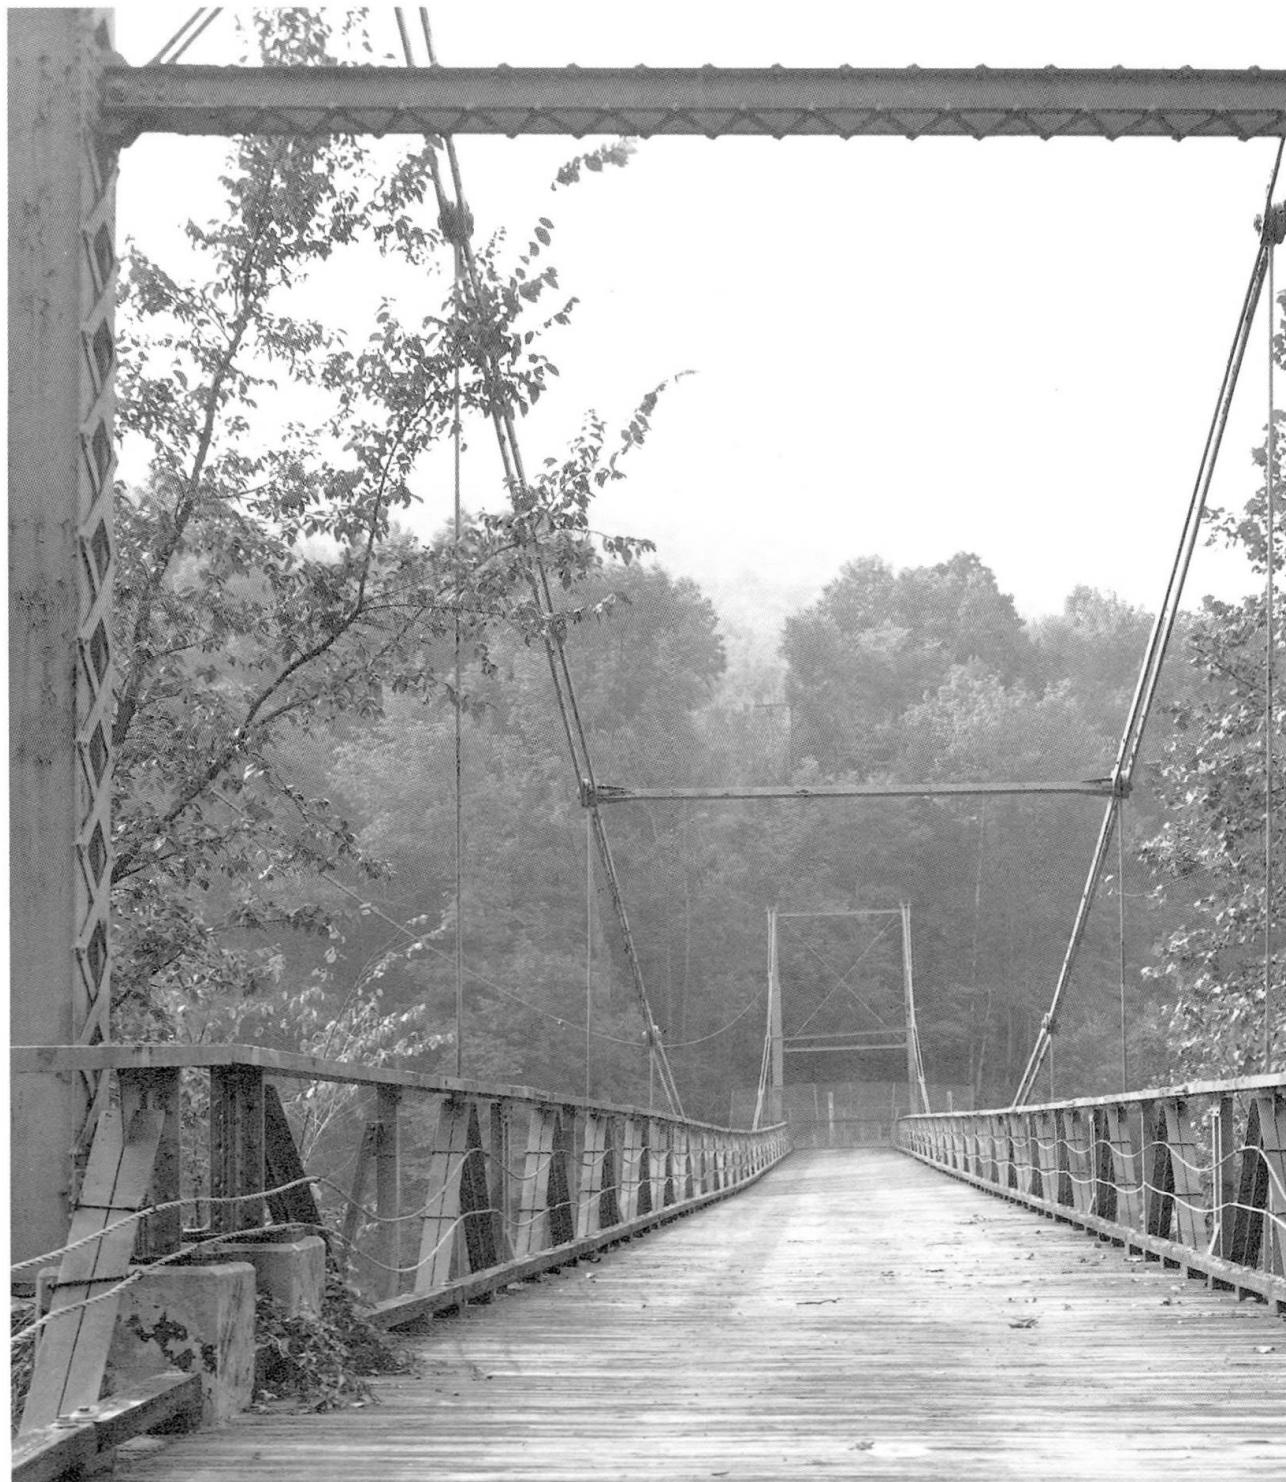
Figure 4. Ca. 1902 eyebar suspension bridge at Lordville, NY that failed and was recorded and demolished in 1986-1987.

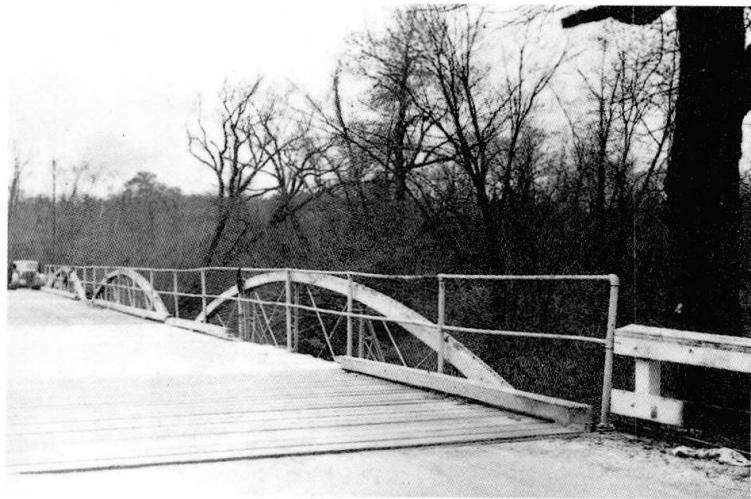
Figure 5. Ca. 1860 King bowstring truss bridge at Allenwood, NJ.

The ca. 1860 patented King bowstring pony truss bridge in New Jersey was the only example of the historic truss type in the state, but it was too narrow and too deteriorated to warrant rehabilitation (Figure 5). Instead of being demolished, the rare old bridge was dismantled and stored until a suitable, protected site can be identified. While its original setting will be lost, the technologically important artifact will be recaptured.

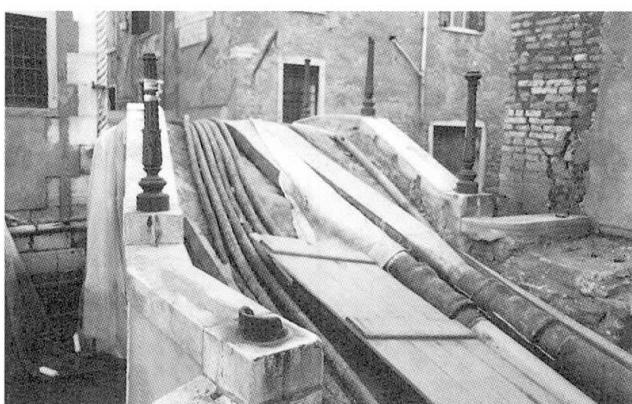
Fig. 1 Services on a bridge.
 Fig. 2 Detachment of plaster.
 Fig. 3 Saline efflorescence.

Early venetian bridges were built in wood, erected on flat piles, low arched and with no steps so that they could be ridden by horses. In the 16th century the town began to thoroughly modify its appearance and the obsolete wooden bridges gave way to the more lasting arched brick bridges. Notwithstanding iron structures, greatly fashionable in the last century, brick bridges represent at present the majority (263). Most of them are in an evident state of physical degrade and lacking adequate and up-to-date census of their real condition. Recent visual inspections showed up a distressing situation, in which the bridges – that still bear on their structural body many pipe-lines (gas, electricity, telephone ...) – present diffused cracks, tiring out of haunches, worn out ties, micro-organisms and saline efflorescences which cause detachment of plaster (Figs 1-3).

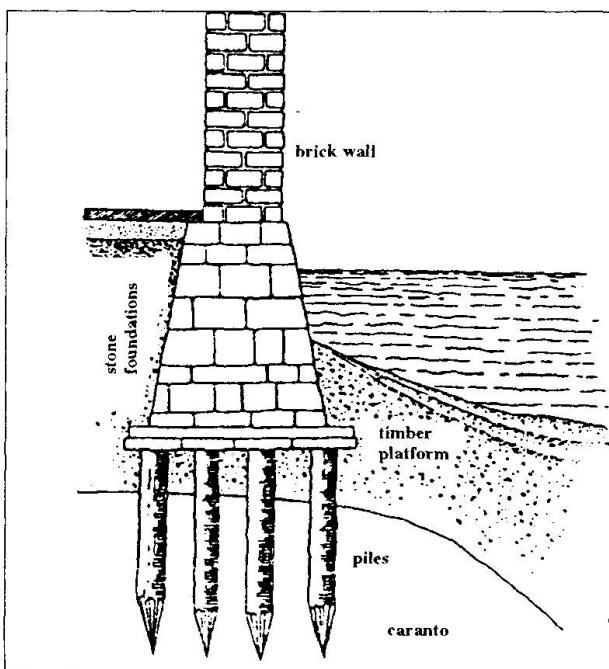
Fig. 4. Venetian building procedure.

The statical behaviour of venetian buildings is based on disconnections and continuities, which allow the highest degree of relative movement among the various components, while assuring stability on the whole structure.
