Zeitschrift: IABSE reports = Rapports AIPC = IVBH Berichte
Band: 70 (1993)
Rubrik: Keynote lecture

Compatibilité de la thérapie avec le monument

Verträglichkeit Instandstellungsmassnahmen mit dem Monument

Appropriate Measures for the Preservation of Monuments

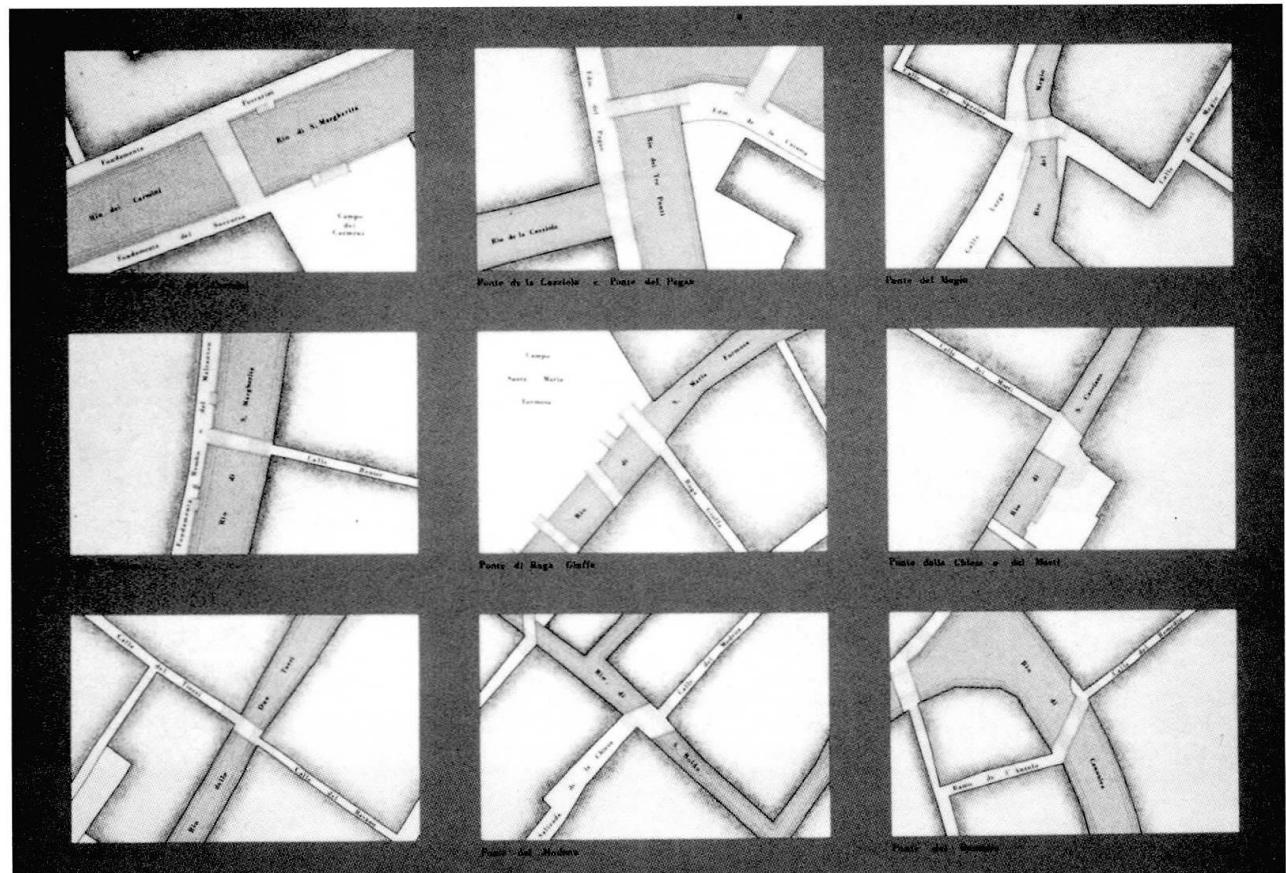
Fig. 5 Example of plan typologies of venetian bridges.

The bridges issued from the “calli” (pathways) and the “calli” are the spontaneous offspring of buildings, regardless of future need of their connection, as both the structure and the shape of many bridges prove. The aim of linking the buildings without altering them has given birth to some utterly unexpected forms: there are twisted bridges that link up “calli” that are not one in front of the other; drawbridges like the one of the Arsenale, which had to leave ships pass; private bridges to enter houses and palaces. Moreover, we can have bridges linking two opposite “fondamente” (pathways running along a canal) or two sides of the same “fondamenta” interrupted by a canal, which can be defined as *regular*, while others are more or less *irregular*, or even “storti” (twisted) as they are named both in the official and popular toponymy. The latter are side bent over the canal or skew to the canal axis because they have to link up two streets leading to the water but not facing each other. Their shape is defined by pre-existing structures, with the scope to meet the needs of contiguous houses.

These bridges have ramps branching out in several directions, widening tops to allow the opening of entrances of houses and shops; little pensile paths are not rare: four, five or even twenty metres long, they were thrown to enter houses which otherwise could be reached only by water.

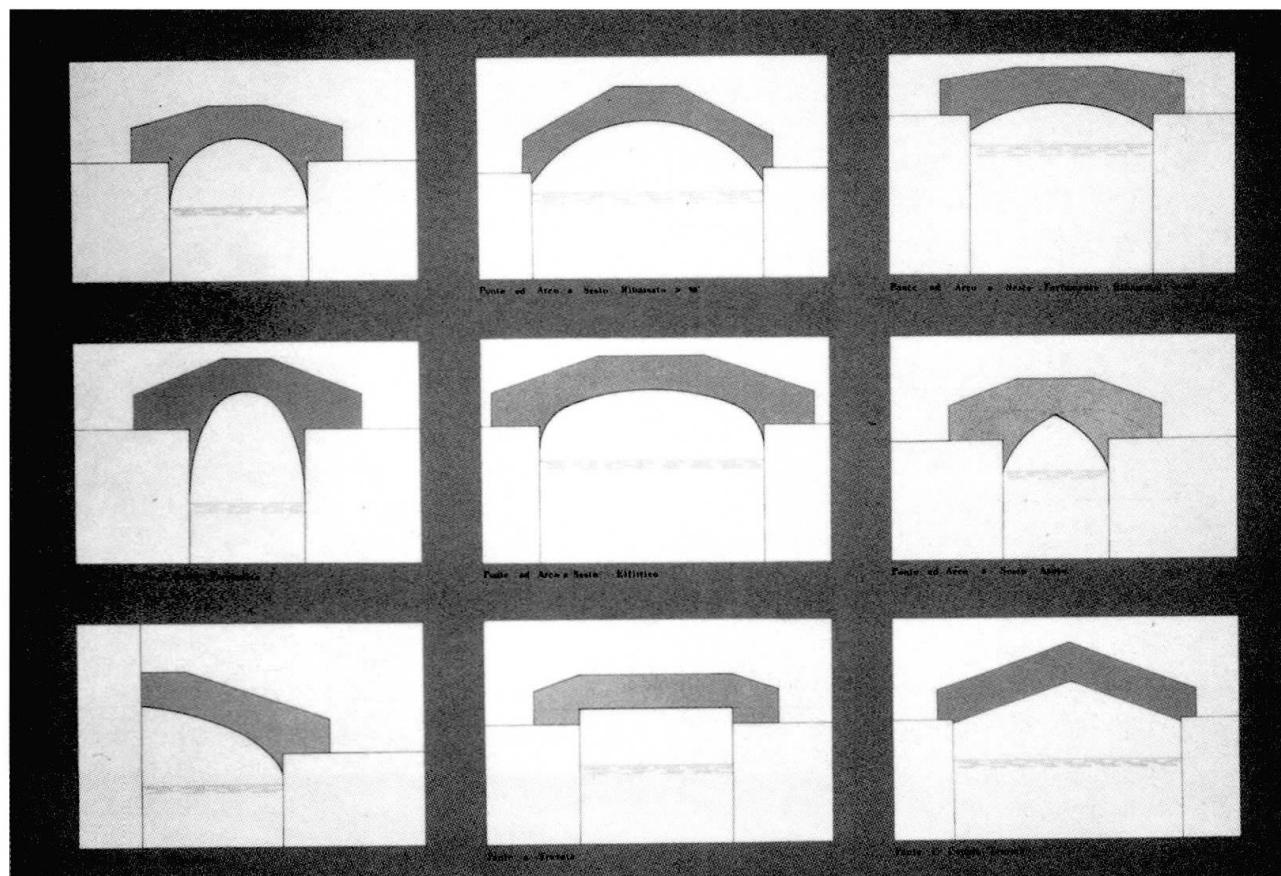
Fig. 6 Schematization of the nine arch typologies of venetian bridges.

The arch of a bridge has to be high enough to let the boats, loaded with goods, pass; with the exception of the three-arched bridge, called ponte Tre Archi on Cannaregio canal, and the mid-arched one at S. Maria del Giglio, all venetian bridges have only one arch, to meet the needs of water traffic. Bridges crossing very narrow canals often have a round arch; in two cases they have an ogive or gothic arch, a shape not easily found in bridge construction.

The half-elliptic and the double girder bridge appear only once (ponte della Feltrina and ponte dell'Arsenale). The arch shape is related to the canal width: in the narrowest canals the use of round, parabolic or ogive arches is preferred, while in the widest canals the depressed arch is more usual (Tab. 1).

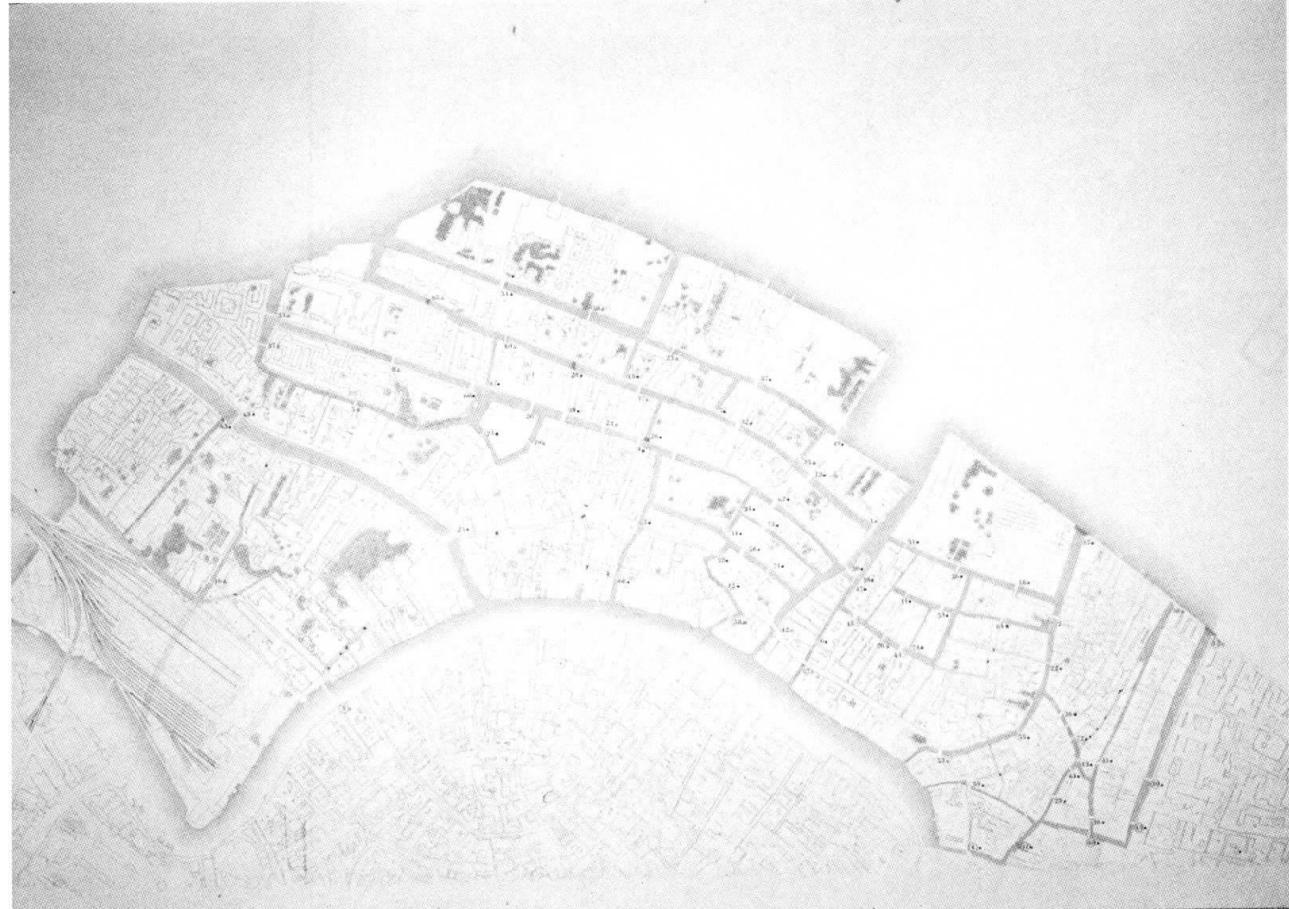
Fig. 7 Example of district map.

Our bridge filing system gives quick information on quantity, type of structure and location. To this purpose we have made use of several instruments, namely: six maps (one for each “sestiere”, as venetian districts are called) (1:2000 scale), synthetical and analytical tables.

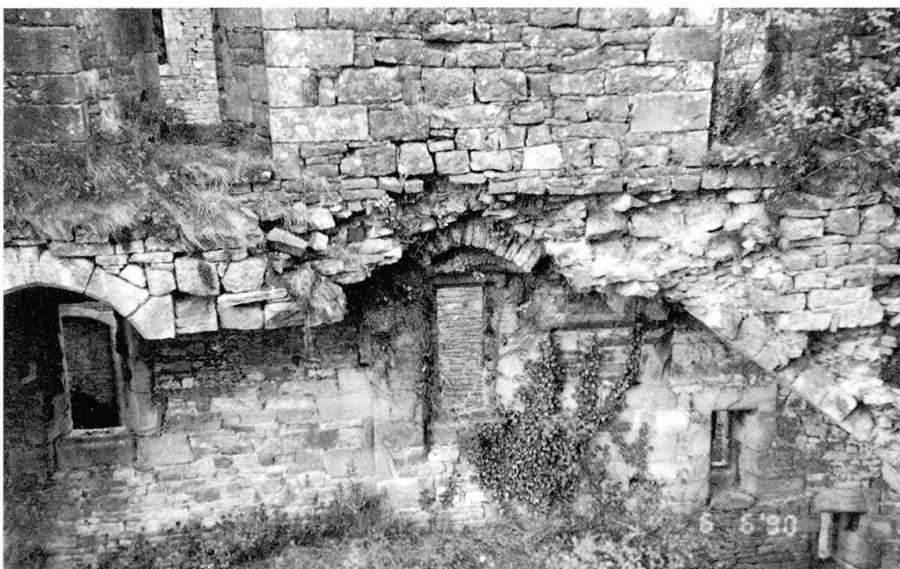
Figure 1.
Castle Bolton.

Major overhangs
of masonry now
supported by
stainless steel
posts.

- Additional supporting works. The additional supporting works thought necessary at Castle Bolton, apart from numbers of small stainless steel dowels to fix loose masonry back locally, consists of some vertical square tube supports in stainless steel. These have been installed to support major overhangs of potentially unstable masonry and are intended as a clear statement of 20th century minimal intervention.

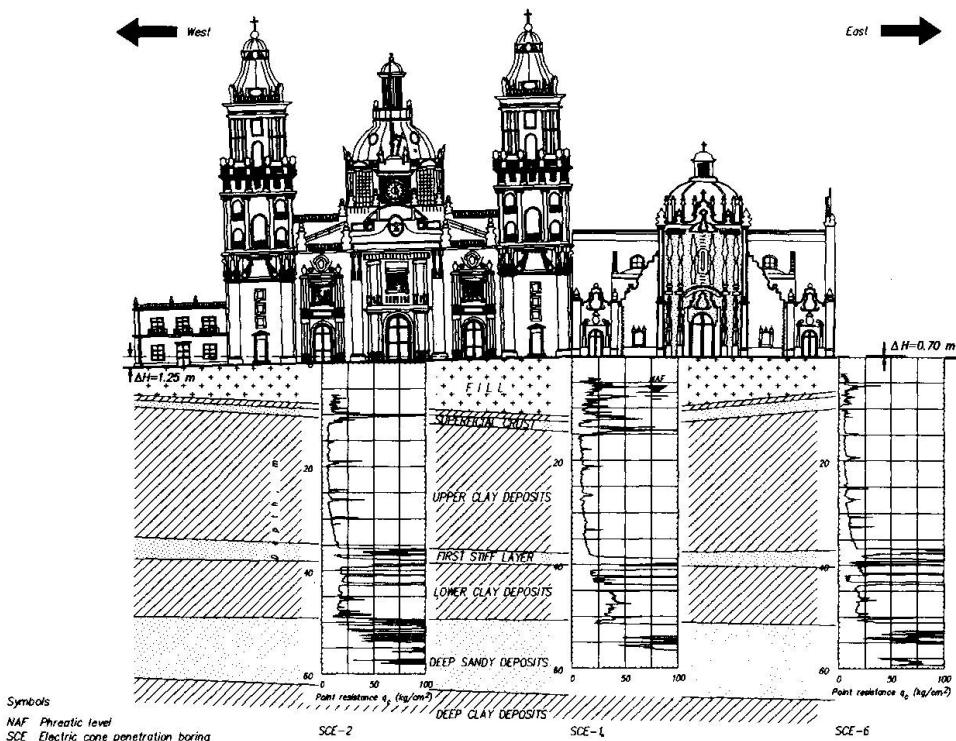
FIG 1 STRATIGRAPHY AT THE SITE AND DIFFERENTIAL SETTLEMENTS AT GROUND LEVEL

Aztec buildings were also constructed over artificial fills, which consolidated the underlying upper clay strata (fig. 1).

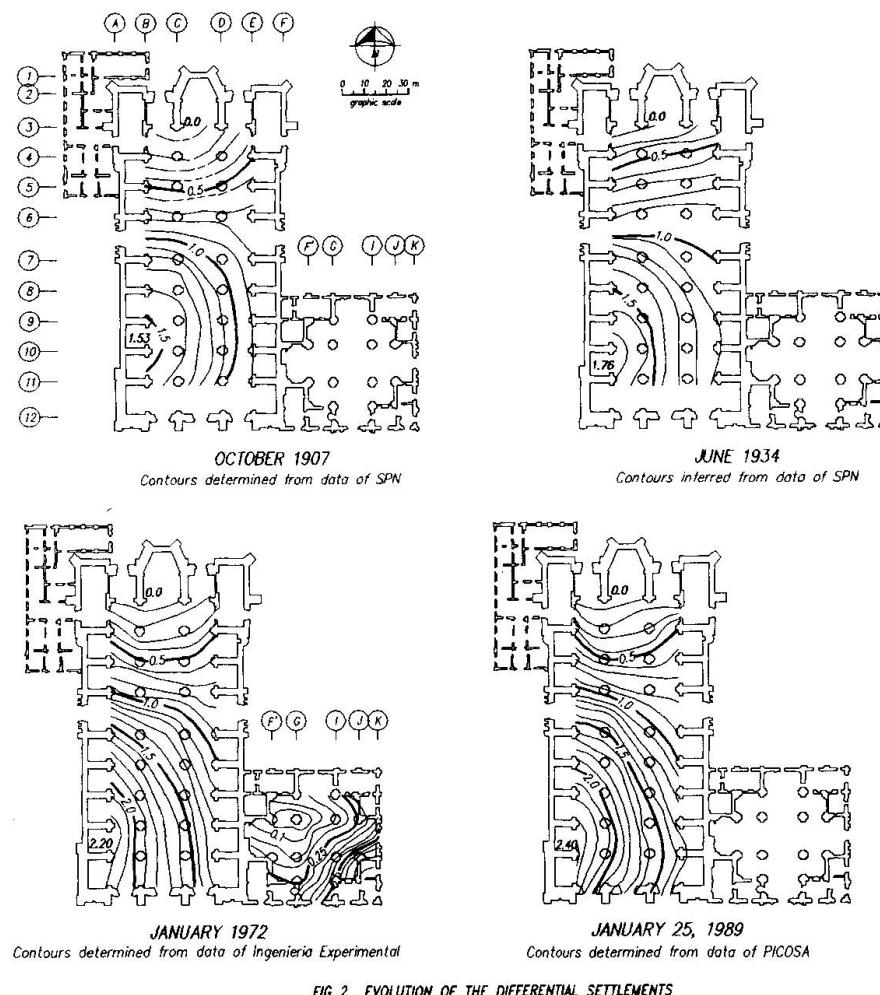
FIG 2 EVOLUTION OF THE DIFFERENTIAL SETTLEMENTS

In April 1989, severe cracking along the building southeast-northwest direction, revealed that alarmingly large settlements were taking place in the Cathedral. A review of all topographic surveys, as well as of all previous actions taken to mitigate the effects of differential settlements followed; the effects of the construction of a subway and a circular drainage tunnel built in front of the Cathedral were also considered. Surveys performed in 1907 revealed the existence of a differential settlement of more than 1.5 m between the apse and the west tower; in 1972, this settlement reached 2.2 m (fig. 2) and exceeded 2.4 m in 1990. Between the two towers, differential settlements are presently 1.25 m. The Sagrario church has tilted easterly and settled more than 90 cm differentially with respect to the Cathedral.

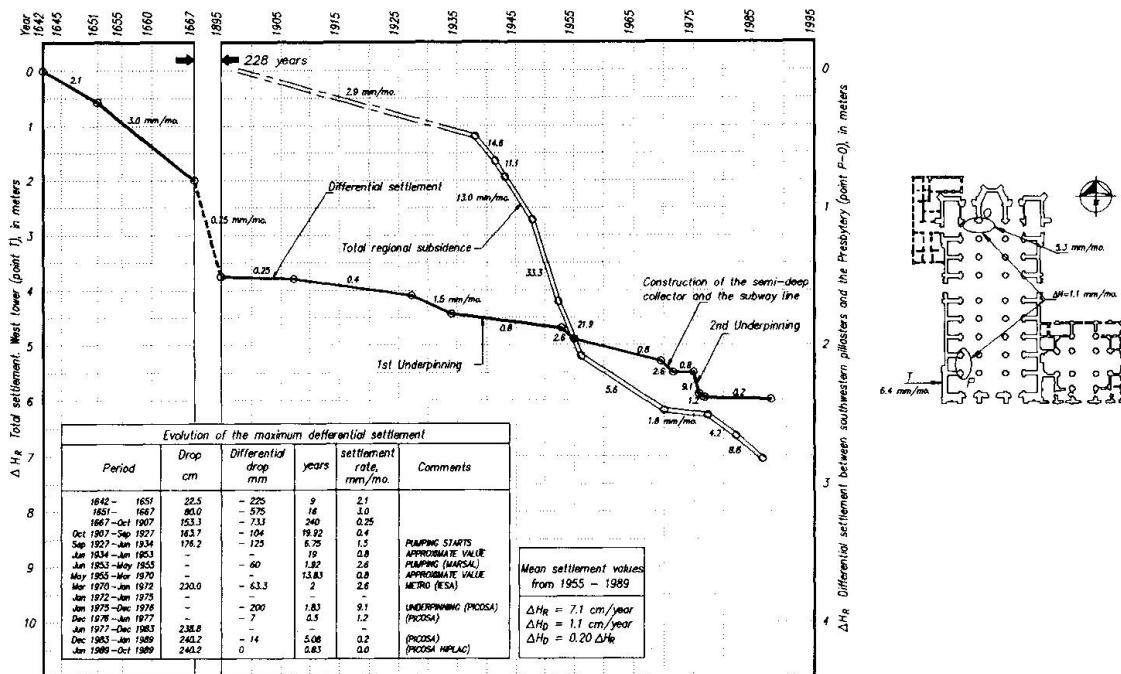
FIG 3 MAXIMUM REGIONAL AND DIFFERENTIAL SETTLEMENTS

Differential settlements in the Cathedral due to non-homogeneous distribution of compressibilities within the underlying soft clay deposits, accounts for 20 percent of the total differential settlements between the apse and the west tower (fig. 3).

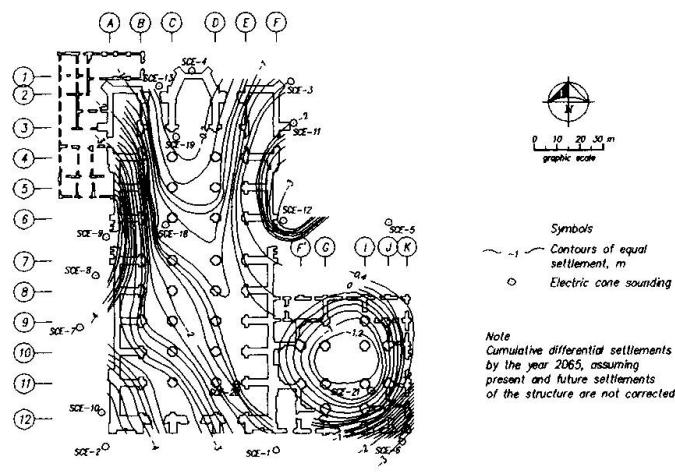
Towards 2010, differential settlements between the apse and the west tower will be 3 m; between the apse and the east tower, 1.6 m and between the central line and the corners of El Sagrario, 0.7 m. In 2065, settlements in the same points will increase to 4.4 m, 2.0 m and 4.2 m respectively. Clearly, these buildings would collapse between 2010 and 2030, if remedial actions are not taken to improve the behavior of their foundations. These structures have satisfactorily resisted many earthquakes through the centuries, but this situation might change as progressive settlements and distortions will implacably increase their seismic vulnerability.

Average total regional settlement in the lake zone is 7.50 m since the turn of this century, which will roughly double in the next 75 years, according to analyses made on the basis of compressibilities determined from undisturbed samples. Future regional subsidence will give rise to more differential settlements in the Cathedral. Predictions of settlement over the periods of 1990 to 2010 and 1990 to 2065 have been clearly plotted (fig. 4).

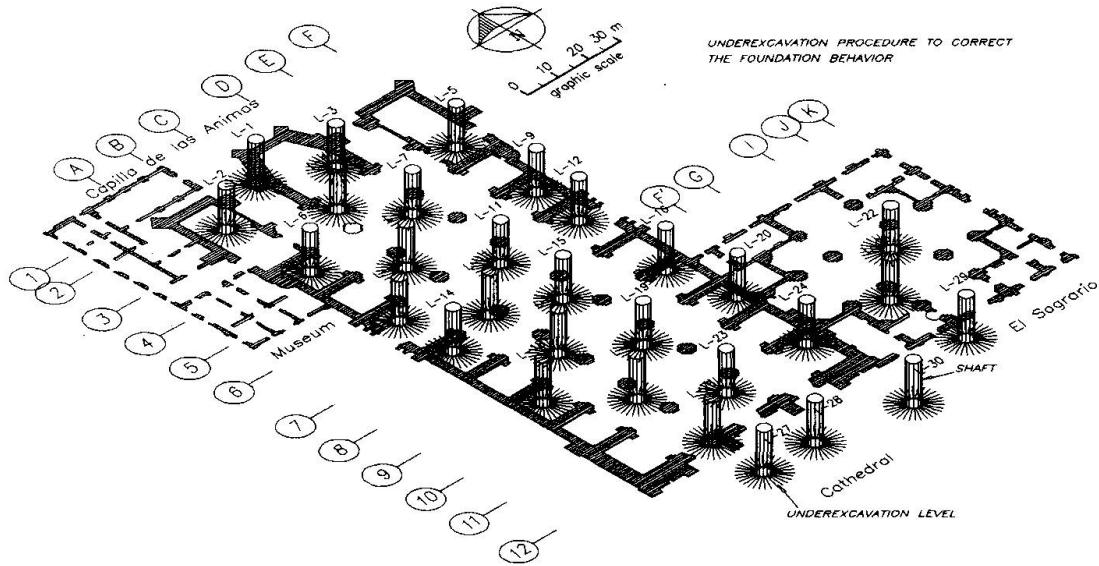
FIG 5 SHAFT AND RADIAL UNDEREXCAVATION BORINGS LOCATION

This procedure started to be implemented in 1991 and some of its results can now be seen, as the construction of shafts (fig. 5) and the effect of continuously pumping water have modified deformation trends by reducing the magnitude of differential settlements and stopping the tilting of lateral naves and their external walls. Future work will result in reversing the movements of naves and walls; columns and walls will also rotate until conditions existing in 1934 can be restored. The project does not intend to straighten the building completely.

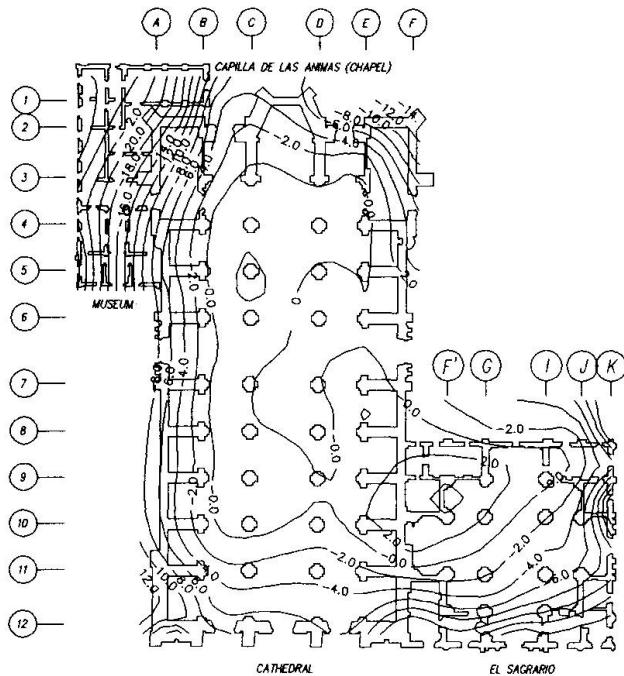
FIG 6A CONTOURS OF EQUAL SETTLEMENT RATE, IN mm/year; MEASUREMENTS FROM JAN 7, 1991 (N20) TO SEPT 2, 1991 (N28)

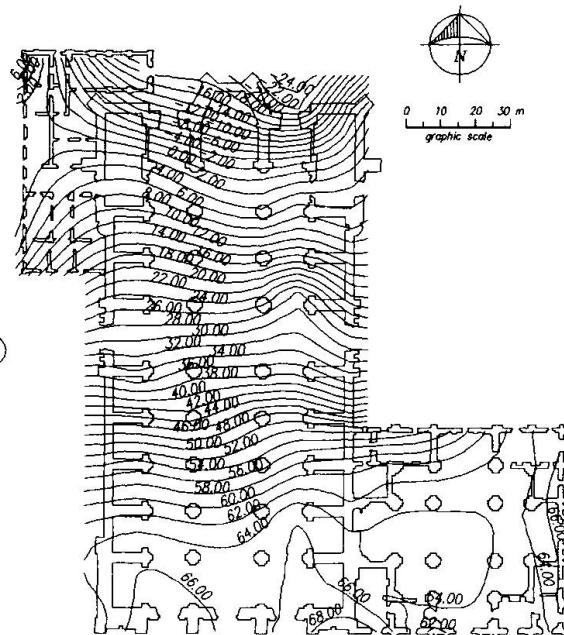
FIG 6B CONTOURS OF EQUAL SETTLEMENT RATE, IN mm/year; MEASUREMENTS FROM OCT 25, 1991 (N-1a) TO OCT 26, 1992 (N-25a)

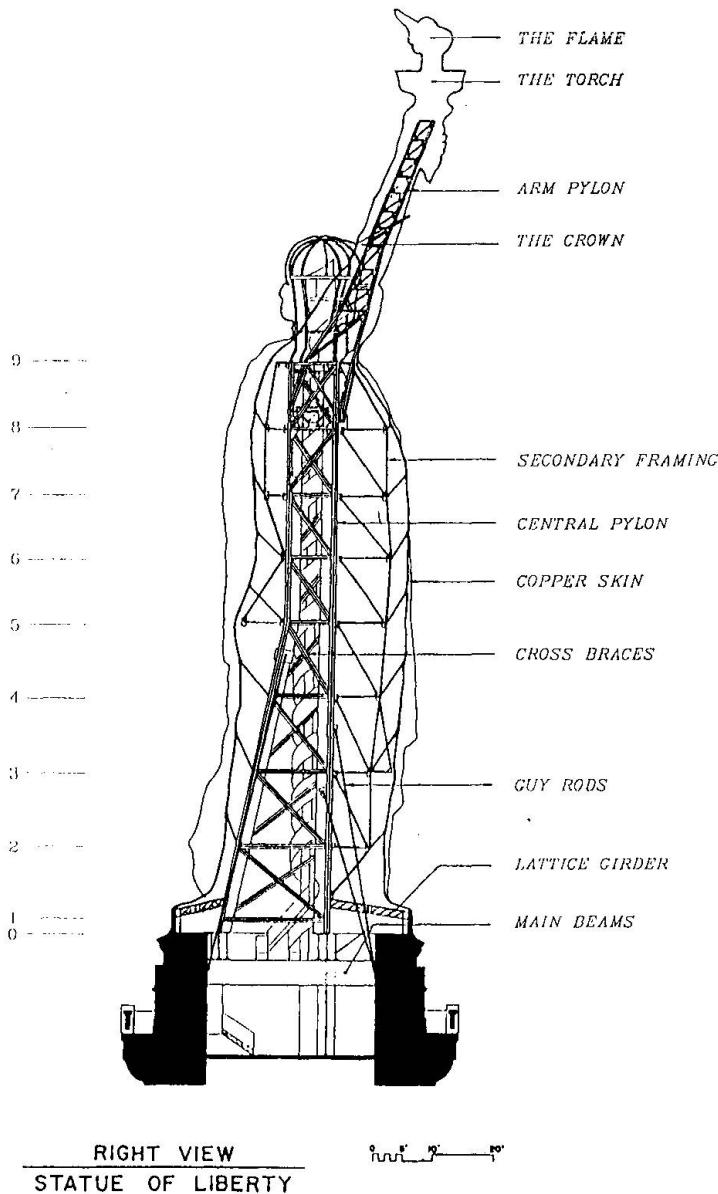
Fig. 1 The Structure of the Statue

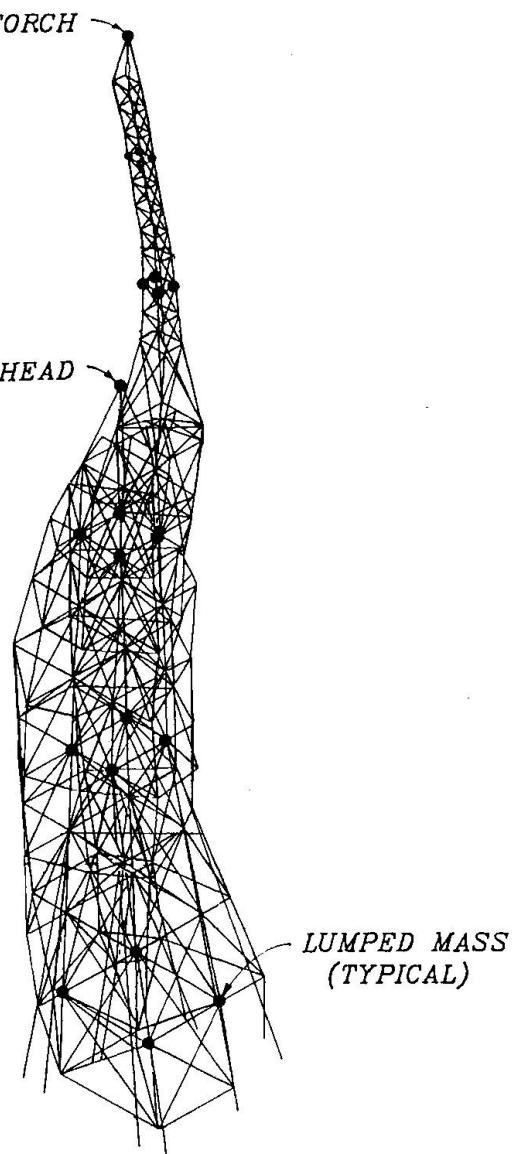
Fig. 3 Finite Element Model

3.2 Finite Element Model (Fig. 3)

The main pylon of the Statue, including the shoulder and the arm framing, was modelled as a three dimensional space truss. The geometric properties, including member sizes and makeup, were obtained largely from field reconnaissance surveys. Any stiffness contributed by the copper skin was conservatively omitted from the model; however, the influence of the "secondary" framework, which transfers the reactions from the skin to the main pylon, was included. The results of the dynamic analysis show that the two lowest modes, having frequencies of 1.66 hz and 1.90 hz, contribute over 95 percent to the response of the Statue under wind loads.

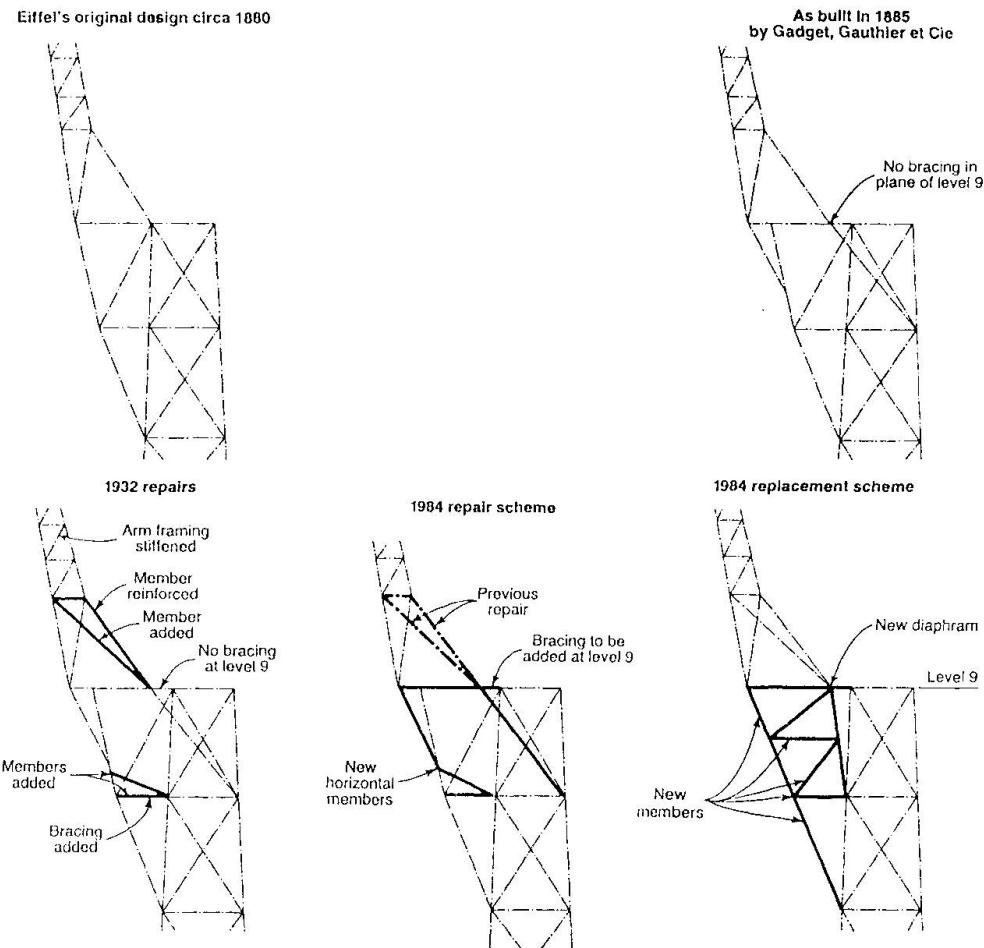
Fig. 4 History and Proposed Repairs of the Right Shoulder

The shoulder and head arch problems have existed since the Statue was constructed, a result of the misalignment of the head and shoulders from the originally designed positions, which created flexibility and overstresses in these areas. In the shoulder, the main deficiency was lack of torsional resistance which resulted in dangerous levels of axial stresses in critical members.

Several attempts to repair the weak shoulder were made in the past, most apparent of these is the unsuccessful attempt made by the U.S. Army in 1932. During the current project, two alternative solutions were proposed. The first alternative, termed the replacement scheme, consisted of removal of several members of the existing deficient shoulder and reconstructing the shoulder with a new truss, to achieve structural continuity to the main pylon. The second alternative, the repair scheme, adds several members to the existing structure to achieve the required rigidity and factor of safety. The history of the problem and proposed repairs of the shoulder are illustrated in Fig. 4.

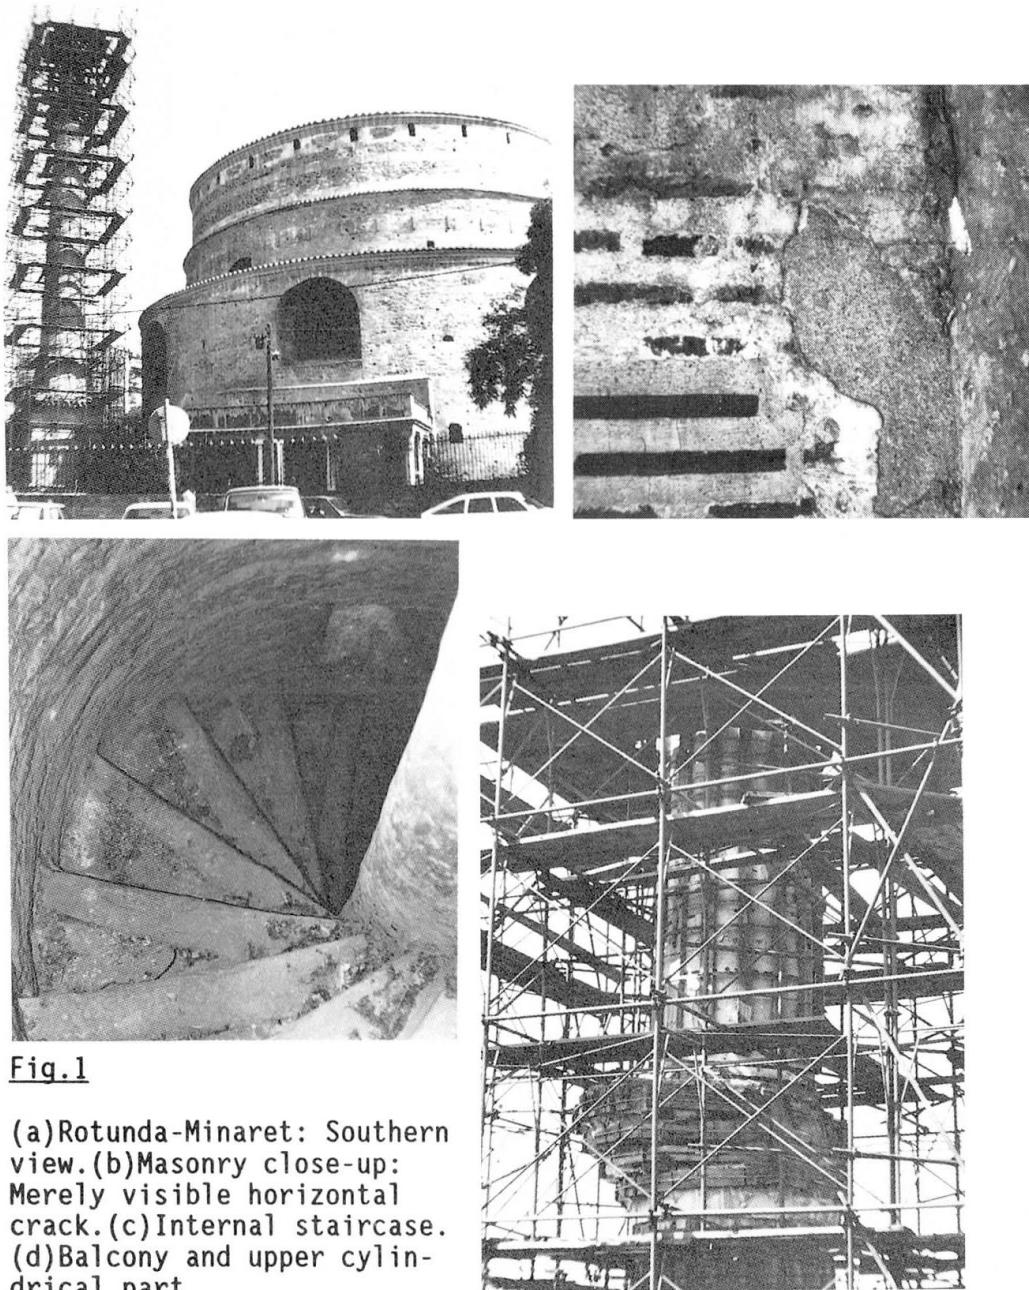
Fig.1

(a) Rotunda-Minaret: Southern view. (b) Masonry close-up: Merely visible horizontal crack. (c) Internal staircase. (d) Balcony and upper cylindrical part

The Minaret is located at a distance of 3.50m western of Rotunda (see Fig.1a). It consists of a 4.50x4.50m square cross-sectioned base, 7.50m in height and is founded on a thick stiff red clay layer approximately 6.00m below the ground level. The base is supporting the trunk of the Minaret consisting of two successive twenty-sided truncated conical parts of 22.00m total height crowned by the muezzin's balcony and the highest fifteen-sided cylindrical part 6.00m in height (see Fig.2). The external diameter of the trunk decreases gradually from 3.25m to 2.10m and finally to 1.75m at the highest cylindrical part. The narrow entrance (0.85x1.95m) is located at the northern face of the base. The internal helical staircase with gradually decreasing diameter ($D=1.80-1.45m$) leads up to the balcony at a height of 29.50m. The small muezzin's doorway (0.50x1.50m) is located at the southern face of the cylindrical trunk penetrated till the top by the narrow staircase ($D=1.35m$). Five narrow loopholes are located along the height of the southern side of the trunk.

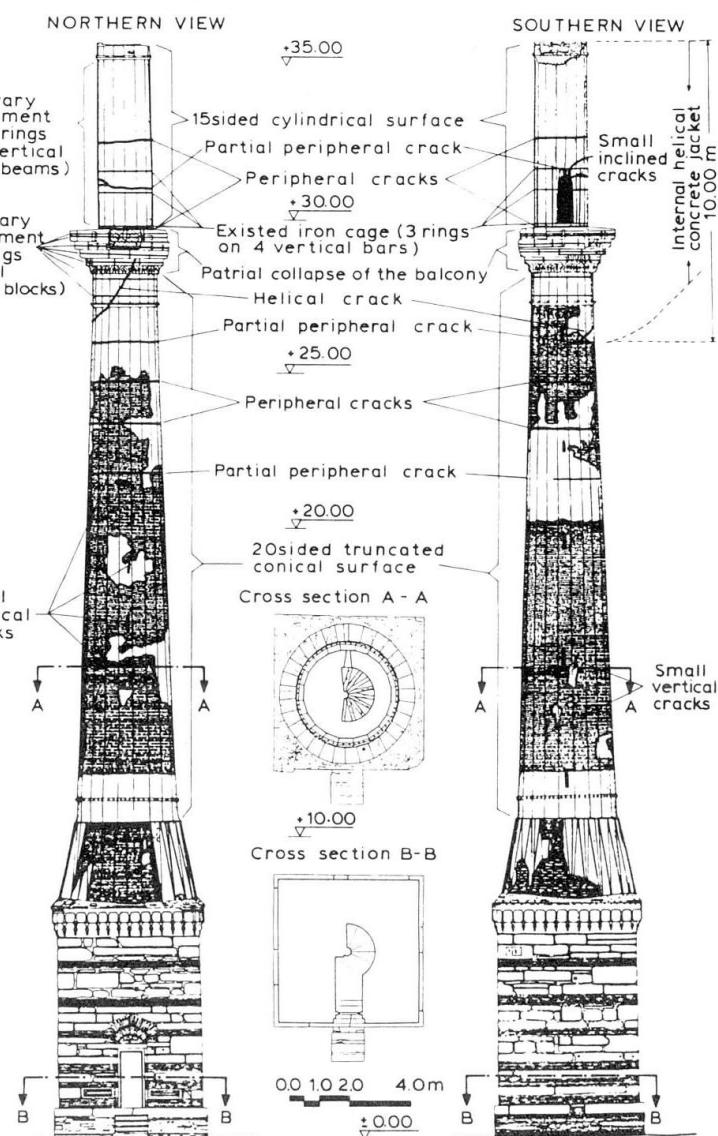
Fig.2 Northern and Southern elevations of the Minaret. Cracking pattern, external emergency interventions

As it can be easily seen in Fig.2, the base of the Minaret is unplastered. The plaster covering has been collapsed at the major part of the trunk, while at the rest of the surface, as well as at the upper cylindrical trunk, it is heavily cracked. Limited superficial deterioration of masonry, especially at the northern face of the trunk has been detected and confirmed by the hammer tests. The wooden beams at the highest steps of the staircase have been heavily corroded due to rain water passing through the open top, as the wooden acute conical roof of the Minaret fall down, probably during an earthquake, at the begining of the

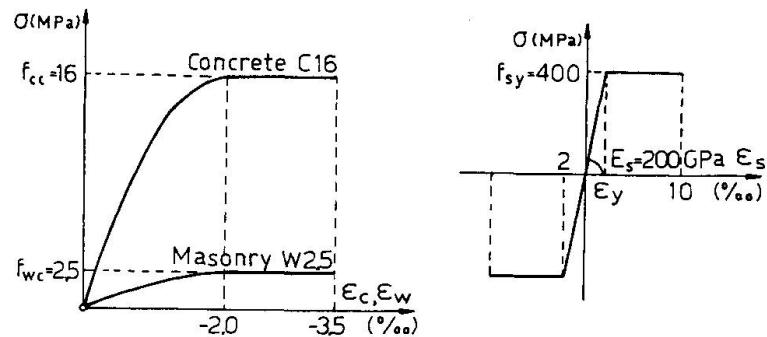
Fig.3 Idealized stress-strain curves for masonry and intervention materials (Concrete, Steel)

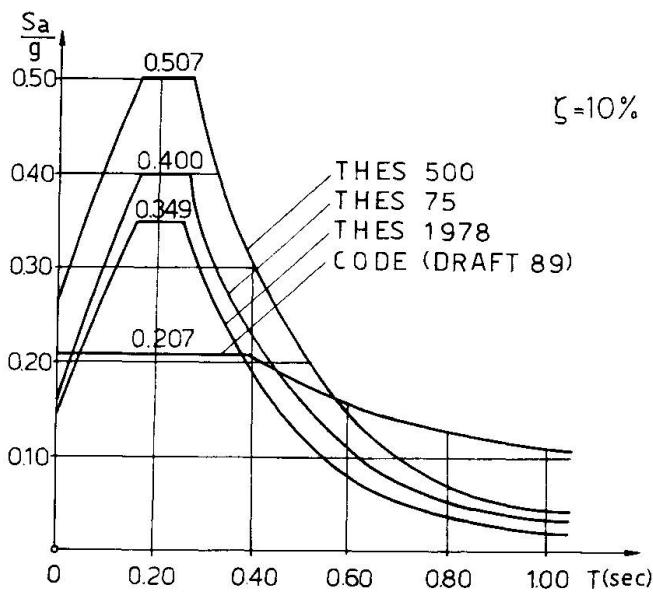
Fig.4 Design seismic acceleration spectrums

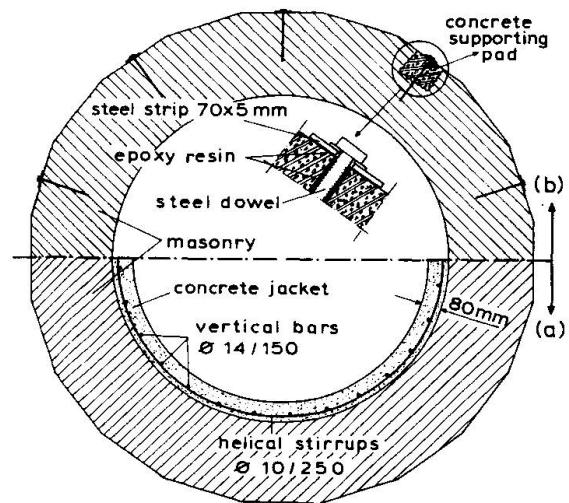
Fig.6 Semisections of Minaret trunk:
(a) Internal concrete jacket,
(b) External steel strips

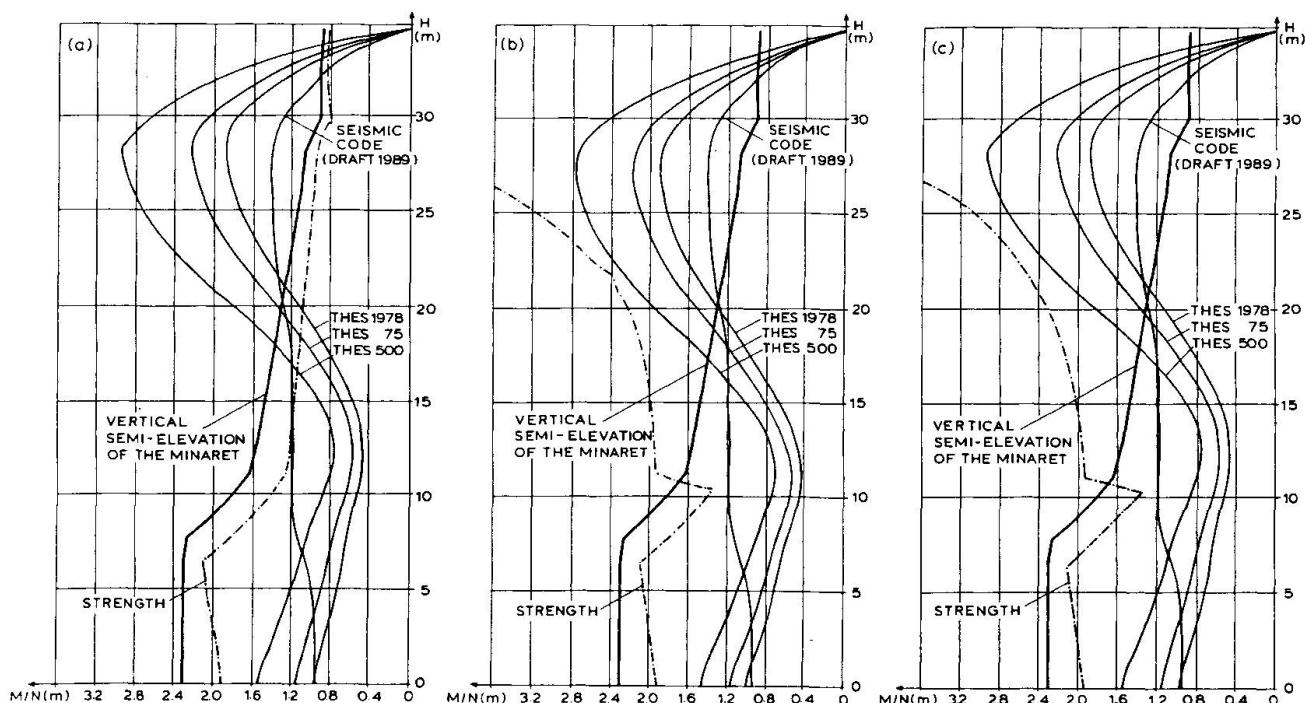
Fig.5 Eccentricity curves under seismic spectrums and strength eccentricity curve: (a) Virgin state, (b) Concrete jacket, (c) External steel strips

It must be pointed out that these analytically obtained findings, concerning the region of inadequacy, match very well with the pathology of the structure (cracking pattern, probable collapse and reconstruction of the upper part).

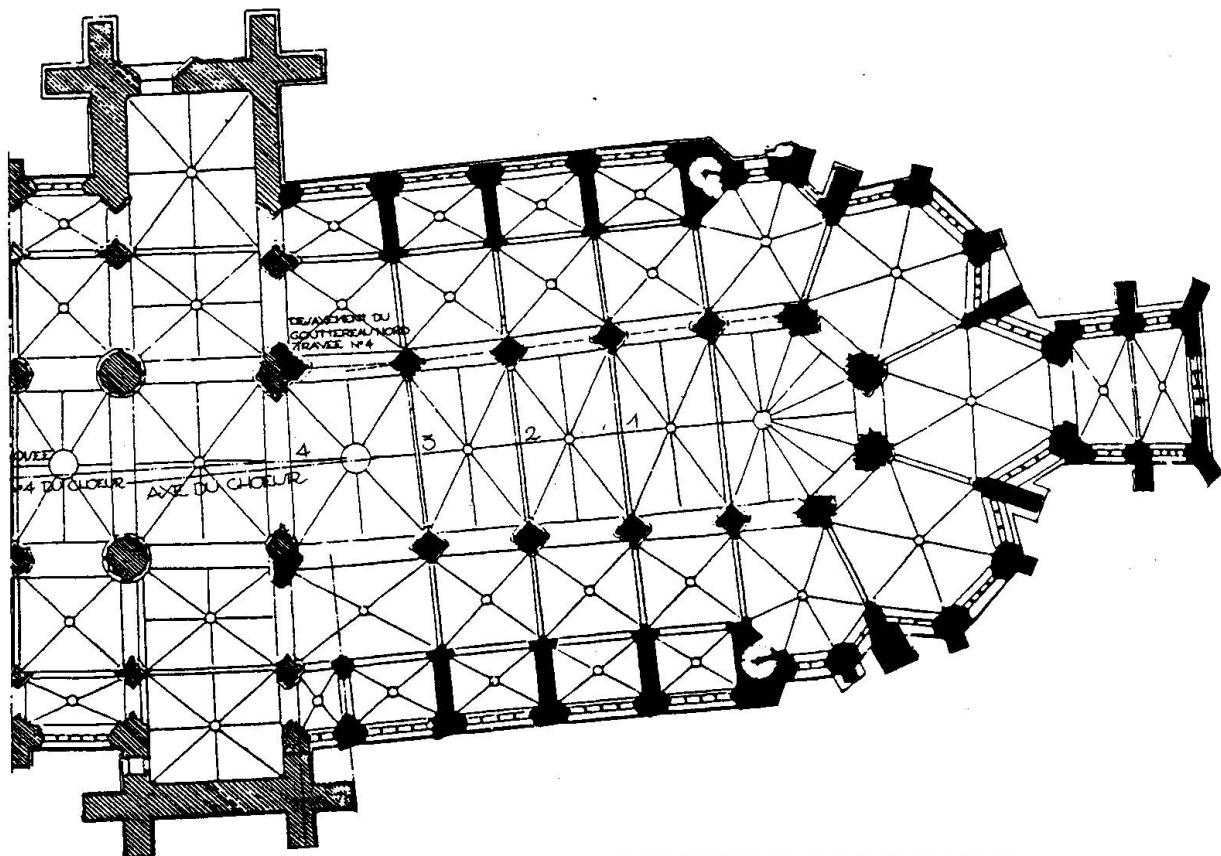
CATHÉDRALE DE QUIMPER
PLAN DU CHŒUR
D'APRÈS CHASSEPIED, CONGRÈS ARCHEOLOGIQUE 1914

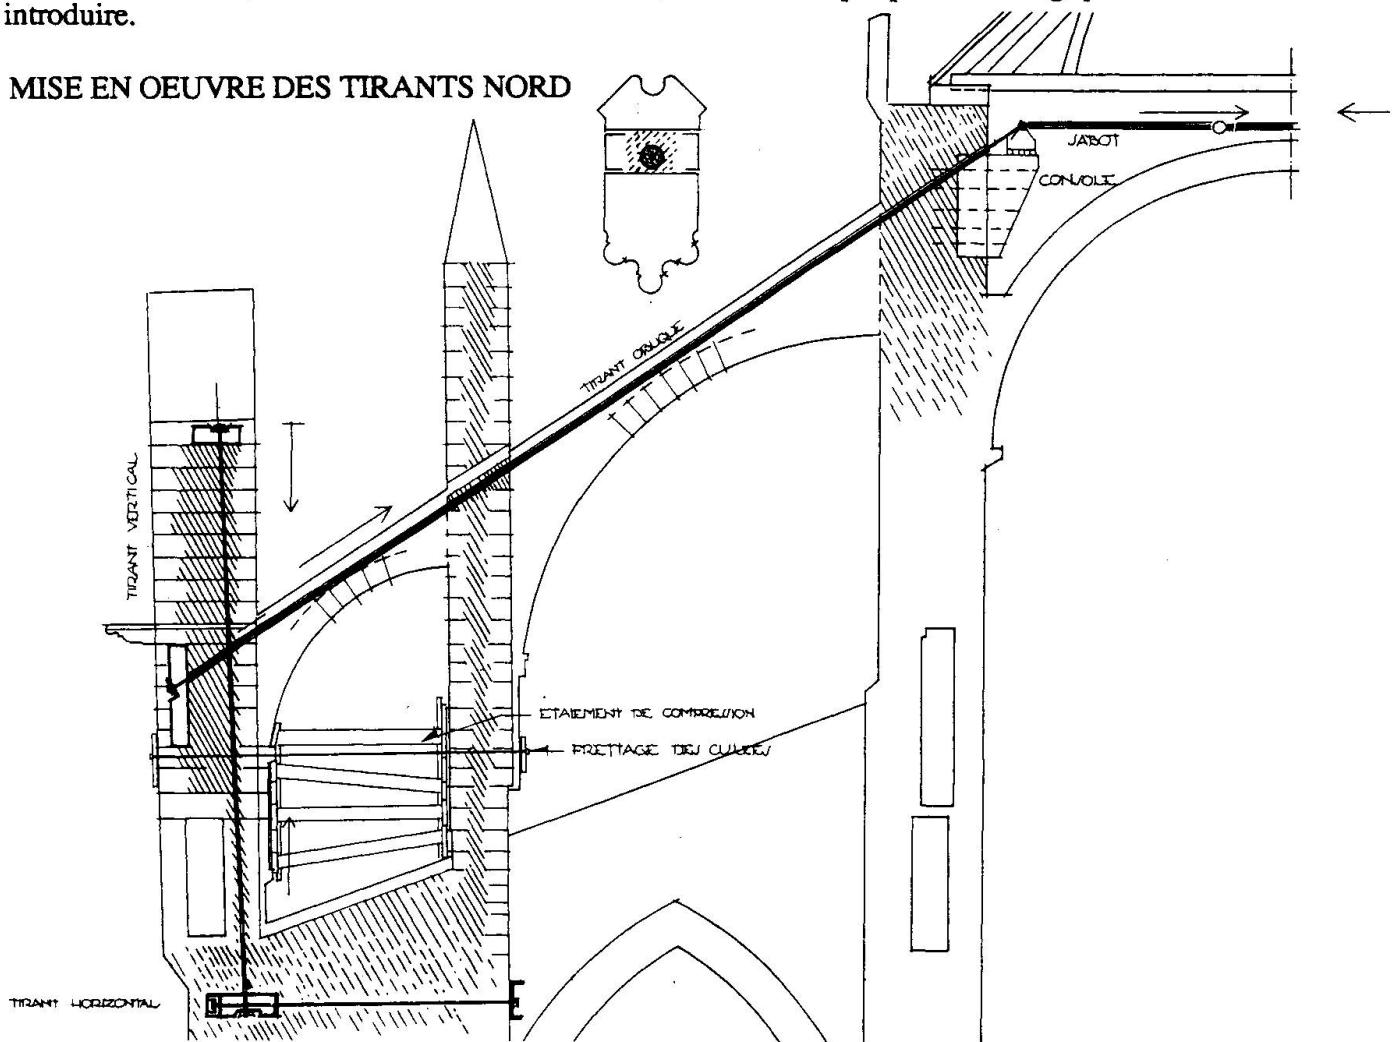
MISE EN OEUVRE DES TIRANTS NORD

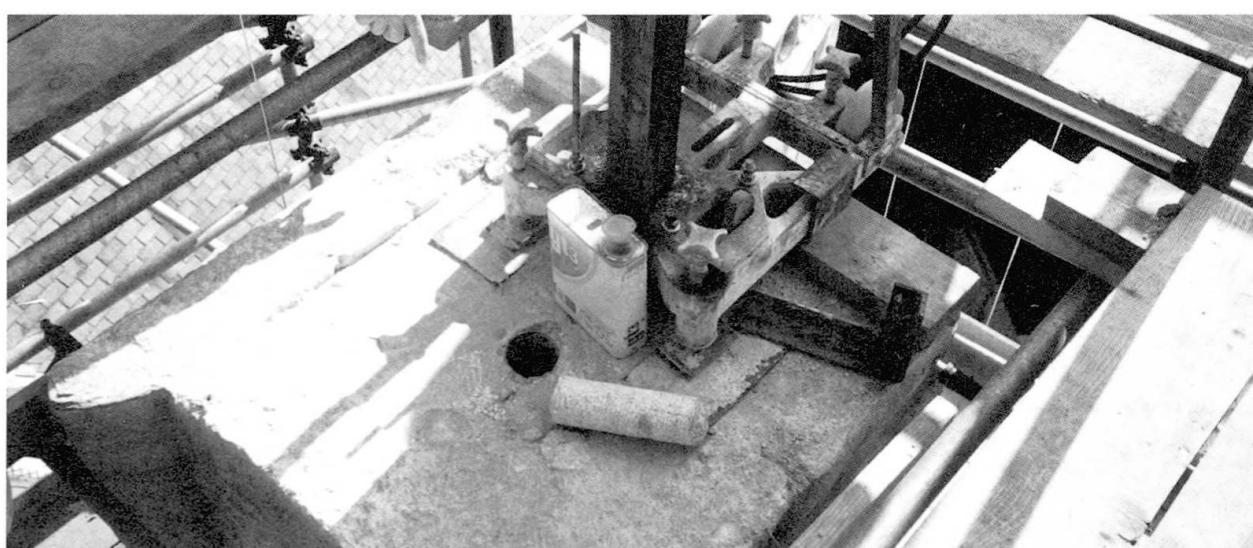
FORAGE DES TIRANTS SUBVERTICAUX

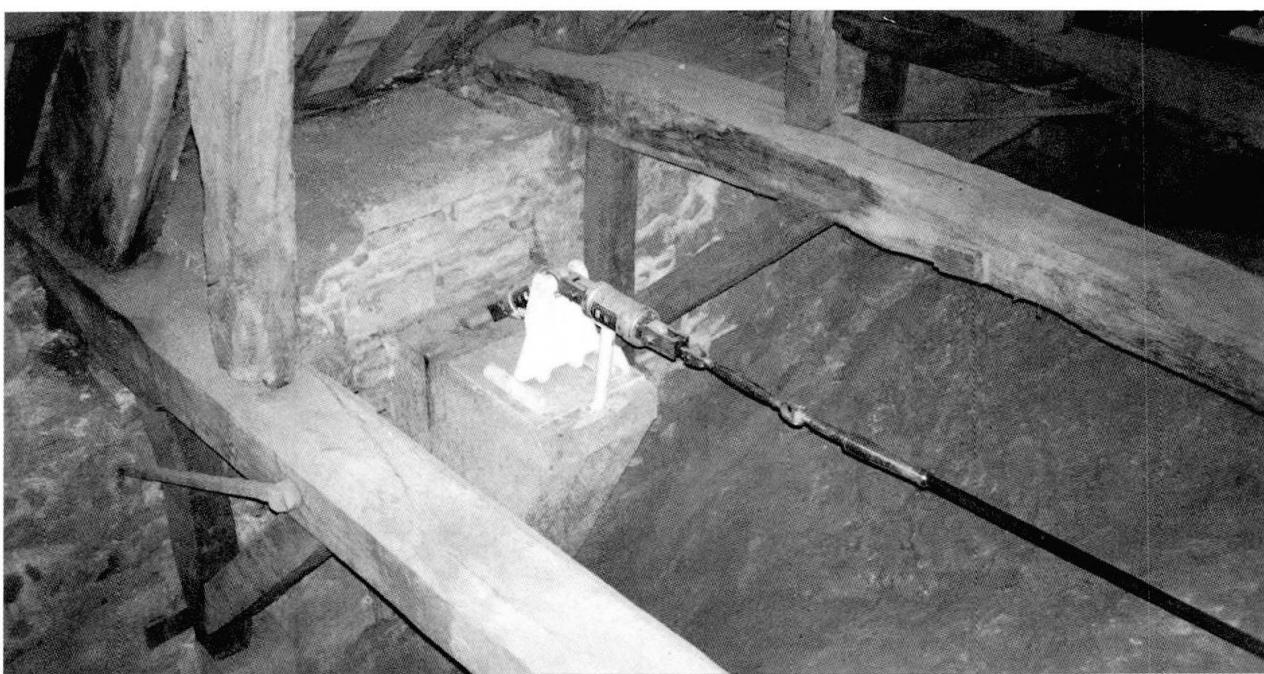
ACCROCHAGE DE TRAPEZE EN COMBLE

- Le tirant de liaison était prévu en acier inoxydable avec enrobage d'un isolant thermique. Mais du fait du coefficient de dilatation très élevé de l'acier inoxydable, seule une isolation par manchon chauffant semblait pouvoir donner une stabilité satisfaisante. Cette formule a été écartée pour des raisons évidentes de maintenance, et la solution a pu être trouvée dans l'emploi de matières composites dérivées de la fibre de carbone (thermiquement stable, incombustible, non magnétique, etc...). Les résultats ont immédiatement marqué une stabilisation de la tension à plus ou moins 6%, de la tension nécessaire.
