Zeitschrift: IABSE reports = Rapports AIPC = IVBH Berichte
Band: 70 (1993)
Rubrik: Keynote lecture

Compatibilité de la thérapie avec le monument

Verträglichkeit Instandstellungsmassnahmen mit dem Monument

Appropriate Measures for the Preservation of Monuments

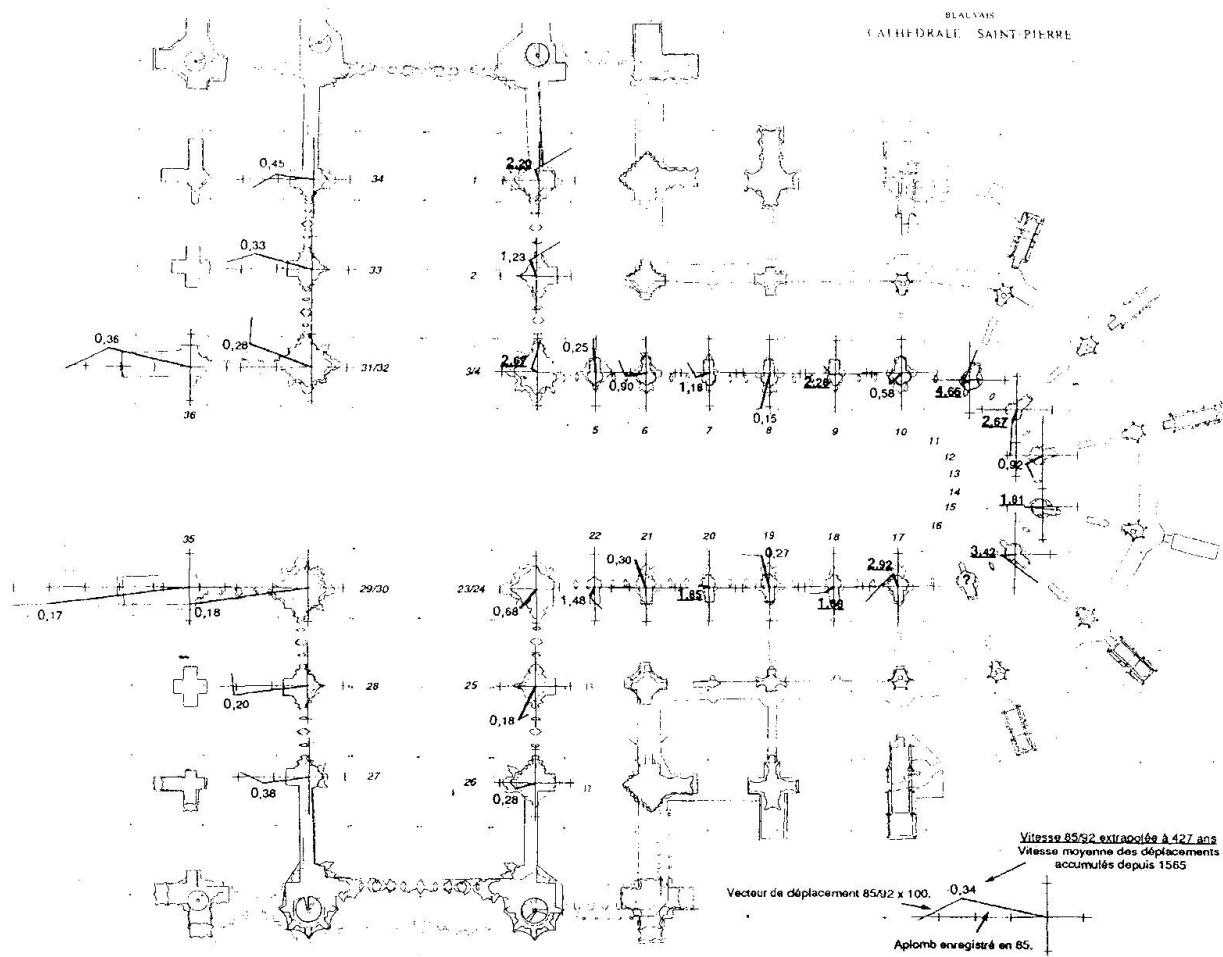
COMPARAISON DES VITESSES DE DÉPLACEMENT EN TÊTE DES PILIERS :
DES ORIGINES À 1985 ET DE 1985 À 1992

Prenant pour hypothèse que les structures ont été élevées sur des aplombs corrects (11), le diagramme ci-après expose pour chaque pilier la valeur du rapport de "la vitesse 1985/1992" à la "vitesse moyenne déduite des déplacements cumulés des origines à 1985" (par ex. pour les 2 piles occidentales de la croisée du Transept, à partir du début du chantier de la Tour-Lanterne : 1992-1565=427 ans).

Les valeurs de ce rapport, inférieures à 1 dans 11 cas sur 14, indiquent qu'il s'est trouvé dans des points particuliers, des phases de plus rapide déformation dans le passé. Cela est attesté pour les 4 Piliers du Carré, dont l'histoire est décomposée en 3 périodes contrastées : 1565/1573, 1573/1605 et 1605/1992. L'énergie dissipée dans le sol du Carré par la chute de la Tour-Lanterne a produit au pied des 4 gros Piliers une compression du terrain dont les effets ont agi un certain temps sur les massifs supports de ces piliers. En revanche on note une accélération : zone d'enlèvement des tirants du Chevet.

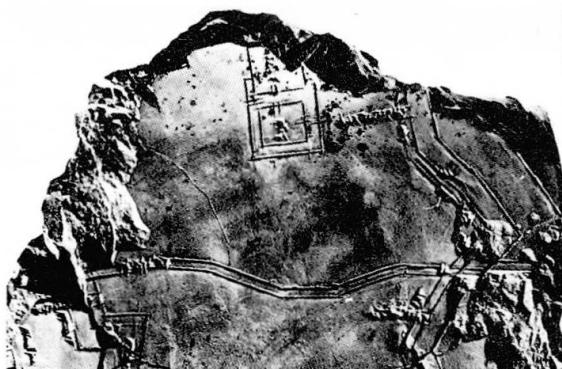
Fig. 3 Clay tablet with a stage-tower plan /7/

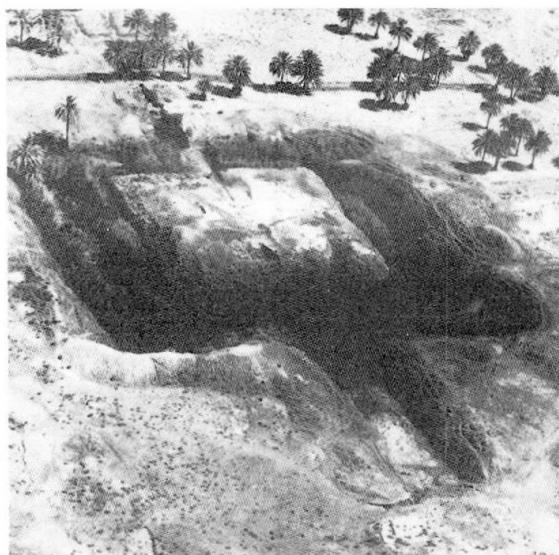
Fig. 5 Archaeological traces of the Tower of Babel /1/

To-day there is only the trace of the Tower of Babel (Fig. 5), a very imperfect echo of the past glory (Fig. 6).

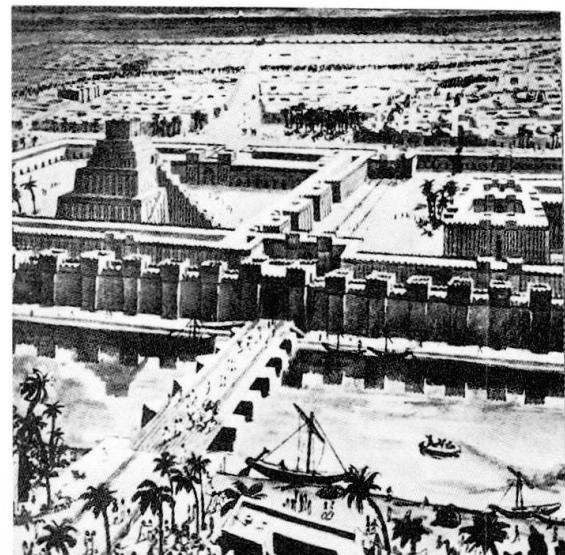
Fig. 6 Reconstruction of the Sacred Area (Temenos) in Babylon /1/

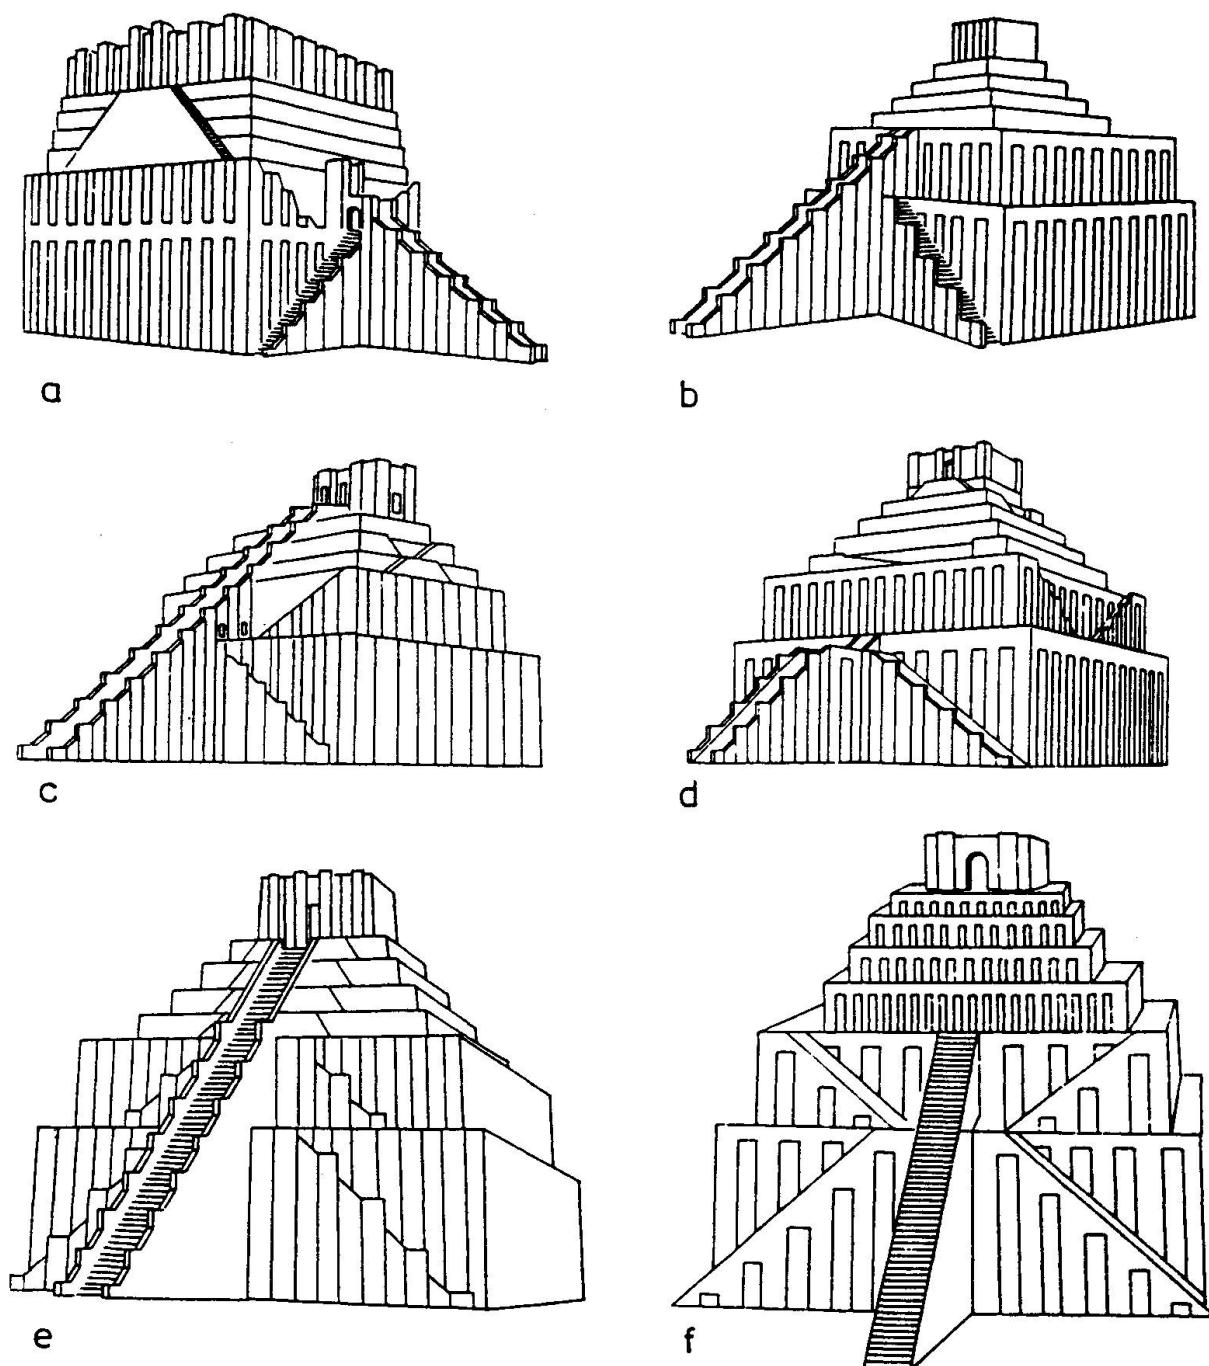
Fig. 7 Reconstructions of the Tower of Babel - by
 a - Koldewey /2/ b - Dombart /2/
 c - Andrae /2/ d - Busink /6/
 e - Moberg /2/ f - Unger /2/

The typical feature of all the previously cited original notes on Babylon and its Tower was that they contained many references to engineering. Some of them concerned E-temen-an-ki's structure, especially the s.c. E-sag-ila Tablet /2/ - here until now left without a detailed analysis. Those descriptions are very important since, presently, only poor traces of the Tower could be found (Fig.5). Different scholars used these notes to develop their Tower images /3/ (Fig. 7).

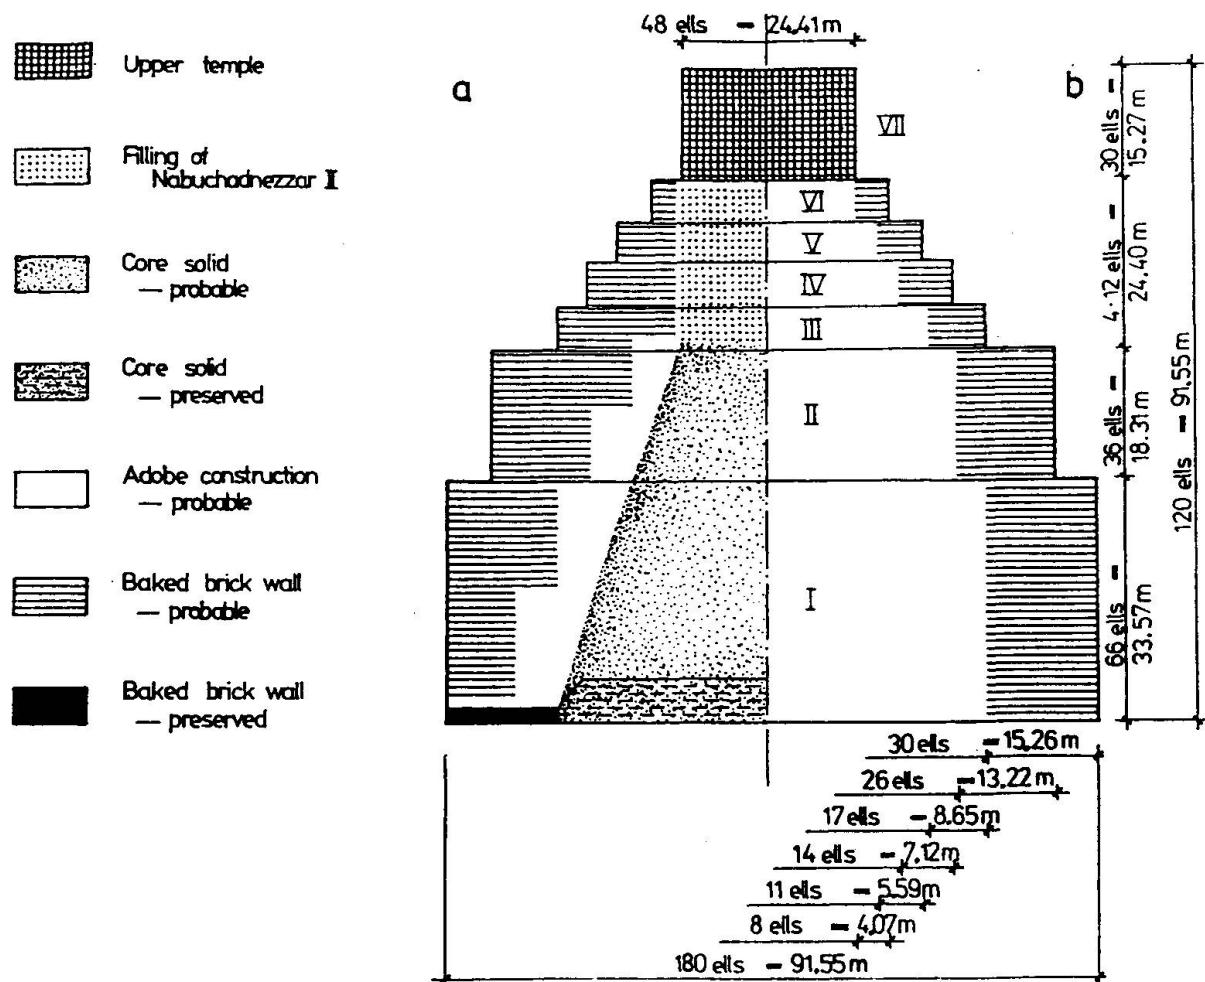
Fig. 8 Structural characteristics of the Tower of Babel - by
a - /2/ b - author

The structural volume of the established shape was also point of research. According to /2/, the mature construction of E-temen-an-ki was that given by the vertical section of Fig. 8 a. Author of this report postulates the Tower structure to represent a co-operating composite of two main parts (Fig. 8 b):

- the square container like enveloping wall, constructed out of baked bricks connected by asphalt - being, according to the sexagesimal counting system of the Babylonians, in thickness one sixth of each story length, and
- the cased inner shaft made out of adobe and debris of former constructions, together with local sandy clay soil - everything with layers of reed inside.

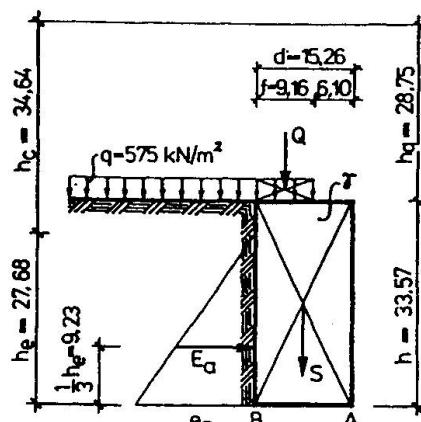
Fig. 9 Tower of Babel mantle wall analysis /3/

Another check should be referred to the ziggurat mantle wall (Fig. 9) /3/ - its strength and stability. The normal stresses at the bottom of this important structural element can be developed using the conservative system of a retaining wall, taking into account the dead load in question and the horizontal pressure of the inner shaft material. The concentrated vertical loads are the following:

Besides that, the Tower wall stability, i.e. rotation about A and sliding along AB (Fig. 9), should be verified. Concerning rotation, the resisting and disturbing moments are, respectively:

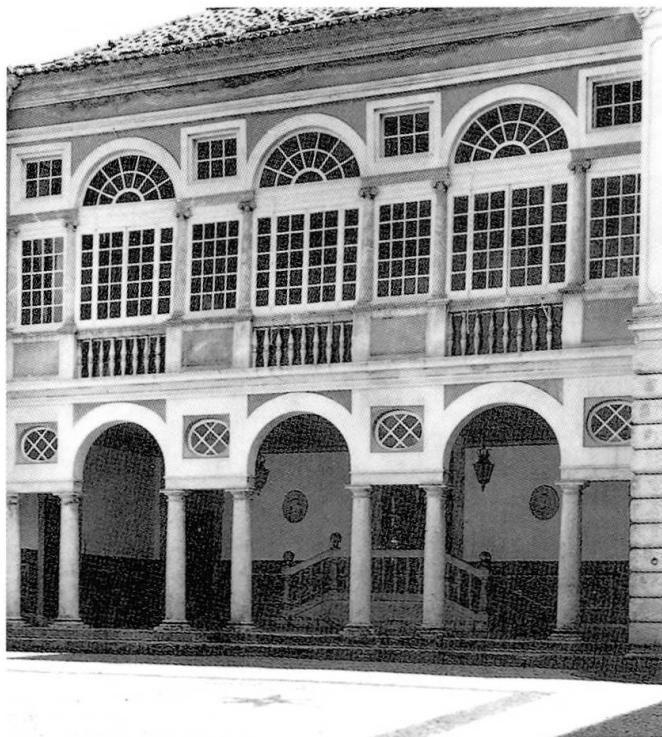
Fig. 2 - The North Loggia Main Facade.
(AZEVEDO [1])

Although the Architect's name is unknown, the main building facade design was probably inspired either by the engravings of Rubens "folio" of the Palaces in Genoa which shows the Villa Sauli by Galeazzo Alessi in 1555-1556, (KUBLER [2]), or on a well known drawing by the Italian architect Sebastiano Serlio, (AZEVEDO [1]). Clearly inspired by the Mannerist style, the north loggia main facade is slightly recessed from the two side towers. The ground floor triple arcade with separated columns supports a loggia with a similar first floor triple arcade supported by marble columns, Fig. 2.

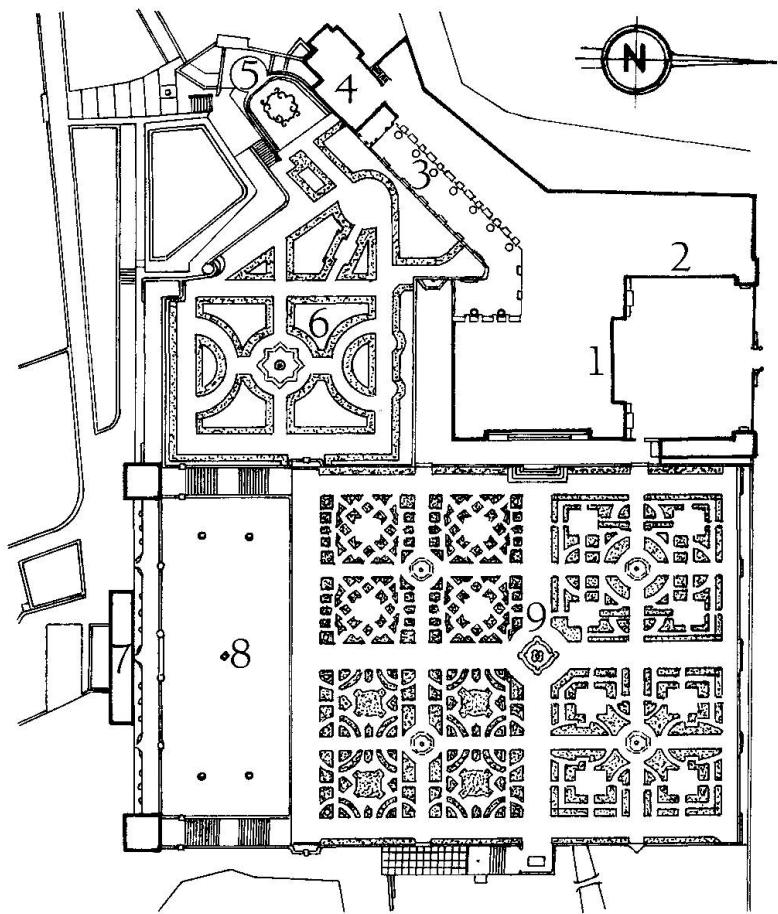
- 1- Main building north loggia;
- 2- XVIIIth century west wing;
- 3- Statues verandah;
- 4- Chapel;
- 5- "Casa do Fresco"
- 6- Venus Gardens;
- 7- Kings Gallery;
- 8- Great Lake;
- 9- Classical Garden.

The beauty of the gardens, strongly influenced by the Italian style, with the elegant building design creates a magnificent architectural compound built in an epoch in which noblemen took greater pleasure in wars than in arts, (CASSIANO NEVES [3]), see Fig. 4, (QUIGNARD and MECO [4]).

The building's surrounding gardens and lakes are an elegant solution to a delicate problem, i.e., to create an enjoyable environment with enough water supply during the summer months. A series of descending water reservoirs (supplied by the nearby Monsanto Hills underground drains) starting at the "Casa do Fresco" (5), and continuing down to the Great Lake (8) are used to water the Venus Garden (6) and the Classical Garden (9), Fig. 4.

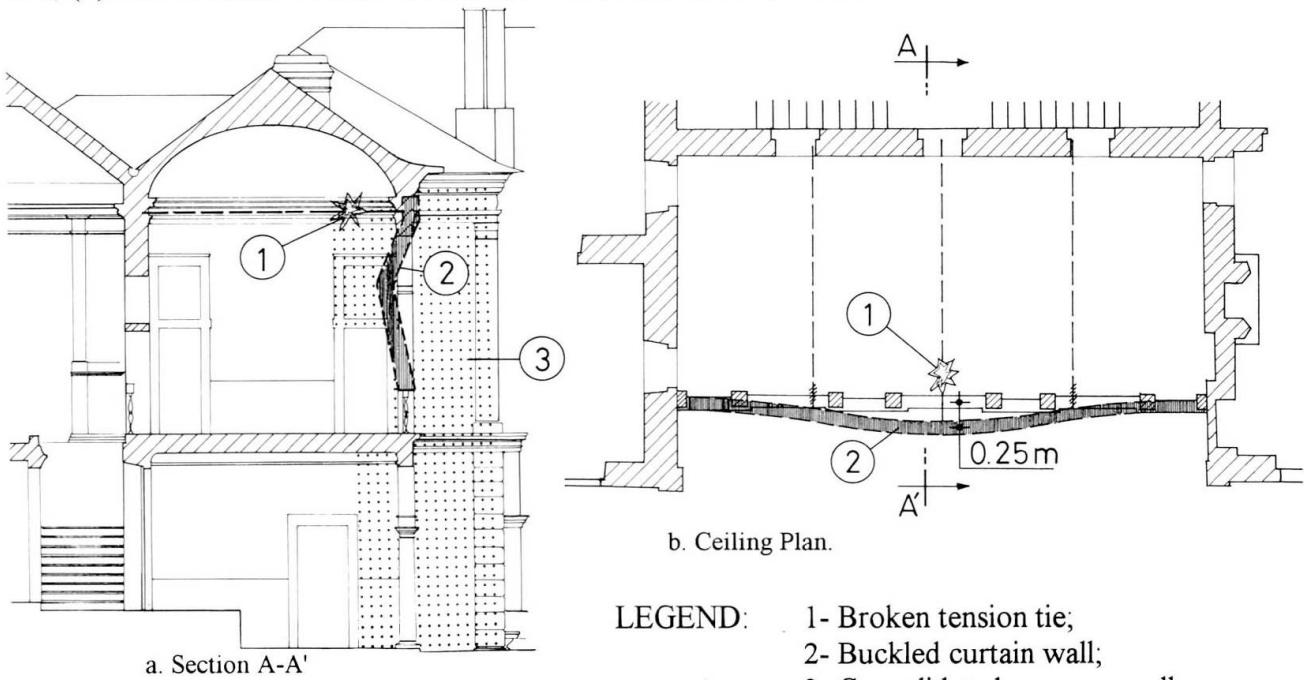
Fig. 6 - North Loggia Facade Collapse Mode.

The site report of the Summer of 1988, showed that the North Loggia facade was on the verge of collapse. The first floor marble columns displayed a horizontal inward displacement which reached 0.25m at the facade midspan. The cornice had horizontal outward displacement of 0.25m, Fig. 6. The facade's generalized bent shape resulted from: (1) a midspan ruptured iron tension bar; (2) the continuous debris falling from the roof the inner plaster painted shell ceiling adjacent to the facade; and, (3) the roof truss deterioration in the wood beam connections.

The existence of heavy compression loads on the 11.50m long "curtain" open wall (4.0m height and 0.25m thick) support system created the ideal conditions for the 2.0m tall marble columns to buckle. The bracing provided by the iron bar ties with a 35mm x 55mm section disappeared when the rainwater, (infiltrating through cracked roof tiles and opened masonry joint), corroded the anchorage eyebar, Fig. 6. The wood roof beams also showed extensive deterioration mainly in the connections at the creast (broken roof tiles) and at the edge supports. Consequently, the bracing effect that once existed through the roof trusses slowly vanished as rotten wood connections developed.

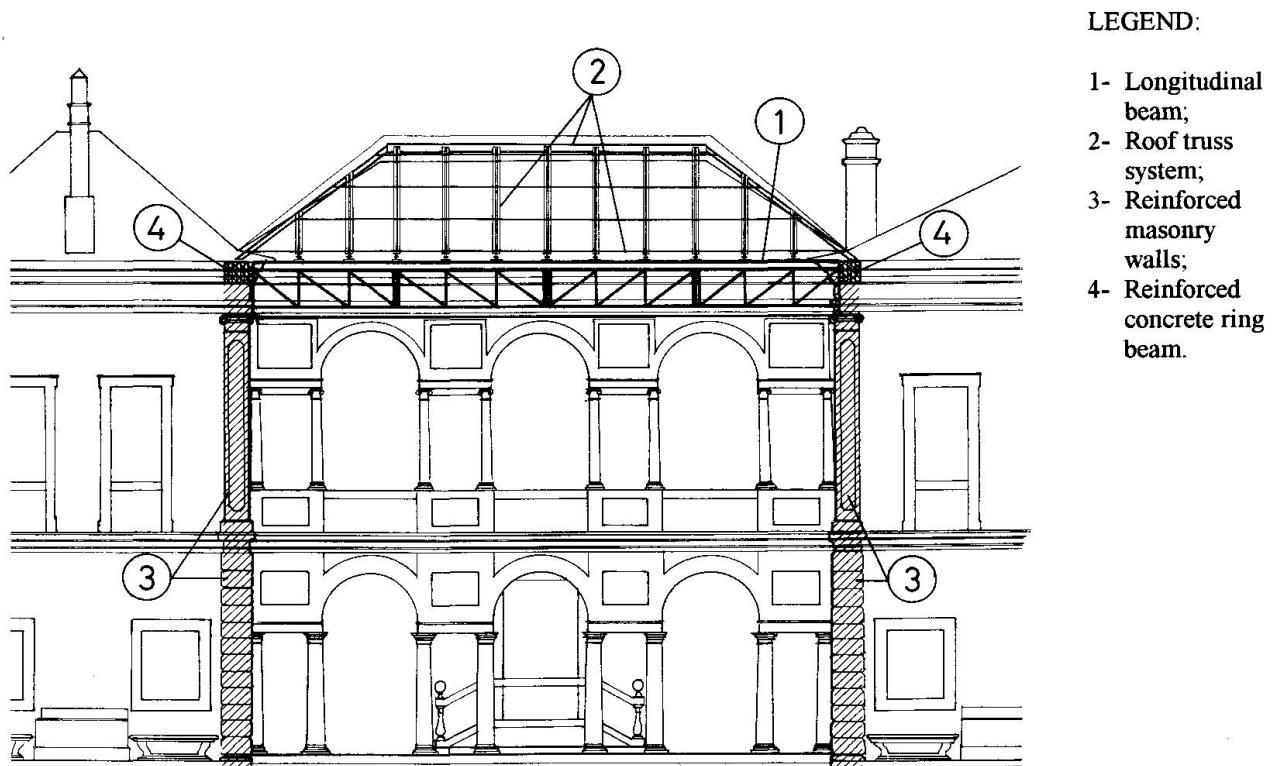
Fig. 7 - North Loggia Facade - Structural Solution

The site visit (Summer 1989) showed an extensively damaged shored roof area in which particular care was taken to preserve the inner ceiling's plaster shell paintings. The overlying roof debris was removed and the masonry clay brick cornice was disassembled, after the moulds and contours were recorded. The recommended structural retrofitting solution consisted in creating a huge portal frame made of a 11.60m long longitudinal steel truss girder and two 0.60m x 3.00m x 10.0m masonry stone columns. The existing wood roof structure was suspended through a second roof steel system installed with hinged connections to the longitudinal beam to avoid roof bending moments.

The objectives with this recommended structural solution were: (1) to reduce the cornice dead load on the columns; (2) to transfer the roof loads applied on the exterior thin wall to the thicker side walls via the longitudinal steel girder; (3) to provide a continuous spatial bracing between the U-shaped masonry wall envelope, the open exterior "curtain" wall and the roof system; and, (4) to increase the safety factor of the existing structure, Fig. 7.

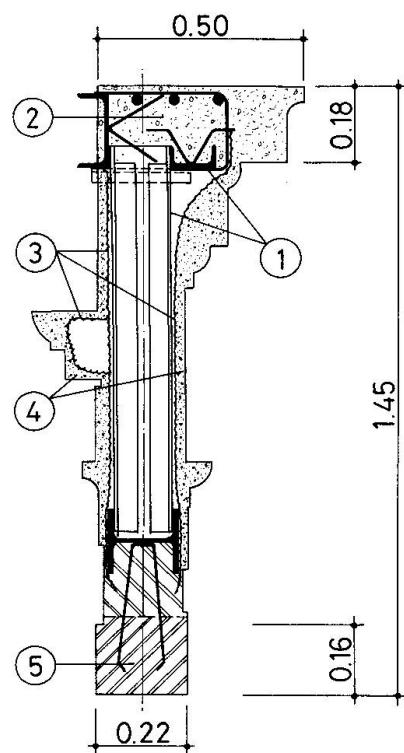
Fig. 8 - Longitudinal beam cross section.

In order to guarantee the overall stability careful site inspection was conducted of the masonry walls. Through several 25mm holes drilled in the walls it was verified that the existing mortar filling the joint had either disintegrated after 300 years in service (probably washed away by infiltrated rainwater) or was in such poor condition that had to be strengthened. A limited "reticolo cementato" technique was used in a 3.00m wall portion. About six hundred 1.0m-long holes were drilled, filled with cement mortar and a 8mm steel rebar. In order to reduce the possibility of steel corrosion the exterior wall was protected with cement epoxy-based mortar. The steel longitudinal beam was coated in rich galvanized zinc to protect it from corrosion and in order to match the existing building cornice, a diamond-shaped zinc coated wiremesh covered with epoxy coated mortar was used, Fig 8.

The architectural detail was easily obtained through the use of these wiremesh panels. The beam top flange was composite with concrete and made continuous with the wall reinforced concrete (RC) ring beam. On the beam top flange stainless steel hinged supports were installed to connect the steel roof truss system. Before constructing the steel roof, the wood truss connections were thoroughly repaired, the inner plaster painted shell ceiling was inspected and a steel tension tie was installed to brace the longitudinal beam, Fig. 9.

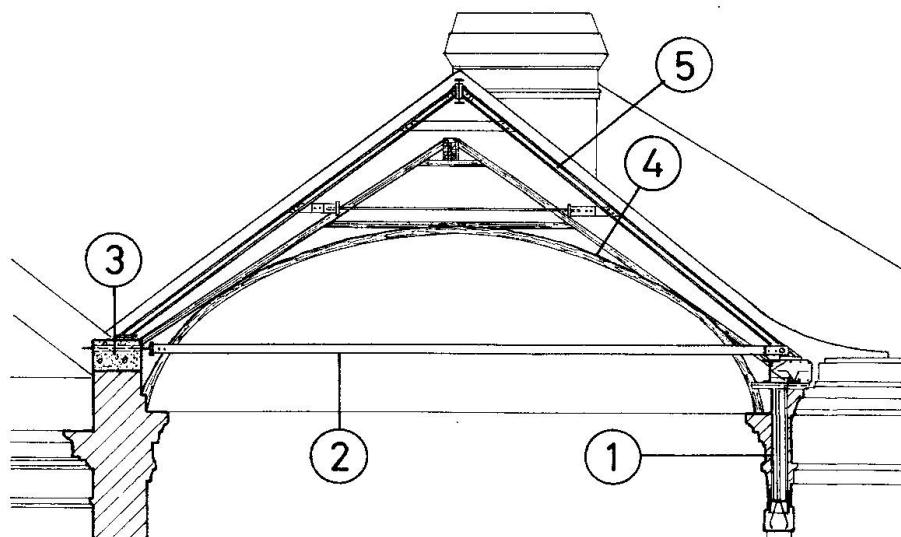
Fig. 9 - Palace North Loggia - Ceiling Cross Section.

Before laying the roof tiles, the wood roofing system was suspended from the steel system with zinc-coated steel rods. Then, moisture-resistant plywood panels covered with an undulated flexible waterproofing membrane were placed on top of the steel truss, so that the roof tiles could be fixed to the structural system.

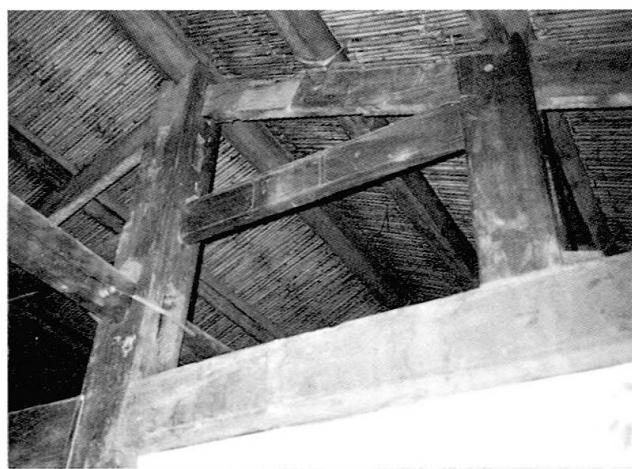
Fig. 3 The wooden Framework

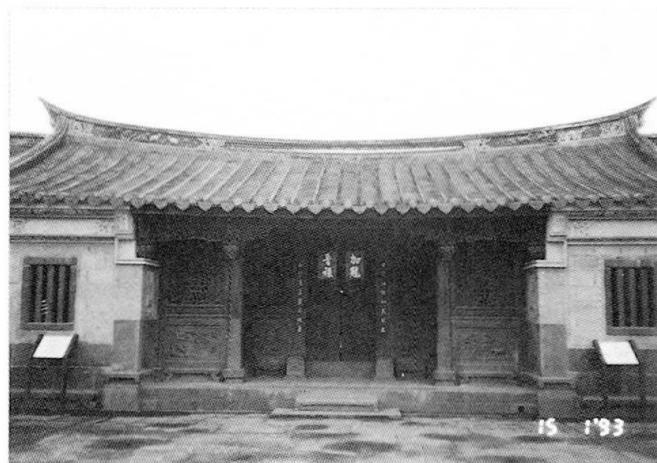
Fig. 5 The bricks and tiles

Three types of bricks laid horizontally in the facade of the lower building are in the southern Fukien style. Those on the rear part of the building are clay bricks. The face brick walls of the side buildings are engraved with tortoiseshell patterns. These probably resulted from a later addition or repair work. The stone slates below the stone waist piece are rather elaborately engraved in the pattern of tables. The entire facade of the dwelling looks neat and handsome. Although its altitude is relatively low, there is a sense of equilibrium (Fig.5).

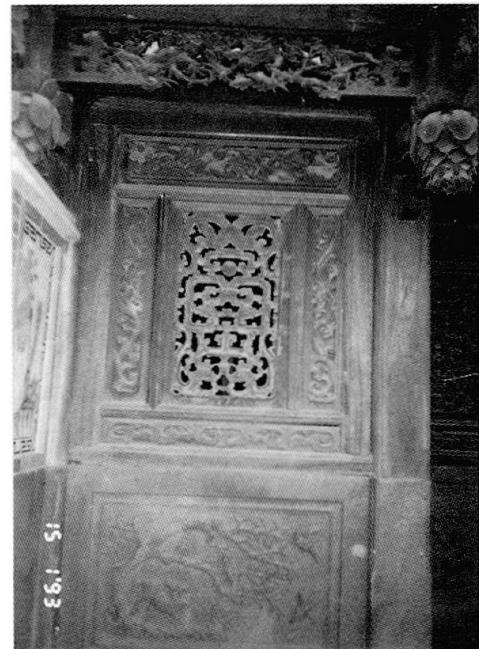
Fig. 6 The fine wood
carving on window
and door

D. The fine wood carving and the windows and doors: The main gate and the slide windows of the main hall are carved hollow. The ornamented waist panels design and engraving techniques are different from one another. The wainscots and waist panels of the doors and bar windows are all carved in one whole piece. The bar windows are of various designs, and since most of them are composed of many single pieces, they are fragile and not easy to preserve. Most of them have decayed and became loose which makes them rather difficult to repair after they are dismantled (Fig.6).

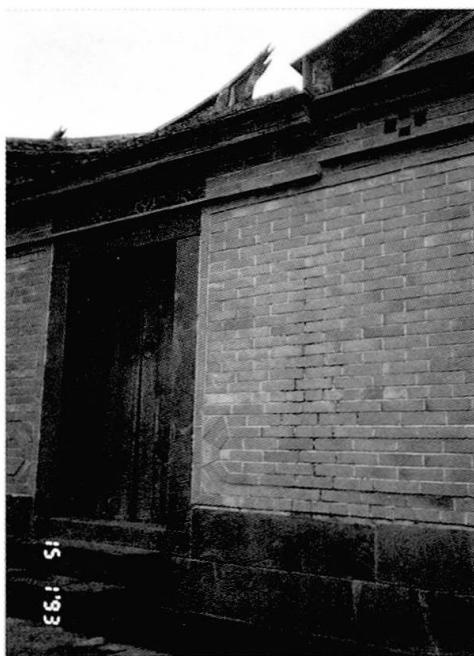
Fig. 7 Unequal settlement
between main hall
and wing house

Due to the misunderstanding of the materials used before and bad repairing the rebuilded homestead are being damped and even forming the crack on the corner of the door and window. Even the connection of the main and winged house are also cracked. The door are thus deformed. The rebuilding work are merely less than five years. The reason of those damage are mainly caused by misuse of cement in stead of clay and gypsum. The foundation are used by concrete instead of original stone layer. These are the first preservation works in Taiwan. Experience gain from them will be good for future works (Fig.7-8).

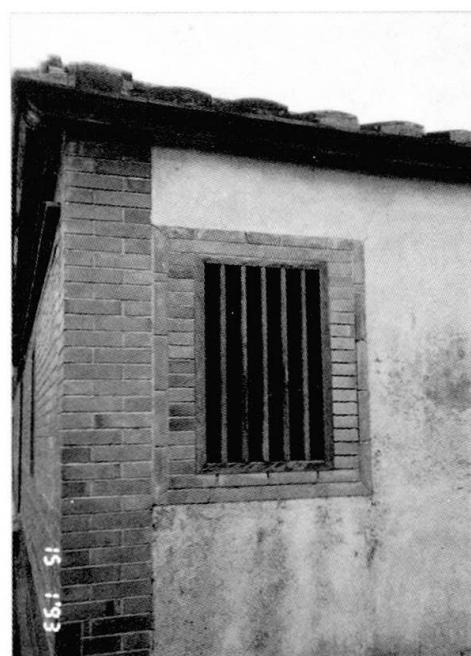
Fig. 8 The damped wall

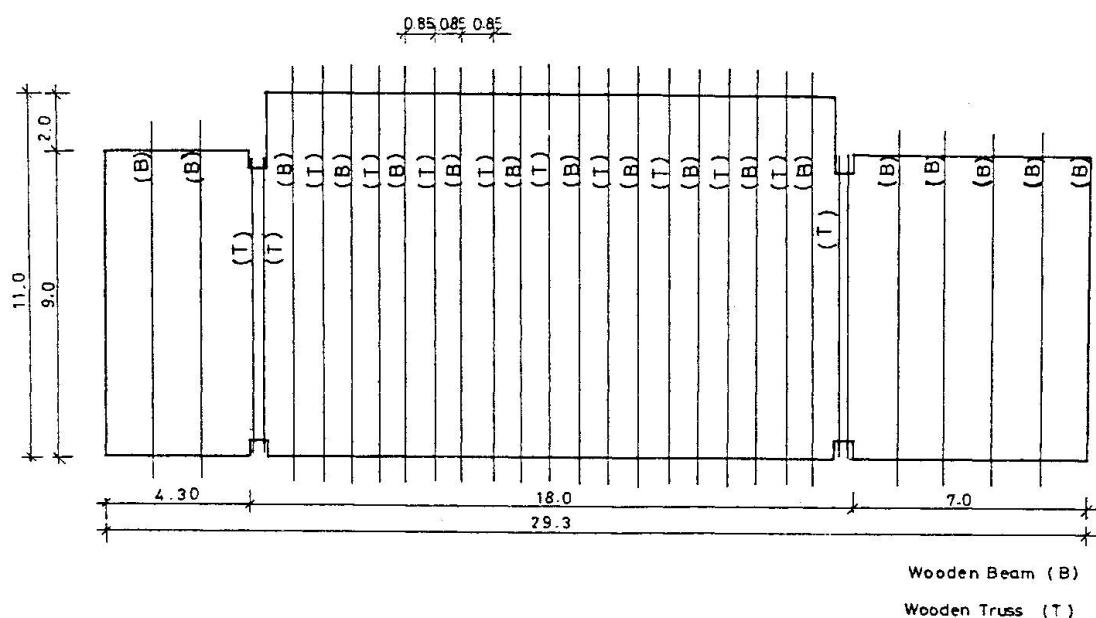
Fig. (1) Layout of the Hall (in the Old Building) showing Locations of Beams and Trusses

This building was well maintained and in a good condition. Nevertheless, there was water leakage in one of its major halls. Figure (1) shows the layout of the hall under study. This hall is one of the most luxurious halls in the palace. The ceiling and walls contain precious masterpiece decorations. The main hall was 18 meters long and 11 meters wide. Connected to this hall from one side was an entrance hall (9 m x 7 m) and from the other side to a hall (9 m x 4.3 m) connecting it to the main throne hall.

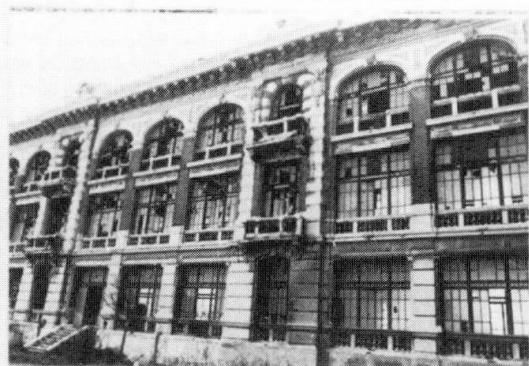
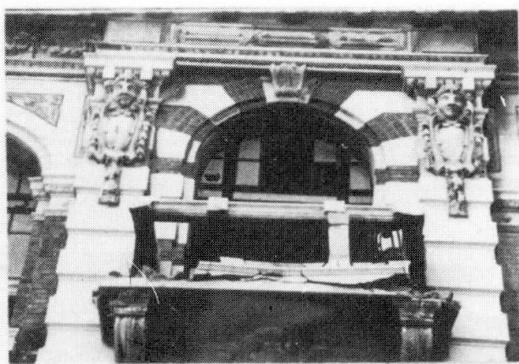
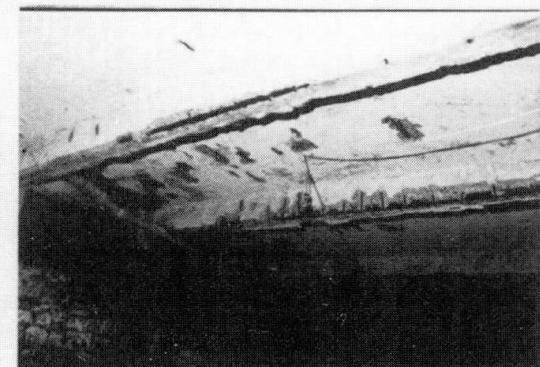
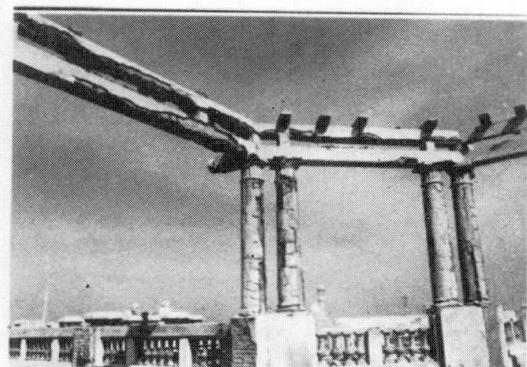
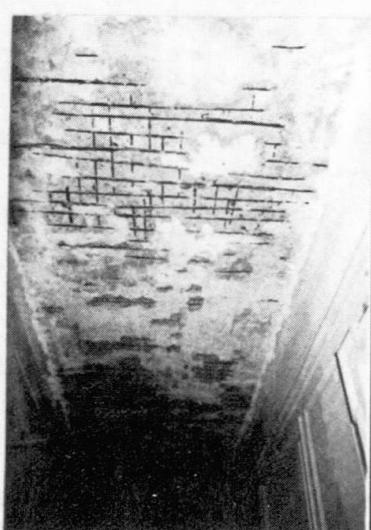
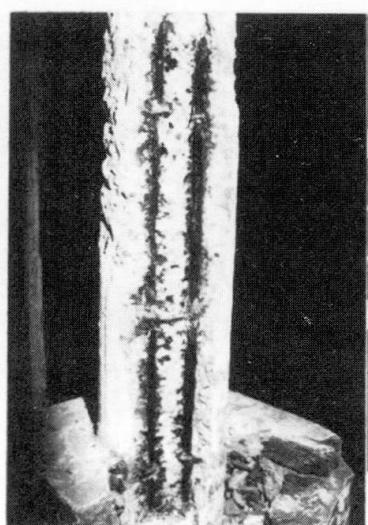
Fig. (2) Photos taken to the Extension Building showing a sample of the damaged parts

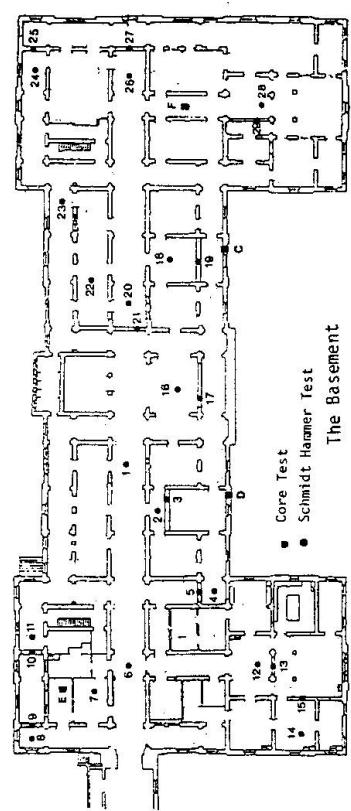
Fig. (3) Layout of the Extension Building (New Building) showing Locations of Tests

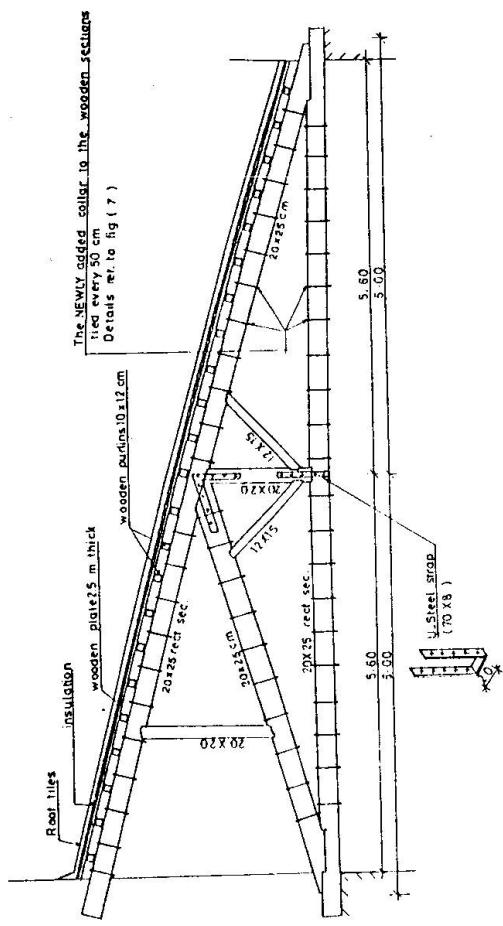
Fig. (4) A Typical Truss of the Old Building Hall (after repair).

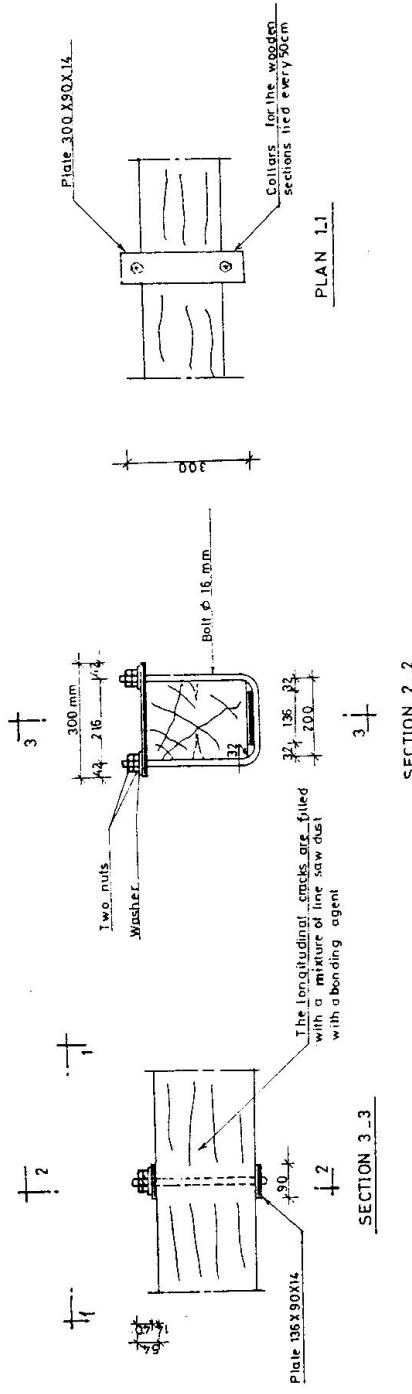
Fig. (5) Collar Details which were connected to the Truss Members

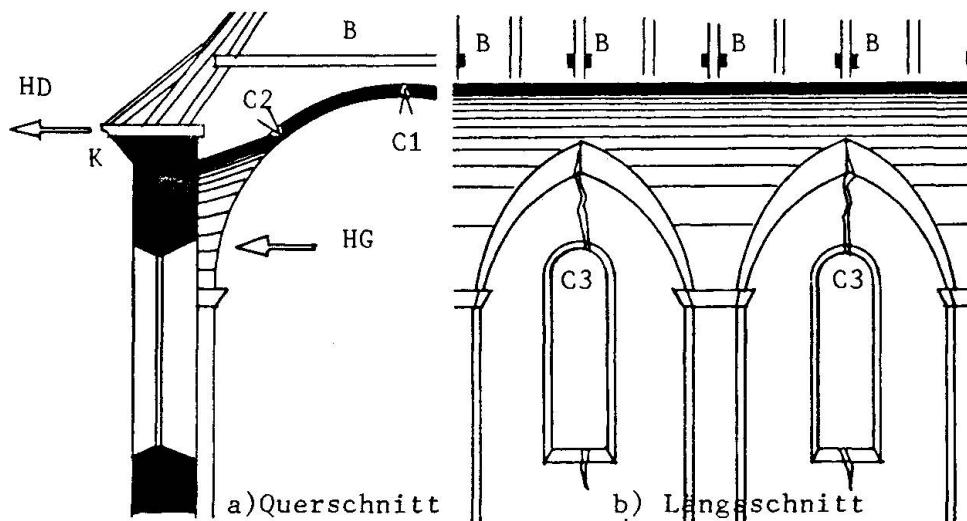
Fig. 1: Tonnengewölbe mit Stichkappen, Kehlbalken B

Die Bewertung der zu Rissen führenden kurzfristigen Zustandsänderungen sei für die Bauweise nach Fig. 1 an einem Tonnengewölbe mit Stichkappen mit den fast immer im Scheitel an der Unterseite auftretenden Rissen C1 und den manchmal zu beobachtenden Rissen C2 an der Gewölbeoberseite in Kämpfernähe vorgenommen. Den einfachen Berechnungen wurde der Modellquerschnitt gemäß Fig. 2 zugrunde gelegt.

Bei der Beurteilung der wichtigen Wirkung der Horizontalschübe der Konstruktion wird meist übersehen, daß Dachstühle dort, wo hochliegende Gewölbescheitel keine Träme zulassen, wie in Fig. 1 und Fig. 3 auch die Dachkonstruktion nicht unbeträchtliche Horizontalschübe, HD, auf die Außenwände ausüben; im Beispiel Fig. 2 als mittlerer Wert ca. 4 kN/m ständig.

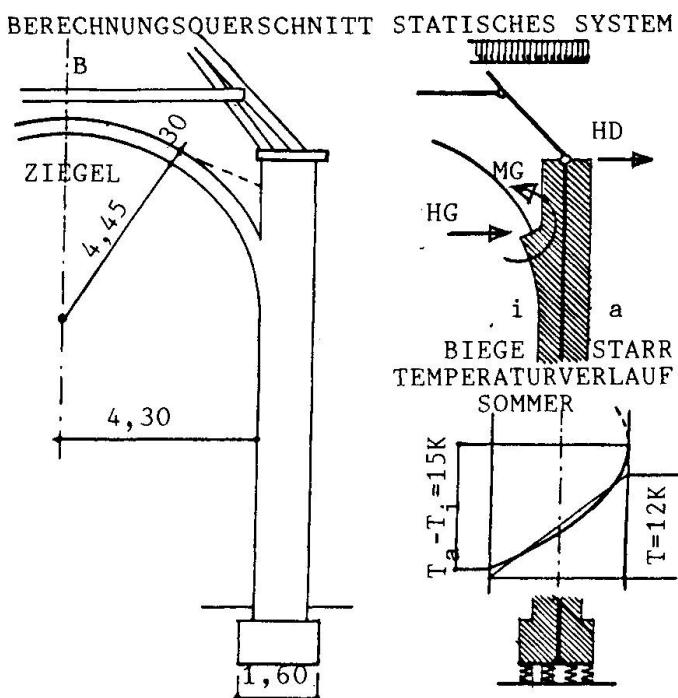
Fig. 2: Kirchenschiff mit Tonnengewölbe
Grundlage für Modellberechnung

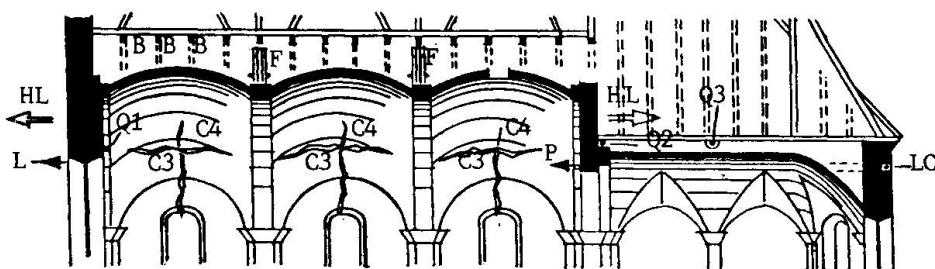
Fig. 3a: In Joche unterteilte Gewölbe, Längsschnitt

In der Bauweise gemäß Fig. 3 ist die Überwölbung in Joche unterteilt, die durch Gurtbögen getrennt sind. Das statische Verhalten der Gurtbögen und die anschließende und mitwirkende Zone der flachen Kuppeln ist in Querrichtung ähnlich dem Beispiel der Tonnengewölbe. Bei diesem - vor allem für das Barock typischen System - ragen die Kuppeln besonders hoch in den Dachstuhl hinein, sodaß die Horizontalschübe HD größer als in dem vorhergehenden Beispiel sind. Die Schalenbereiche zwischen den Gurtbögen sind in Kirchenquerrichtung wesentlich biegesteifer als die Gurtbögen bzw. als das Tonnengewölbe gem. Fig. 1. Bei allen Lastfällen, die zu einer horizontalen Verschiebung der Kämpferbereiche K nach außen führen, treten beim System gemäß Fig. 3 an den Stellen, vergleichbar C2 der Fig. 1, nicht nur Biegerisse auf, sondern auch eine völlige Durchtrennung der Gewölbeschale an den Stellen C4 der Fig. 3, wie sehr oft zu beobachten ist. Die horizontale Verschiebung der Mauerkrone K nach außen führt dazu, daß die Mauerrippen in Fig. 3b, die offenbar als horizontale Stützung der Gewölbeschalen gedacht waren, sich von der Mauerkrone ablösen und die dabei entstehenden bis zu 20 mm breiten Spalten C5 die Funktion dieser Rippen wirkungslos machen.

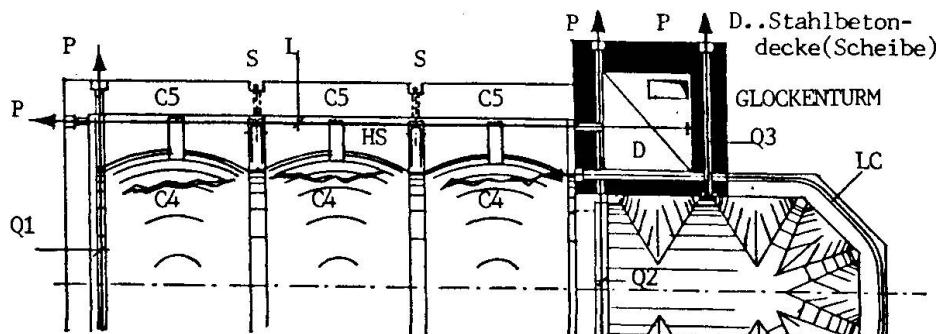
Fig. 3b: In Joche unterteilte Gewölbe, Grundriß zu 3a im Dachgeschoß

L,LC horizontale Längs-, Q1,Q2,Q3 horizontale Querspannglieder

Die flachen Kuppeln der Konstruktion gem. Fig. 3 üben als doppelt gekrümmte Schalen auch horizontale Reaktionen in der Längsrichtung des Gebäudes aus, die in Fig. 3a mit HL bezeichnet sind. Diese Horizontalkraft überträgt sich durch Schalenwirkung der Kuppeln auf die Längswände des Gebäudes und verstärkt auf diese Weise die Längszugspannungen in den Seitenwänden und trägt verstärkt zu C3 bei.

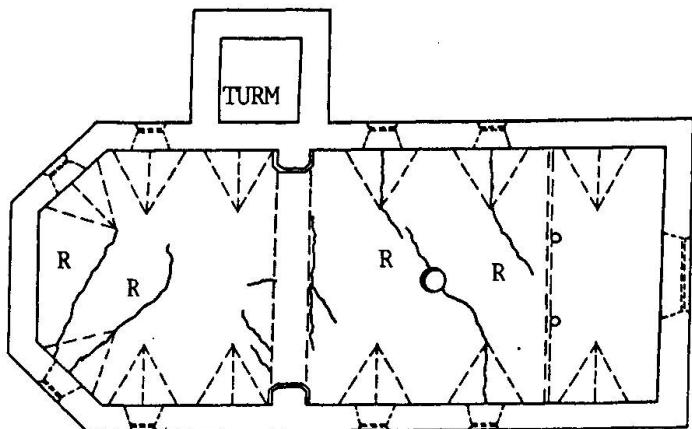
Fig. 4: Draufsicht auf Tonnengewölbe mit untypischem Rißbild R

Fig. 4 zeigt schräg verlaufende Risse im Tonnengewölbe einer kleinen Kirche auf gutem Baugrund, die mit oben dargelegten Überlegungen nicht in Einklang zu bringen waren. Die Ursache der Rißverläufe ließ sich erkennen als die Befragung der Bewohner ergab, daß während des II. Weltkrieges in kaum 70 m Entfernung von der Turmseite der Kirche ein kleiner Steinbruch errichtet wurde, der dzt. nicht mehr in Betrieb ist.

Deutlich sieht man, daß der Turm ablenkend auf die Richtung der Risse infolge der Erschütterungswellen wirkt.

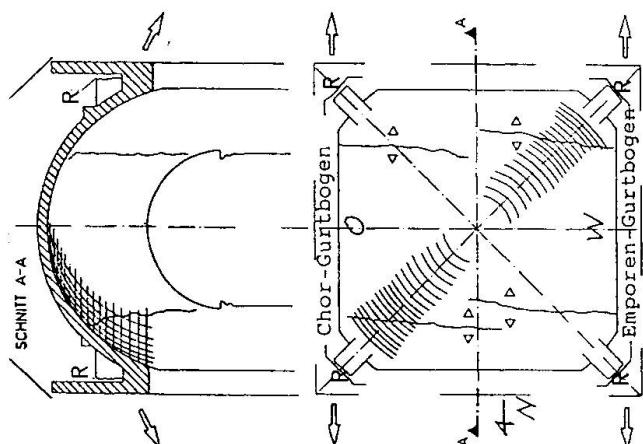
Fig. 5: Rißbild einer Hängekuppel, auf Gurt- und Schildbögen

In Fig. 5 sind im Grundriß Risse in einer Kuppel dargestellt, die in Tirol in Itter nach dem Erdbeben im Friaul 1976 verstärkt auftraten [2]. In dem Zentralbau hätte man nach statischen Gesichtspunkten Risse in Radialrichtung im unteren Teil der Kuppel erwartet. Die Orientierung der Risse zeigt aber deutlich ein Ausweichen der Nord- und Südwand nach außen, was auch zu der Trennung R der als horizontale Stützung der Kuppel gedachten Mauerrippen führte. Die Analyse der Risse und deren Lage ergibt:

Erstens liefert ein Temperaturunterschied von $\Delta T = 12 \text{ K}$ Zwängungsbiegespannungen von mind. $\pm 0,13 \text{ N/mm}^2$, die aber proportional dem E-Modul des Mauerwerkes je nach dessen Güte auch bei $\pm 0,2 \text{ N/mm}^2$ liegen können. Diese Spannungen treten fast in der gesamten Kuppel auf.

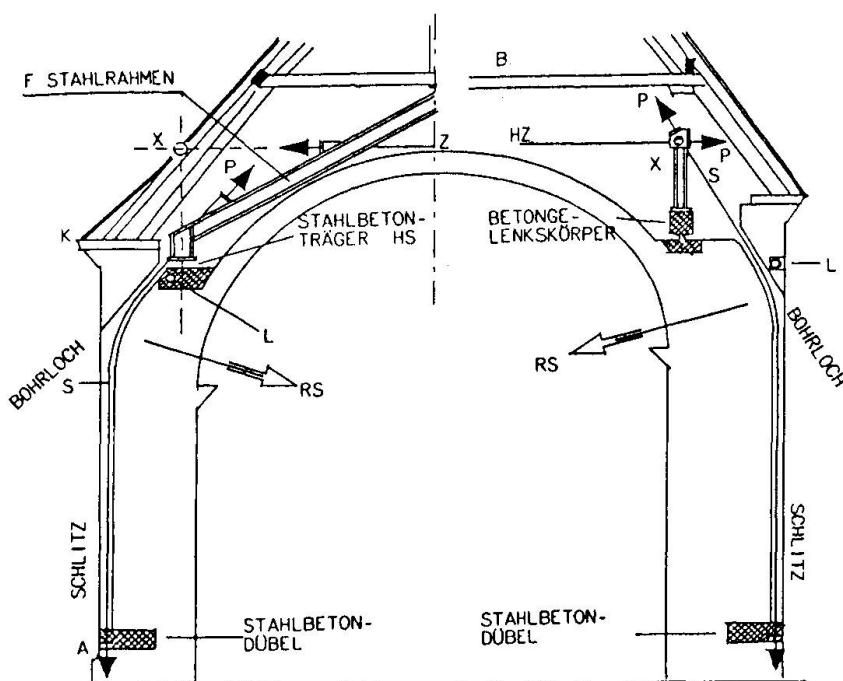
Die Fig. 6 zeigt drei Beispiele, wie man die gleiche Wirkung durch Konstruktionen erreichen kann, die im Kirchenschiff vom Benutzer der Kirche nicht gesehen werden können. Der Druck gegen den Horizontalschub des Bogens wird durch die Reaktionskräfte R des gekrümmten Abschnittes von Spannkabeln S erreicht.

Die Endverankerung dieser Spannglieder befindet sich möglichst tief unten am Punkt A. Von dort aus läuft das Spannkabel in einem lotrechten Schlitz in der Wand und in einem geneigten Abschnitt in einem Bohrloch zur Stützenkonstruktion. Punkte P in Fig. 6 bezeichnen Stellen, wo die Spannglieder S vorgespannt werden. Wenn es die räumlichen Verhältnisse erlaubten, wurde die in Fig. 6, rechte Hälfte, dargestellte als einfachste Lösung ausgeführt. Das Vorspannglied HZ stellt ein "hochliegendes Zugband" dar. Um jede horizontale Reaktionskraft auf die Lager der Stützen für P - dargestellt auf der rechten

Als Grundwert für die Ablenkkraft RS in Fig. 6 wurde angenommen, daß sie mit den Horizontalschüben HG und HD möglichst gleichförmige Bodenpressung unter den Längswänden ergeben, wobei die Höhenlage von RS ein festzulegender Parameter ist. Spannkraftverluste durch Kriechen und Wärmedehnungsunterschiede zwischen Spannglied und Mauerwerk sollen zugeschlagen werden, wobei über eine obere Grenze an Vorspannkraft, die wieder Risse oder zu große Druckspannungen erzeugt, nicht hinausgegangen werden darf.

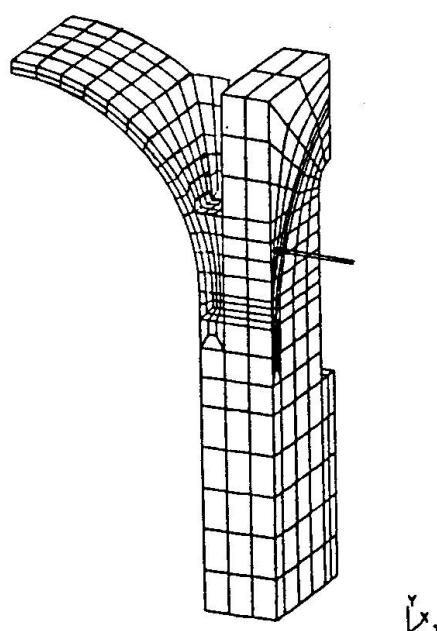
Fig. 7: FEM-Netz zur 3D-Berechnung

Es treten dann nur unwesentliche Zugspannungen an anderen Stellen auf, die für eine weitere Optimierung den Aufwand nicht lohnen. Die FEM-Untersuchungen wurden sowohl als ebenes Problem ohne Stichkappen und als 3D-Problem mit Stichkappen und Fensteröffnungen, Fig. 7, am Institut für Festigkeitslehre und Flächentragwerke der Universität Innsbruck im Kapitel, das von Dr. Stark behandelt wurde, durchgeführt [6].

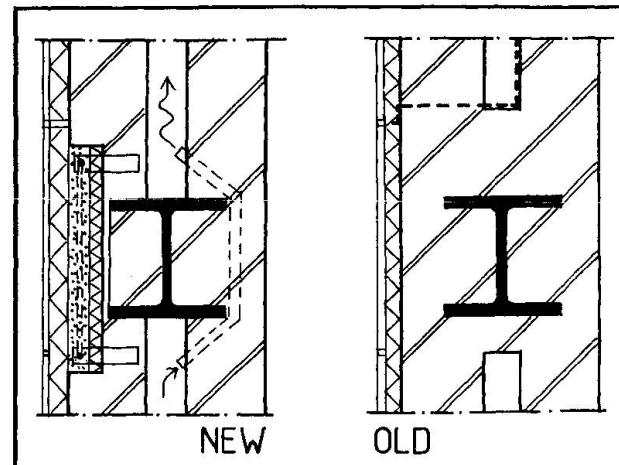
Fig. 4. The steel frame of the Gooiland hotel is placed in a brick cavity wall, a solution that caused severe damage. Today the steel is protected against extreme temperature changes

The steelframe is partly placed in a brickwork cavity wall: a peculiar mixture of a 'modern' frame with a traditional construction, that again looks like it was given a functionalist' image by the tile covering. The cavity was meant only to provide thermal isolation and was therefore not ventilated. The tiles were necessary to keep the water out, since by lack of ventilation, water could not vaporize and leave. But when the facades collect heat in the summer, the steel shows a relatively greater extension as compared to the surroundings and cracked the tiled surface. Through these cracks, water entered after all. Since the lead strips on the beams, meant to lead water outside, were cut shorter than originally intended, water could reach the steel. The beams corroded, increasing their volume and pushing the outer wall away.
