**Zeitschrift:** IABSE reports = Rapports AIPC = IVBH Berichte  
**Band:** 70 (1993)  
**Rubrik:** Keynote lecture

## Compatibilité de la thérapie avec le monument

Appropriate Measures for the Preservation of Monuments

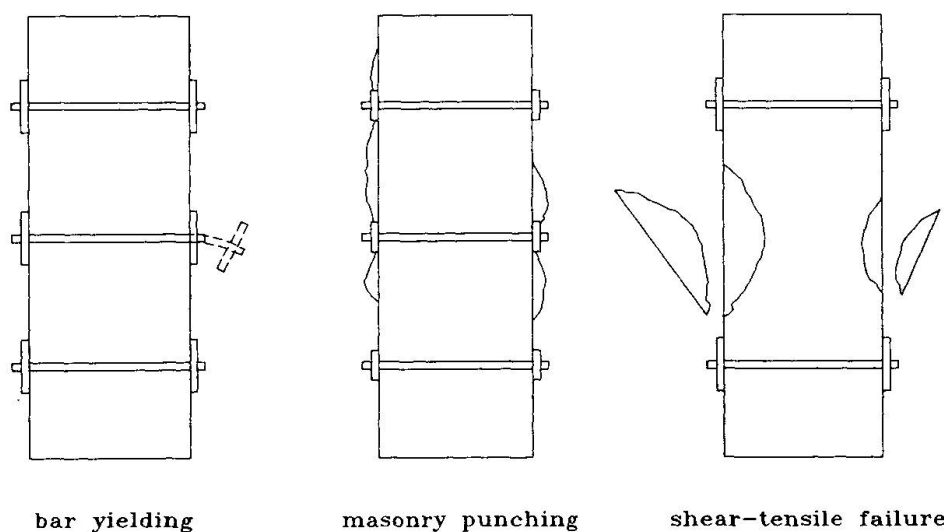
**Fig. 1** Possible failure modes. From the left hand side: yielding and fracture of bars; punching of masonry beneath the confining plates; shear-tensile failure in the unconfined region

As already mentioned three fundamental failure modes have been considered, as shown in figure 1. For the purpose of some preliminary estimation of the failure mode to be expected, a bidimensional behaviour was assumed, imposing a perfect confinement in the third direction. These conditions could correspond to those of a wall with width significantly larger than thickness, and have been reproduced in the tests applying much stiffer bars and plates covering the whole side in one of the horizontal directions (see figure 2).

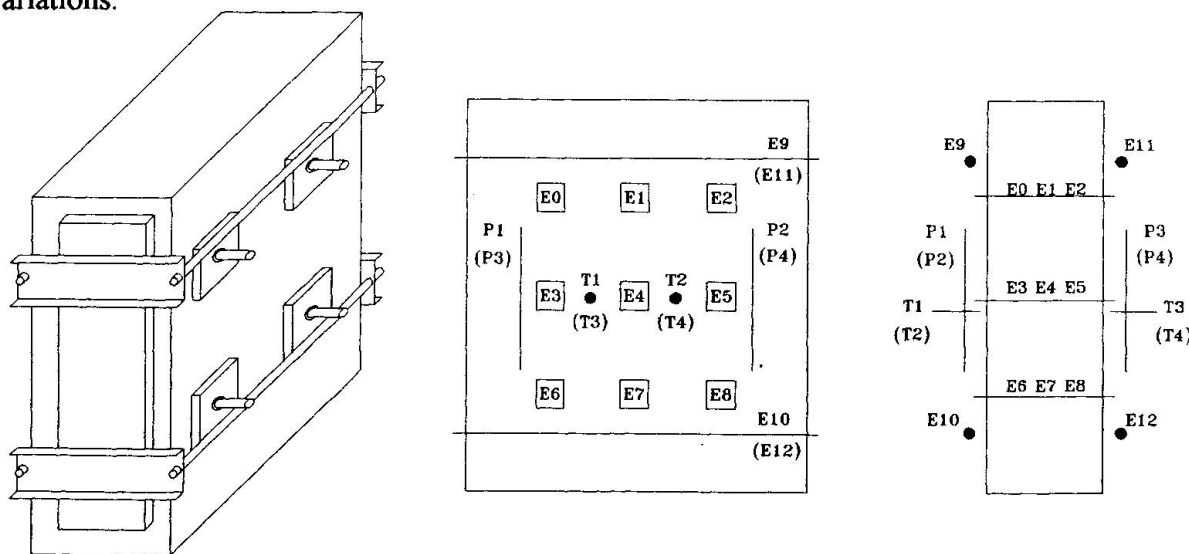
Fig. 2 Test setup (P: linear potentiometers, T: LVDT, E: Strain gauges)

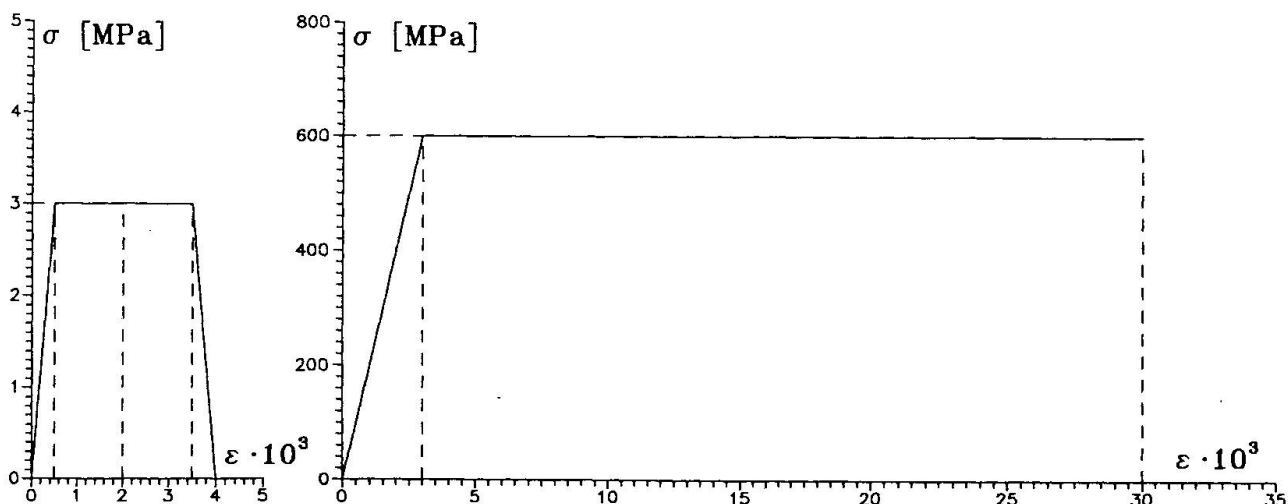
Fig. 3 Assumed material behaviour. Left: masonry; right: steel bar

Assuming the materials behaviour as shown in figure 3, the total energy absorption capacity of the wall can be approximately evaluated as 1400 kN mm, the energy absorption capacity of each reinforcing bar as 140 kN mm. The energy increment should therefore be estimated as 40%, for the case with 4 bars, and 90% for the case with 9 bars, provided that the assumptions mentioned above are applicable and that the final collapse corresponds to a contemporary fracture of all bars. The energy increment could correspond to different combinations of strength and deformation capacity variations.

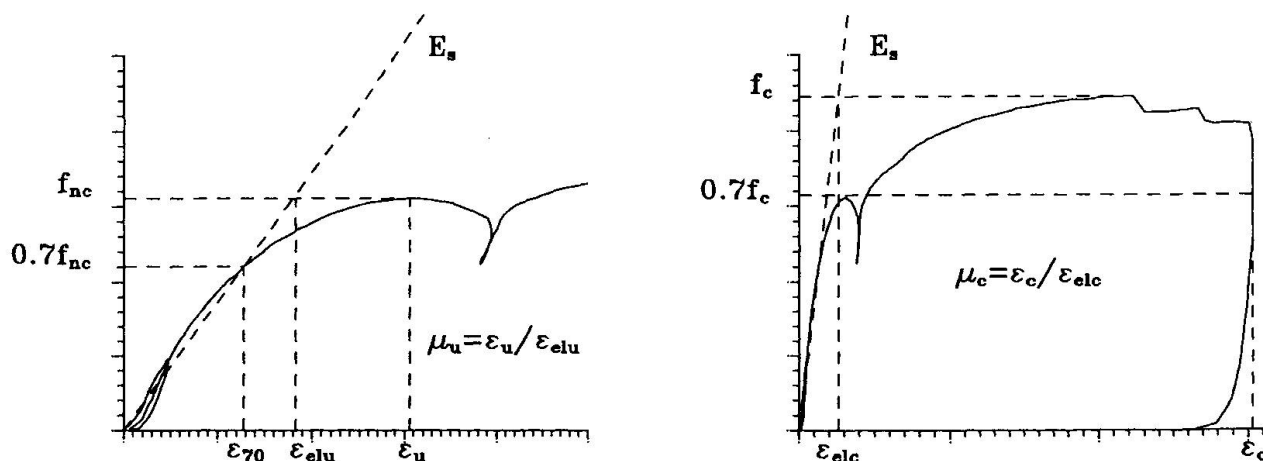
Fig. 4 Typical stress-strain curve obtained from the tests (the definition used for stiffness, equivalent elastic limit and ductility are shown)

The ultimate deformation capacity of the unconfined specimens was equal to 0.24% (average, c.o.v. 0.26), with an equivalent "ductility" ( $\mu_u$ , defined according to figure 4) of 1.76 (c.o.v. 0.12).

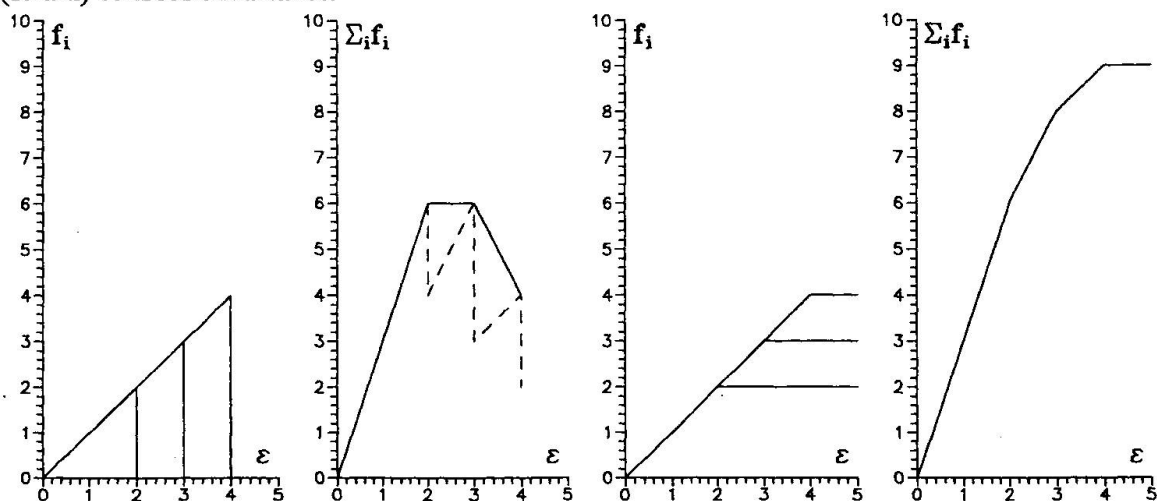
**Fig. 5** Comparison of the overall behaviour shown by systems made with materials of different strength working in parallel. Left: elastic-brittle; right: elastic perfectly plastic.

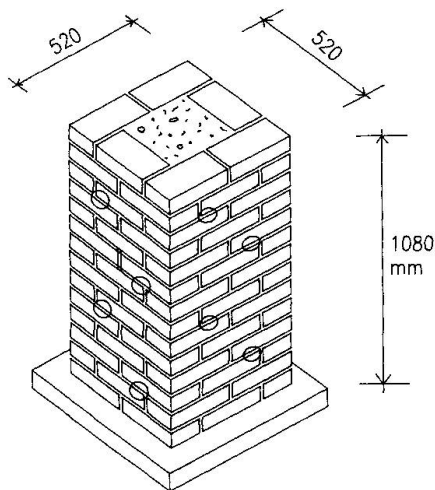
Fig. 1 Test column showing arrangement of connectors

Fig. 1 clearly shows the shape and geometry of the columns. The fill layer was reproduced with rubble taken from the Castello della Venaria. Grain size is described in fig. 2.

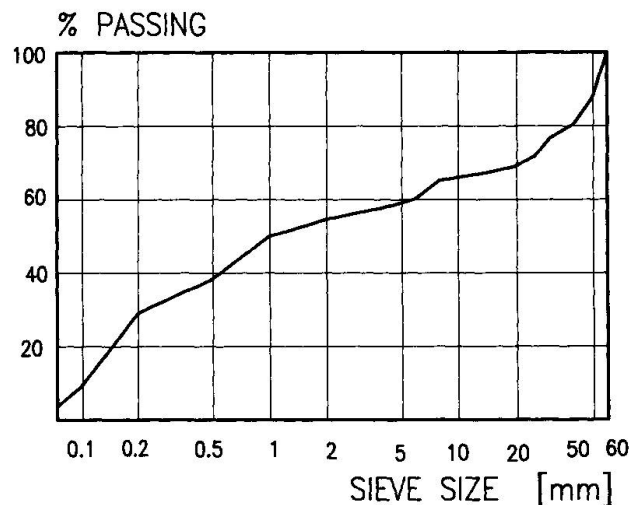
Fig. 2 Grain size of the fill material

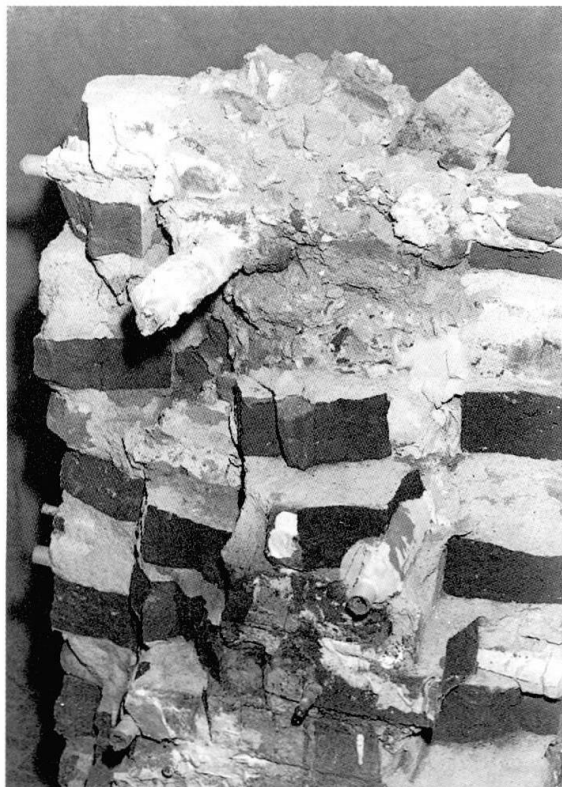
Fig. 4 Inside view of consolidated column with the connectors in place.

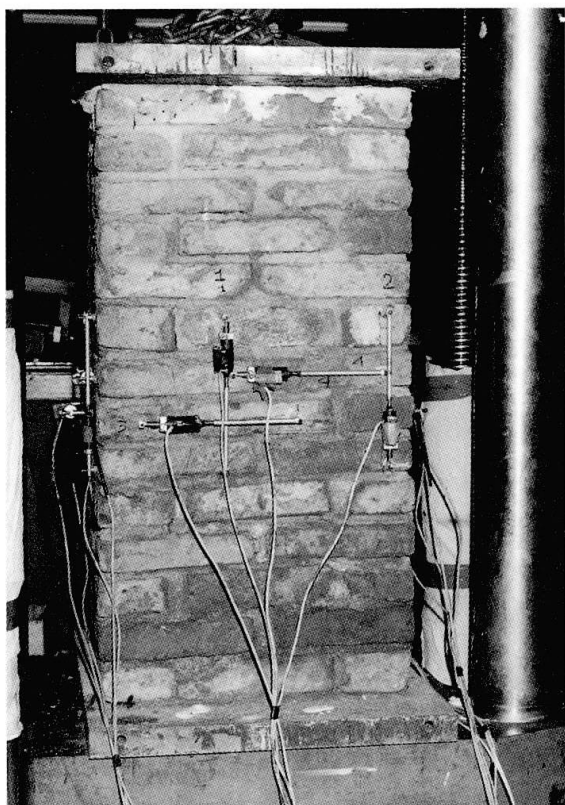
Fig. 5 Arrangement of the strain gauges

After about 30 days of ageing at  $20^\circ\text{C}$  temperature and 65% humidity, the specimens were subjected to centred compressive tests up to advanced cracking. For each load level, strains were measured by means of 16 potentiometric transducers on 250 mm gauges, arranged as shown in fig. 5.

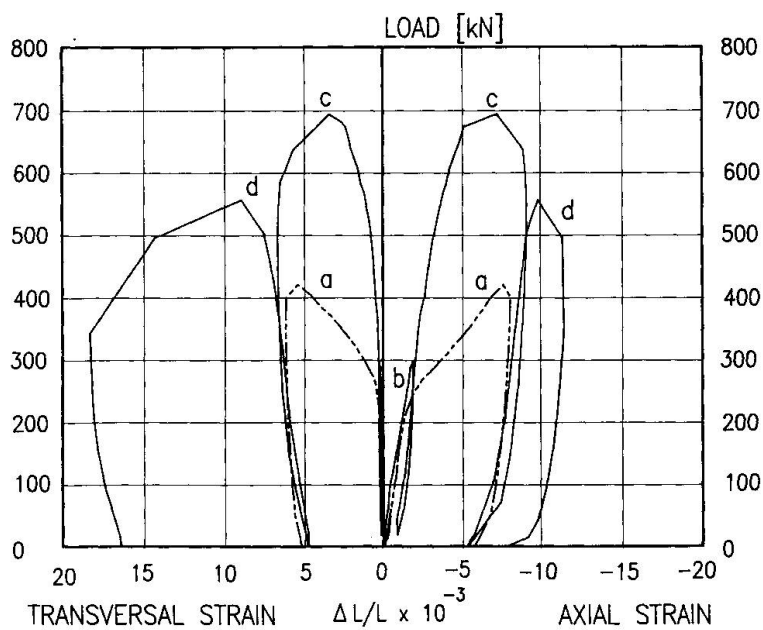
Fig. 8 Load-strain diagram, specimen No. 7

Consolidated specimens were tested until failure by the same procedure employed in the earlier series of tests. Figs. 7 and 8 reproduce the diagrams for two

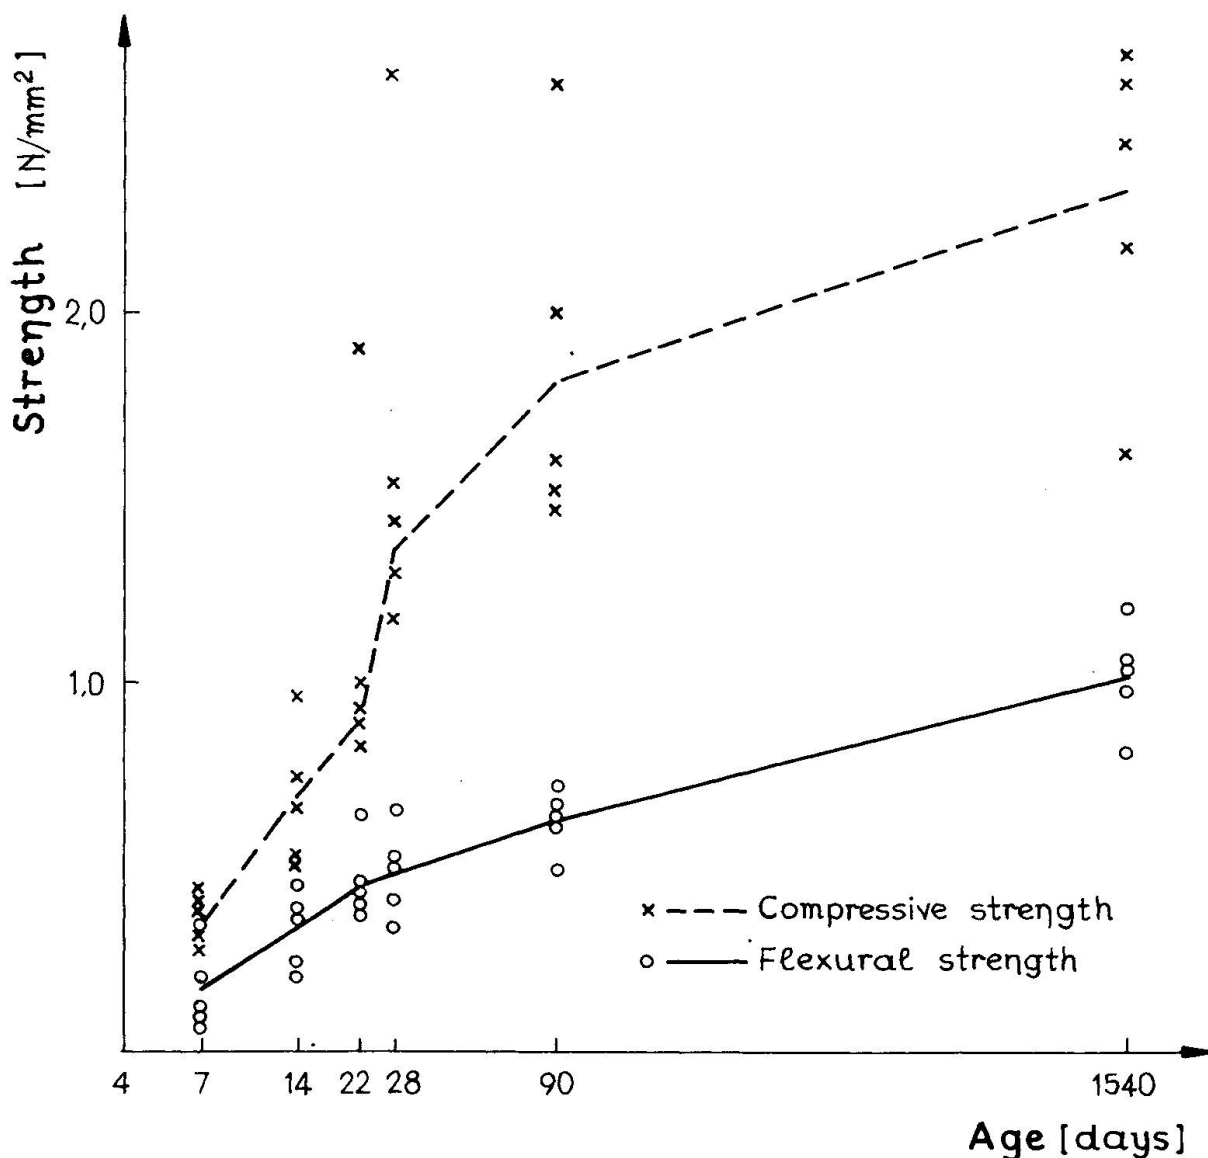
Fig. 1 Strength development of grouts G<sub>3</sub>, G<sub>4</sub>, G<sub>5</sub>, G<sub>6</sub>, G<sub>7</sub>

The long-time strength of mortars and grouts must be taken into account in the analysis of bearing capacity of under restoration masonry as well as the masonry deformations. Therefore, a slight decrease in mortar strength must be expected after one year. In contrast, grout strength is slightly increased after years. This leads to the suggestion that in order to achieve the require strength for repairing a masonry a higher strength mixture should be designed.

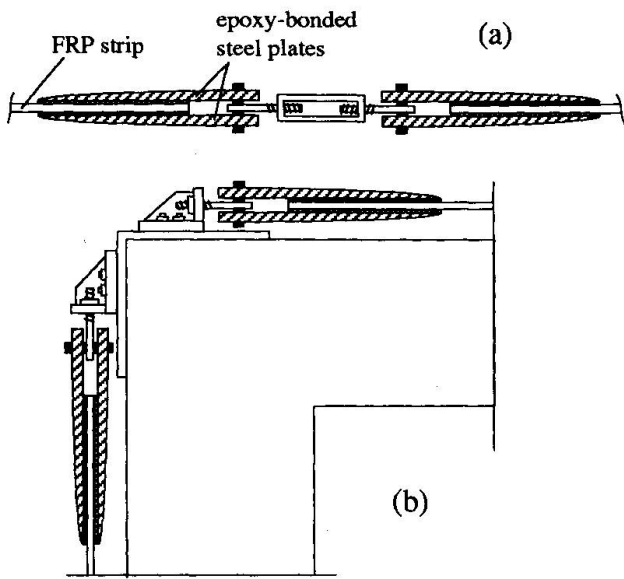
Fig. 2 Conceptual FRP anchorage/attachment for (a) circumferential prestressing of circular domes; and (b) masonry structure corners.

Due to their anisotropic nature, unidirectional composites have relatively low transverse compressive strength (approx.  $0.1f_{FRP,t}$ ) and even lower (interlaminar) shear strength. Furthermore, because of their brittle nature, the materials are sensitive to stress concentrations and hence cannot be pierced or threaded. Finally, their abrasion resistance allows only limited frictional stresses. Thus, conventional anchoring solutions (upset heads, threads, wedges, etc.) are not applicable, and relatively large anchor lengths are required. Strip-like tendons may be better than round ones for external post-tensioning of masonry, because they minimize anchor lengths (due to their large surface area) and simplify the attachment of anchorages on the masonry walls. Proposed concepts for anchorages and their attachment on masonry are illustrated in Fig. 2.

Figure 2(a) refers to circumferential prestressing of structures with a circular plan and involves a single FRP tendon around the perimeter, gripped at each end between a pair of steel plates to which it is epoxy-bonded. The two pairs of plates extend into a corresponding threaded steel bar and are coupled by a usual threaded bar coupler. Because FRP tendons cannot be bent to a large curvature, they cannot turn around sharp corners of the structure and have to be individually anchored there. For this latter case the anchorage in Fig. 2(b) is proposed herein, involving a structural steel angle weakly attached to the corner of the wall and transferring prestressing forces to the masonry through bearing stresses. The two tendons anchored at the same corner angle have to be prestressed gradually, by alternate turning of the nuts at their end anchorage, so that at each corner the moments of the individual tendon forces with respect to the corresponding wall mid-surface counterbalance each other. For no such end moment to develop during tensioning at a dead or passive anchorage (P in Fig. 1(b)), the two pairs of tendons actively anchored at two diametrically opposite corners (A in Fig. 1(b)) have to be tensioned simultaneously.

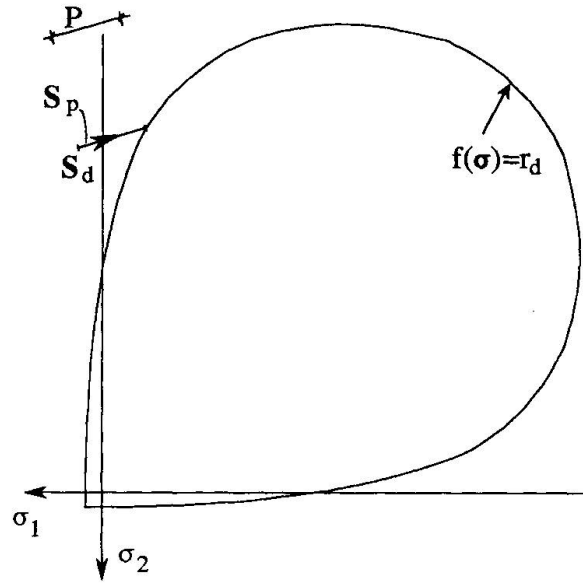
Fig. 3 Illustration of design procedure.

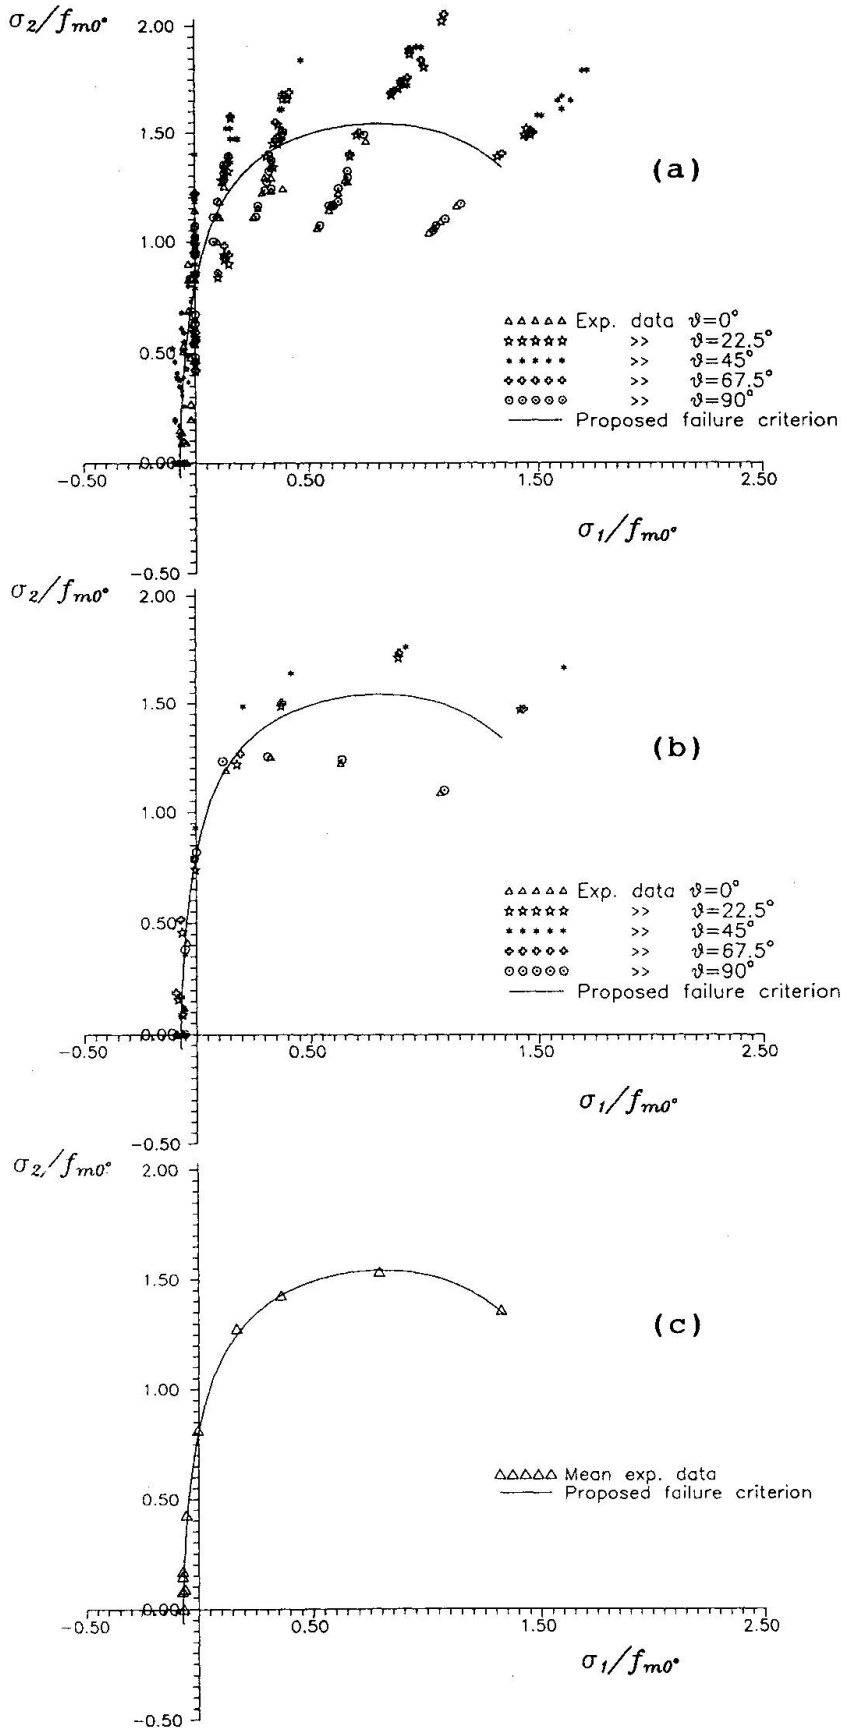
**Fig. 1** Test data from [4, 5] and proposed failure criterion. (a) Individual data; (b) average data for each  $\theta$  value; (c) average data for all  $\theta$ .

medieval and Renaissance monuments. Despite of its importance, though, it has never been the subject of a systematic experimental investigation, such as those reported for brick masonry under biaxial stresses [4, 5]. In view of this lack of test data the authors had to resort to these latter results on solid brick masonry tested to failure under a variety of biaxial tension-compression and compression-tension principal stress combinations, oriented at various angles  $\theta$  equal to  $0^\circ$ ,  $22.5^\circ$ ,  $45^\circ$ ,  $67.5^\circ$  and  $90^\circ$  with respect to the bed joints, and to fit a biaxial failure criterion to them after removing the dependence on the angle of  $\theta$ .

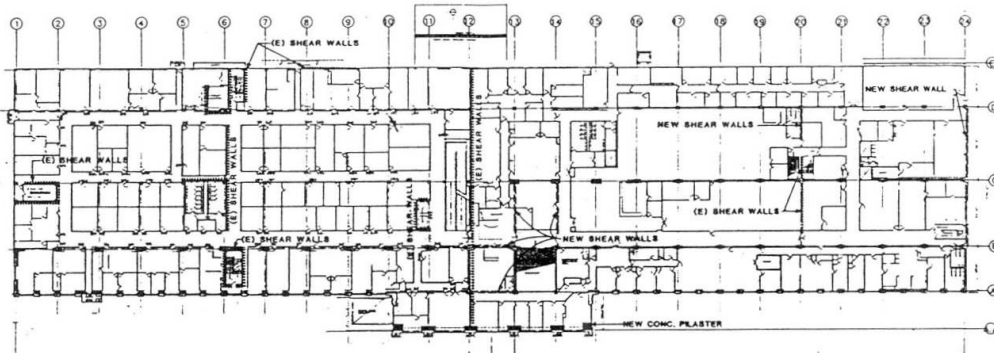
Figure 1. Second Floor of Ferry Building showing existing and recommended locations of shear walls. The tower is between columns 12-13-A-B.

San Francisco's Ferry Building was built in the 1890s at the edge of San Francisco Bay on land fill. The three-story structure is about 200 m by 45 m in plan with reinforced concrete floors supported by structural steel beams and columns. The first floor columns are primarily cast iron. The roof is wood sheathing on light steel trusses and the facade is sandstone backed with brick. A tower rises from the center which is about 10 m square and 55 m high. The tower is framed with structural steel including eyebar diagonal X-bracing. The facade is sheet metal over wood above about 35 m. The foundations are timber piles through about 30 m of soft clays to sand bearing below. Figures 1 and 2 illustrate the building.

Based on a detailed analysis at the beginning of the project, we also recommended adding some additional interior reinforced concrete shear walls beneath the tower and in the south half of the building. This work is also being funded by FEMA as a reasonable measure to reduce damage in future earthquakes. Care is being taken on locating these walls to minimize their impact on the historic fabric remaining on the interior of the building.

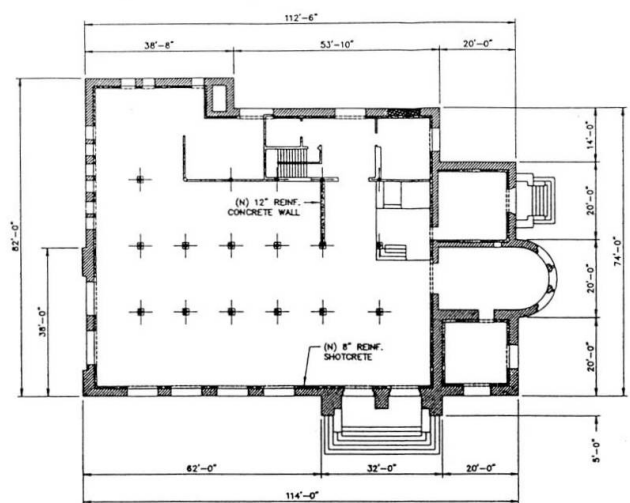
Figure 6. Proposed strengthening of San Jose Museum of Art - First Floor Plan.

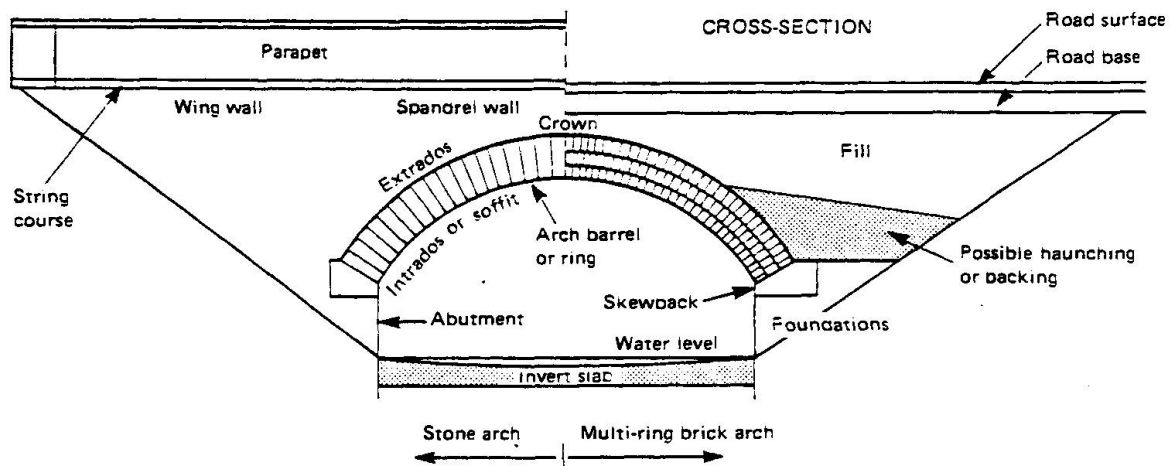
Fig 1 Typical masonry arch bridge construction

Many of them have deteriorated due to the effects of weathering and traffic: some of the traffic they are now required to carry is much heavier than was envisaged when they were built. There are a variety of commonly used repair and strengthening methods used to maintain their function or to increase their load carrying capacity. This paper discusses the common types of deterioration and the effectiveness and cost of some repair and strengthening methods. Typical construction of masonry arch bridges is shown in figure 1.

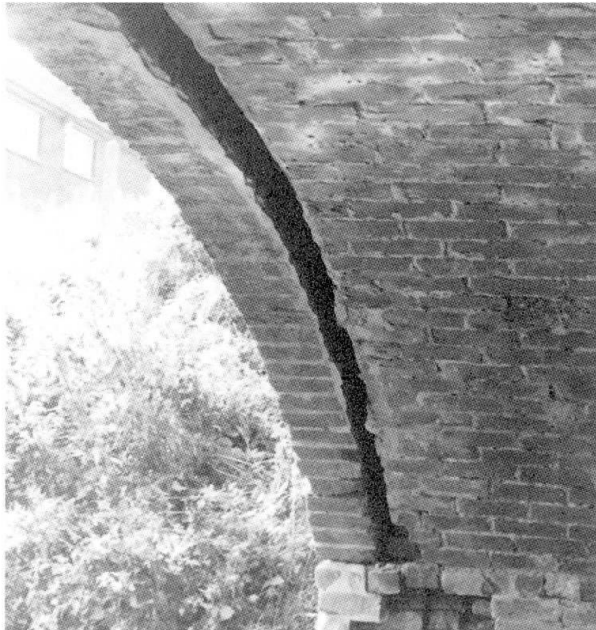
Fig 2 Crack in arch ring

Spandrel walls stiffen the arch ring at its edges. Flexing of the arch ring due to traffic loads will produce shear stresses in the ring where the relatively flexible part with only fill above it is stiffened by the spandrel wall, and these stresses may result in a crack. A severe example of such a crack is shown in figure 2. This type of failure may be assisted by rainwater getting into the structure at the parapet/surface joint and causing particular damage to the arch ring mortar where the spandrel wall meets the ring.

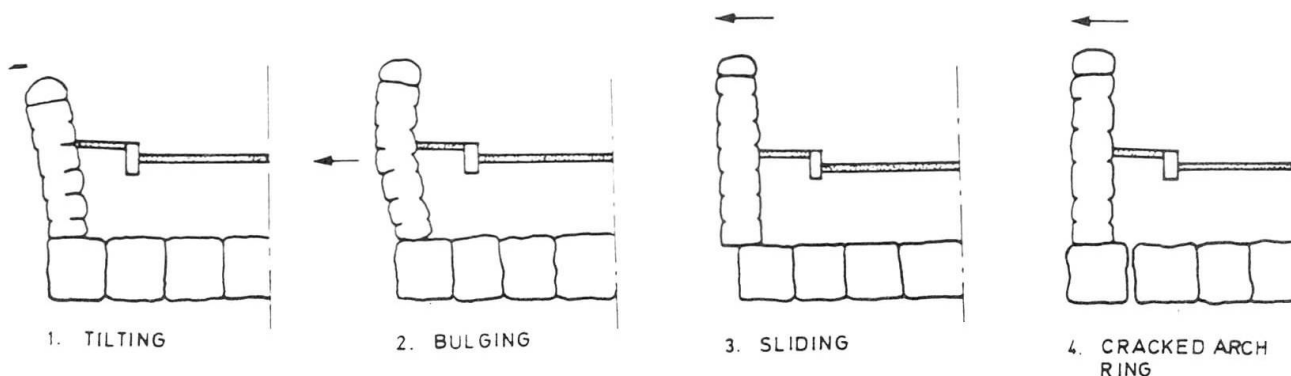
Fig 3 Spandrel wall failures

Spandrel walls probably represent the biggest single problem with masonry arch bridges. They suffer from the normal problems associated with exposed masonry such as weathering and loss of pointing. They are also frequently affected by dead and live load lateral forces generated through the fill or as a result of vehicle impact on the parapet or by freezing of the fill. The effect may be (see figure 3) outward rotation, sliding on the arch ring, cracking of the arch ring, or bulging.

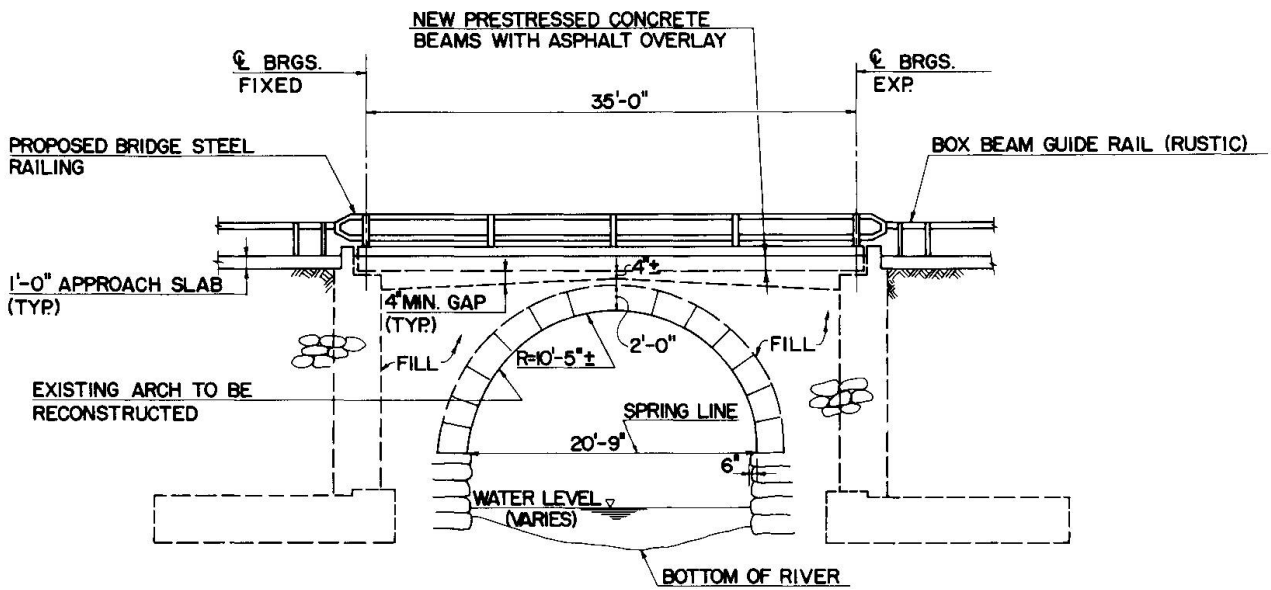
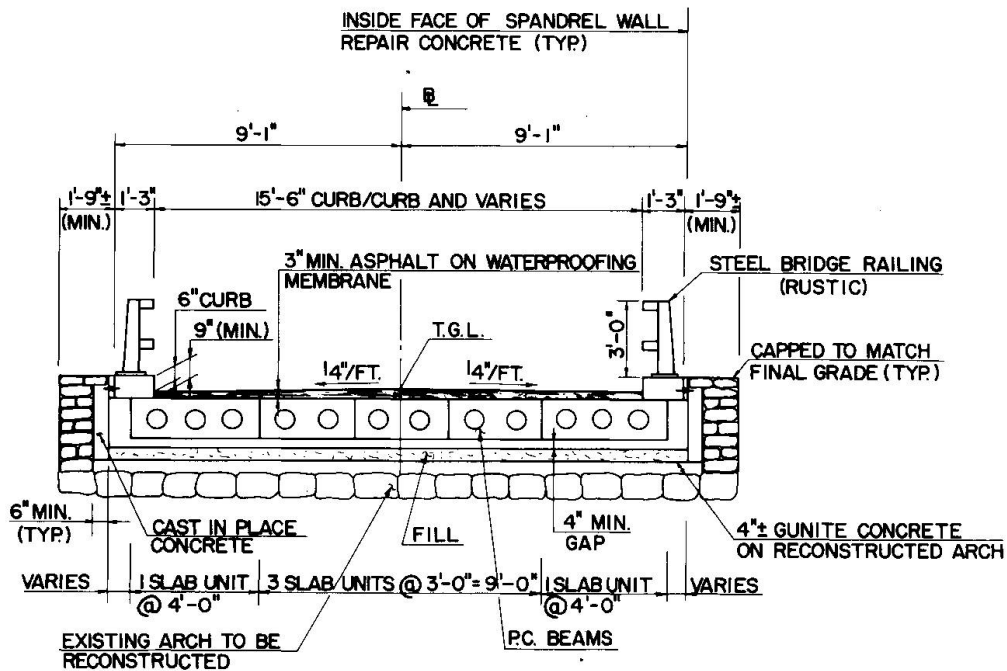
KEELER LANE  
BRIDGE RESTORATION  
NORTH SALEM, N.Y.

**ELEVATION**

**BRIDGE SECTION**

Figure 2. Rehabilitation plans for ca. 1840 Keeler Lane stone arch bridge at North Salem, NY.

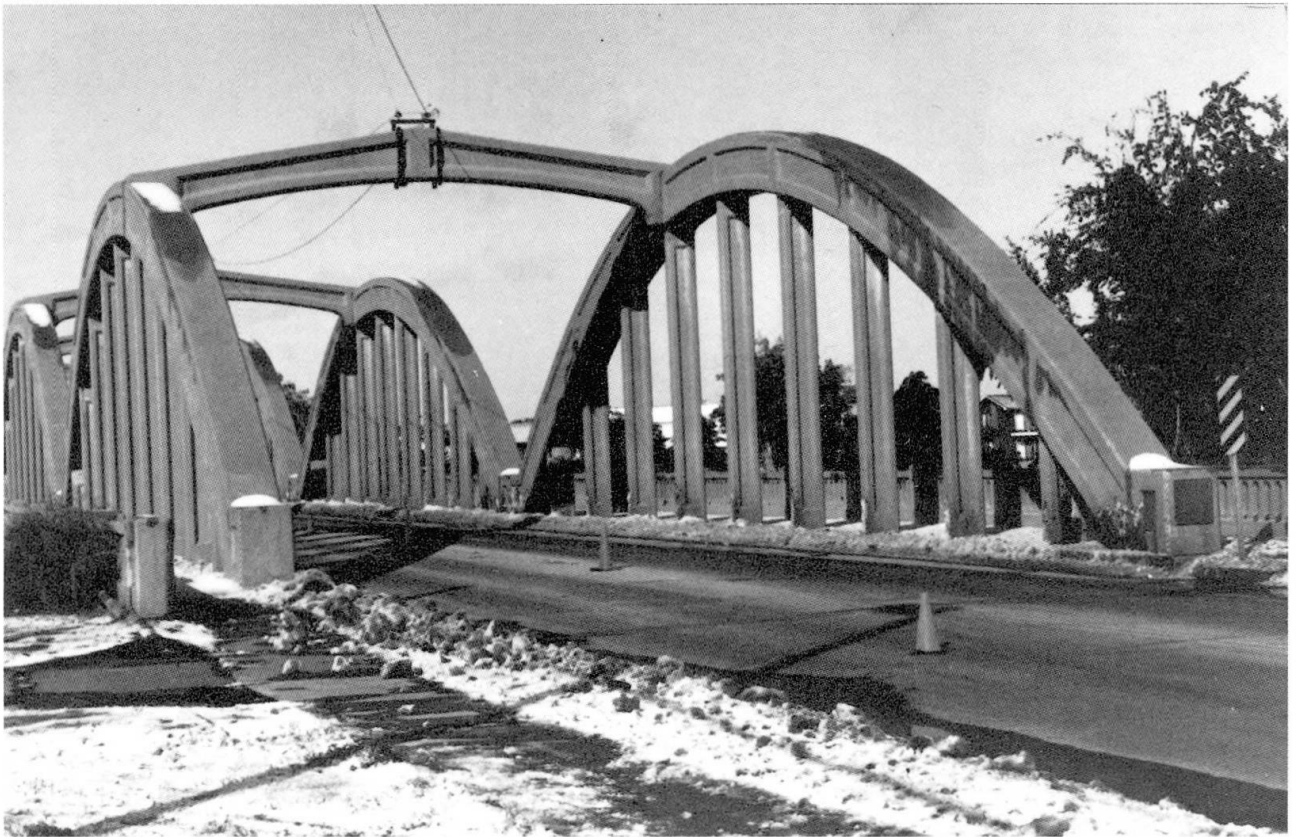
Figure 3. Circa 1930 patented Marsh encased steel through arch span at Wichita, Kansas.

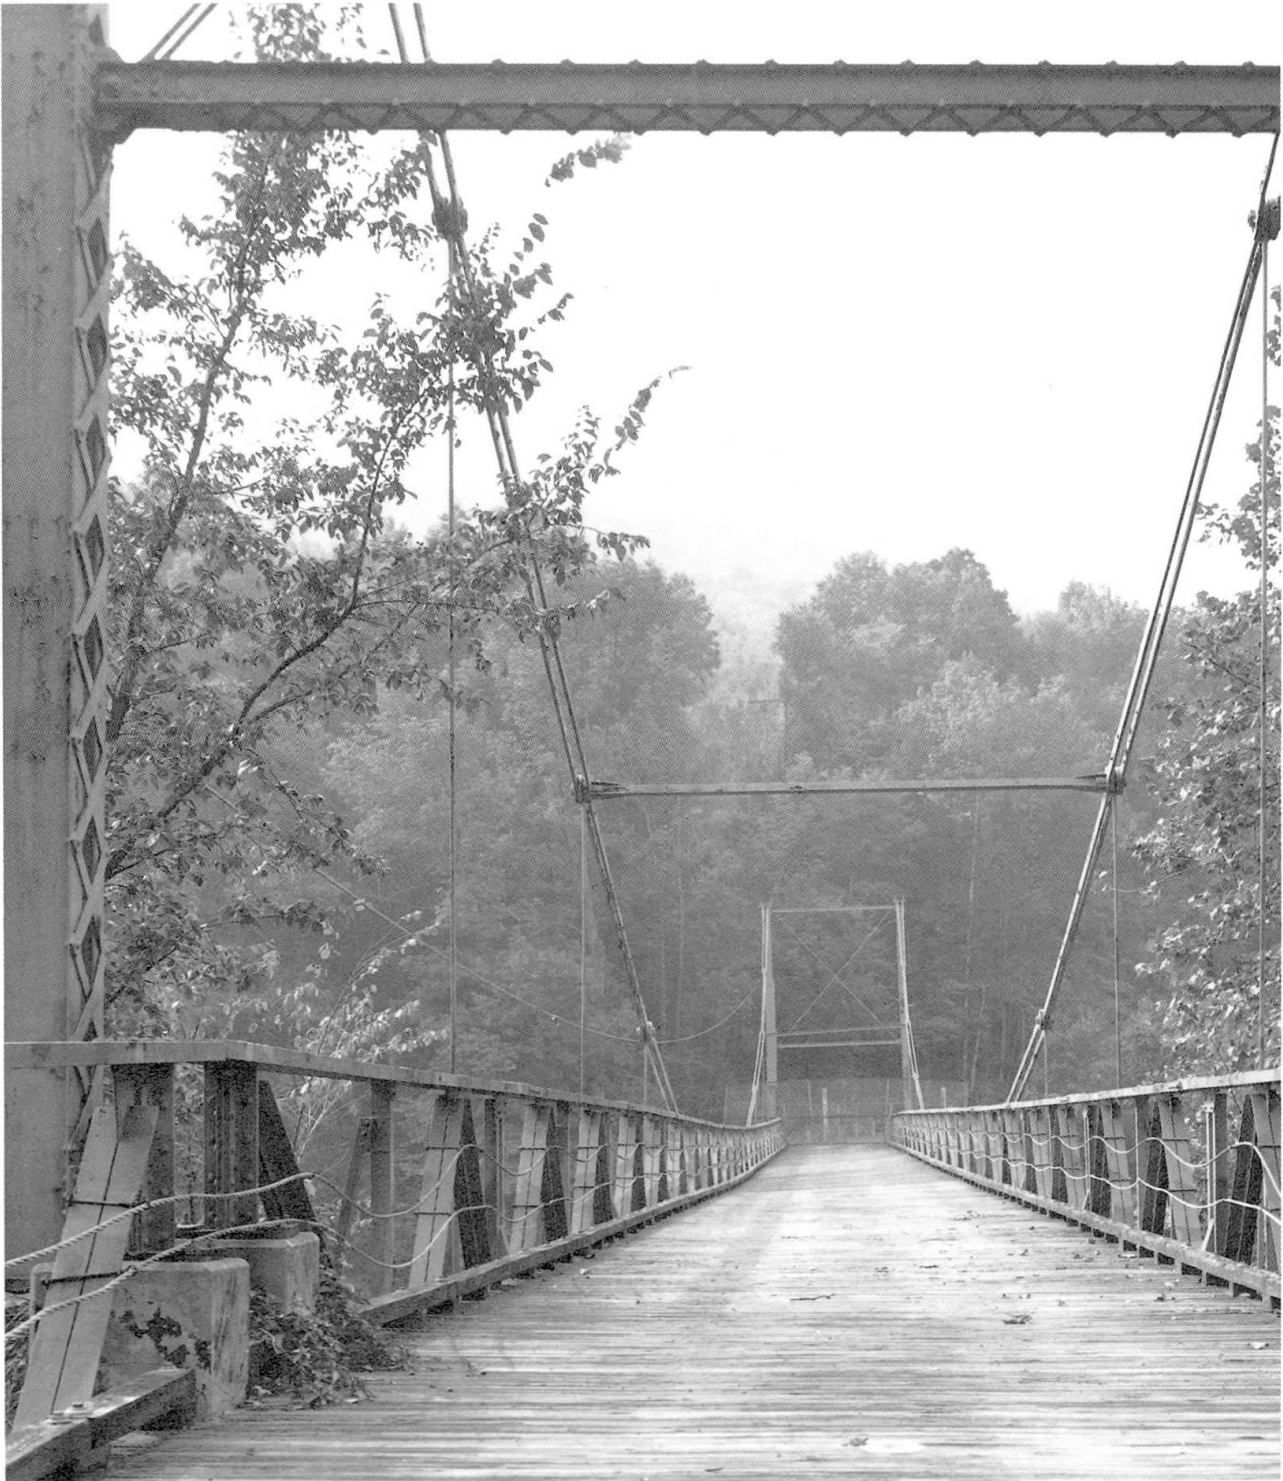
Figure 4. Ca. 1902 eyebar suspension bridge at Lordville, NY that failed and was recorded and demolished in 1986-1987.

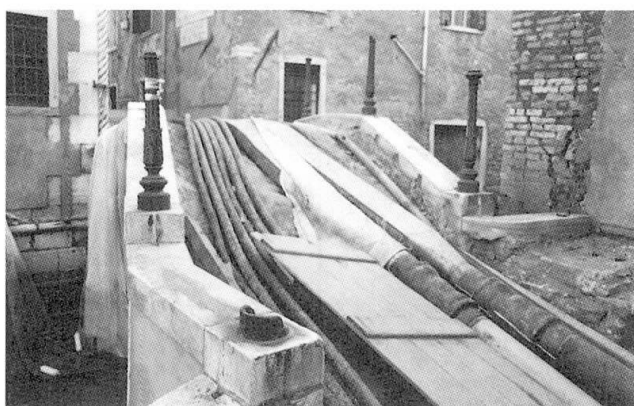
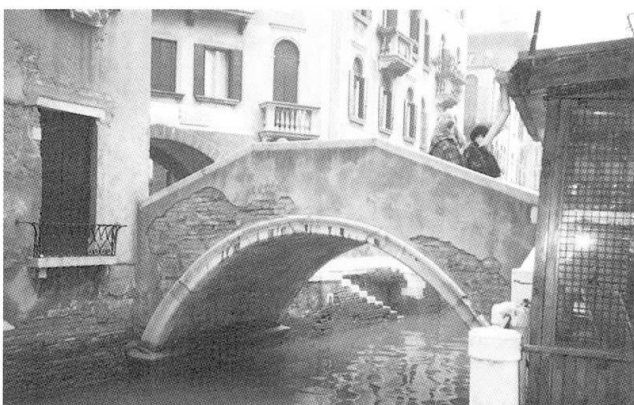
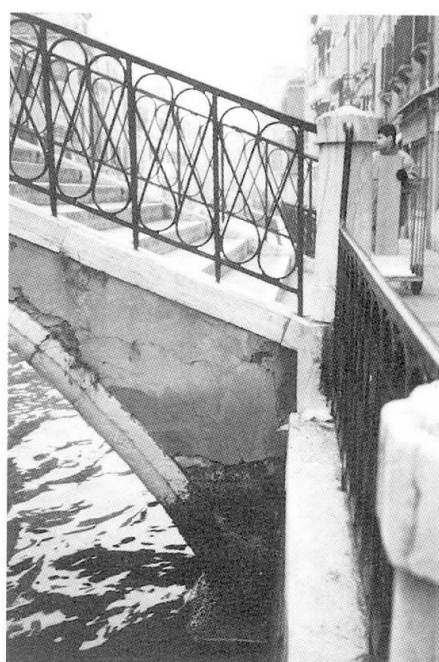
Fig. 1 Services on a bridge.  
Fig. 2 Detachment of plaster.  
Fig. 3 Saline efflorescence.

Early venetian bridges were built in wood, erected on flat piles, low arched and with no steps so that they could be ridden by horses. In the 16th century the town began to thoroughly modify its appearance and the obsolete wooden bridges gave way to the more lasting arched brick bridges. Notwithstanding iron structures, greatly fashionable in the last century, brick bridges represent at present the majority (263). Most of them are in an evident state of physical degrade and lacking adequate and up-to-date census of their real condition. Recent visual inspections showed up a distressing situation, in which the bridges – that still bear on their structural body many pipe-lines (gas, electricity, telephone ...) – present diffused cracks, tiring out of haunches, worn out ties, micro-organisms and saline efflorescences which cause detachment of plaster (Figs 1-3).

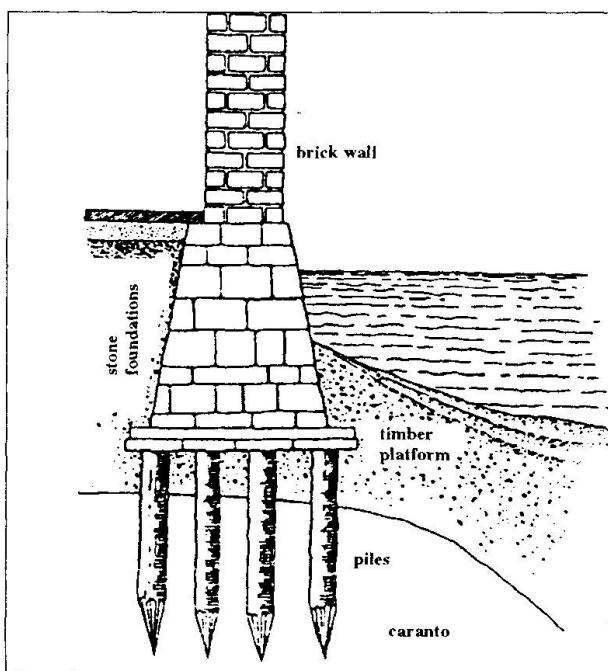
Fig. 4. Venetian building procedure.

The statical behaviour of venetian buildings is based on disconnections and continuities, which allow the highest degree of relative movement among the various components, while assuring stability on the whole structure.

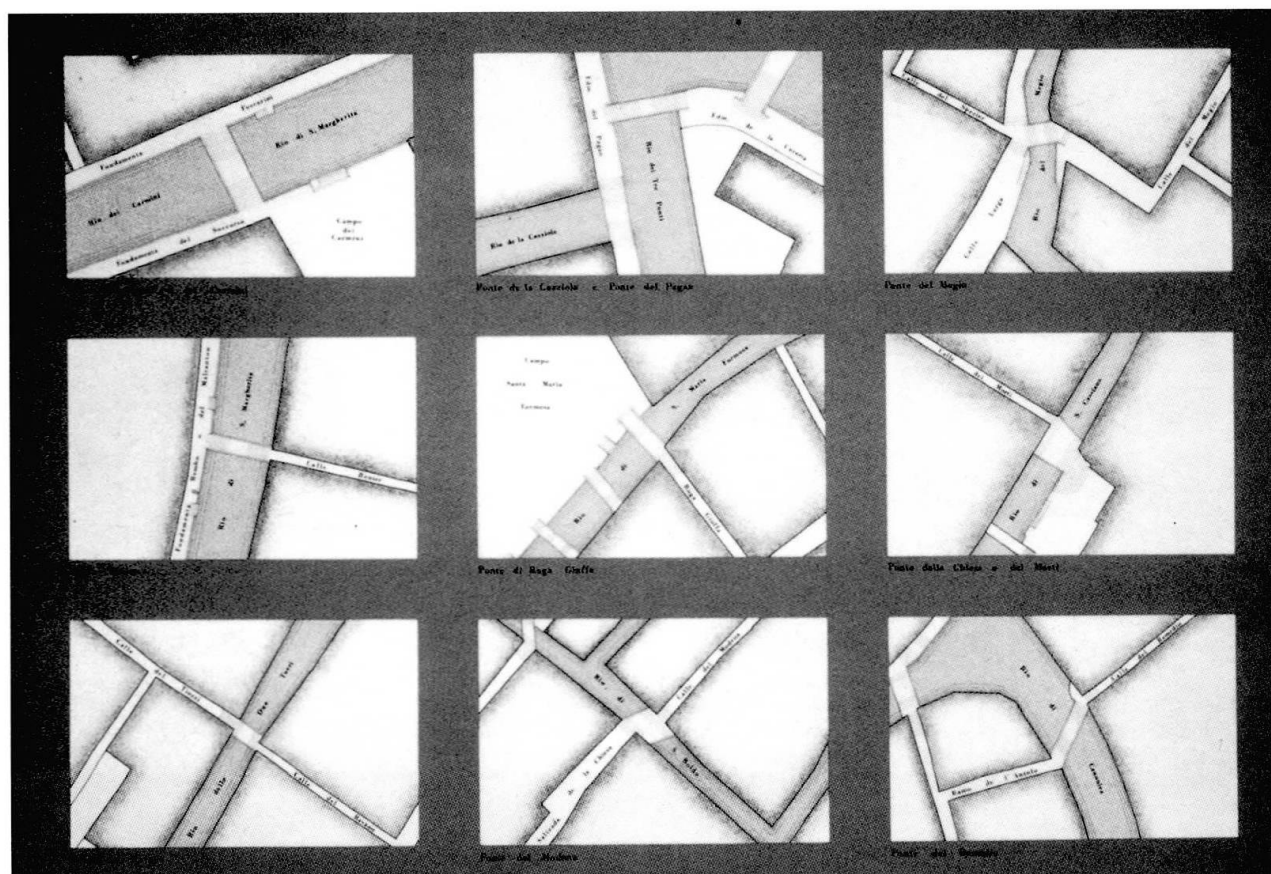
Fig. 5 Example of plan typologies of venetian bridges.

The bridges issued from the “calli” (pathways) and the “calli” are the spontaneous offspring of buildings, regardless of future need of their connection, as both the structure and the shape of many bridges prove. The aim of linking the buildings without altering them has given birth to some utterly unexpected forms: there are twisted bridges that link up “calli” that are not one in front of the other; drawbridges like the one of the Arsenale, which had to leave ships pass; private bridges to enter houses and palaces. Moreover, we can have bridges linking two opposite “fondamente” (pathways running along a canal) or two sides of the same “fondamenta” interrupted by a canal, which can be defined as *regular*, while others are more or less *irregular*, or even “storti” (twisted) as they are named both in the official and popular toponymy. The latter are side bent over the canal or skew to the canal axis because they have to link up two streets leading to the water but not facing each other. Their shape is defined by pre-existing structures, with the scope to meet the needs of contiguous houses.

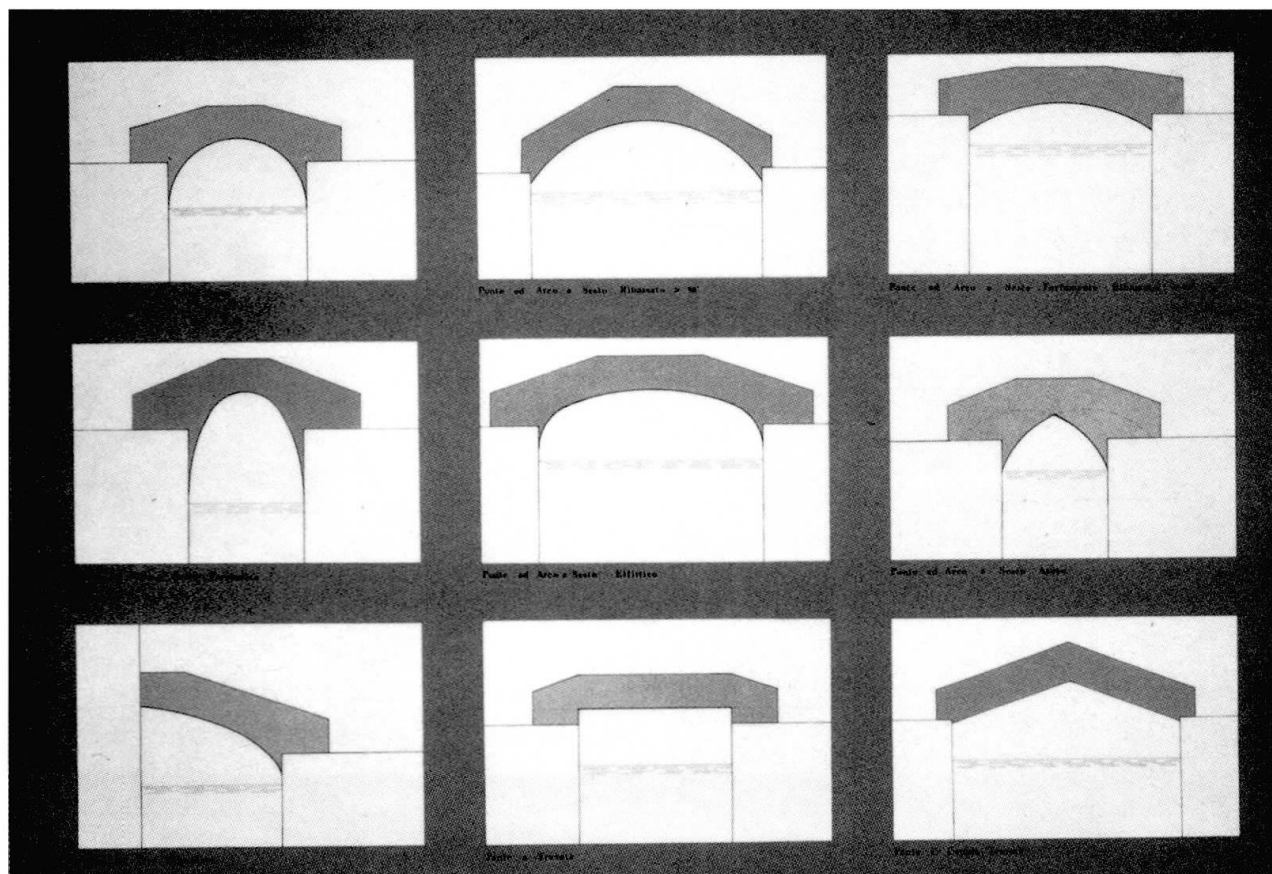
Fig. 6 Schematization of the nine arch typologies of venetian bridges.

The arch of a bridge has to be high enough to let the boats, loaded with goods, pass; with the exception of the three-arched bridge, called ponte Tre Archi on Cannaregio canal, and the mid-arched one at S. Maria del Giglio, all venetian bridges have only one arch, to meet the needs of water traffic. Bridges crossing very narrow canals often have a round arch; in two cases they have an ogive or gothic arch, a shape not easily found in bridge construction.

The half-elliptic and the double girder bridge appear only once (ponte della Feltrina and ponte dell'Arsenale). The arch shape is related to the canal width: in the narrowest canals the use of round, parabolic or ogive arches is preferred, while in the widest canals the depressed arch is more usual (Tab. 1).
