**Zeitschrift:** IABSE reports = Rapports AIPC = IVBH Berichte  
**Band:** 70 (1993)  
**Rubrik:** Keynote lecture

## Compatibilité de la thérapie avec le monument

Appropriate Measures for the Preservation of Monuments

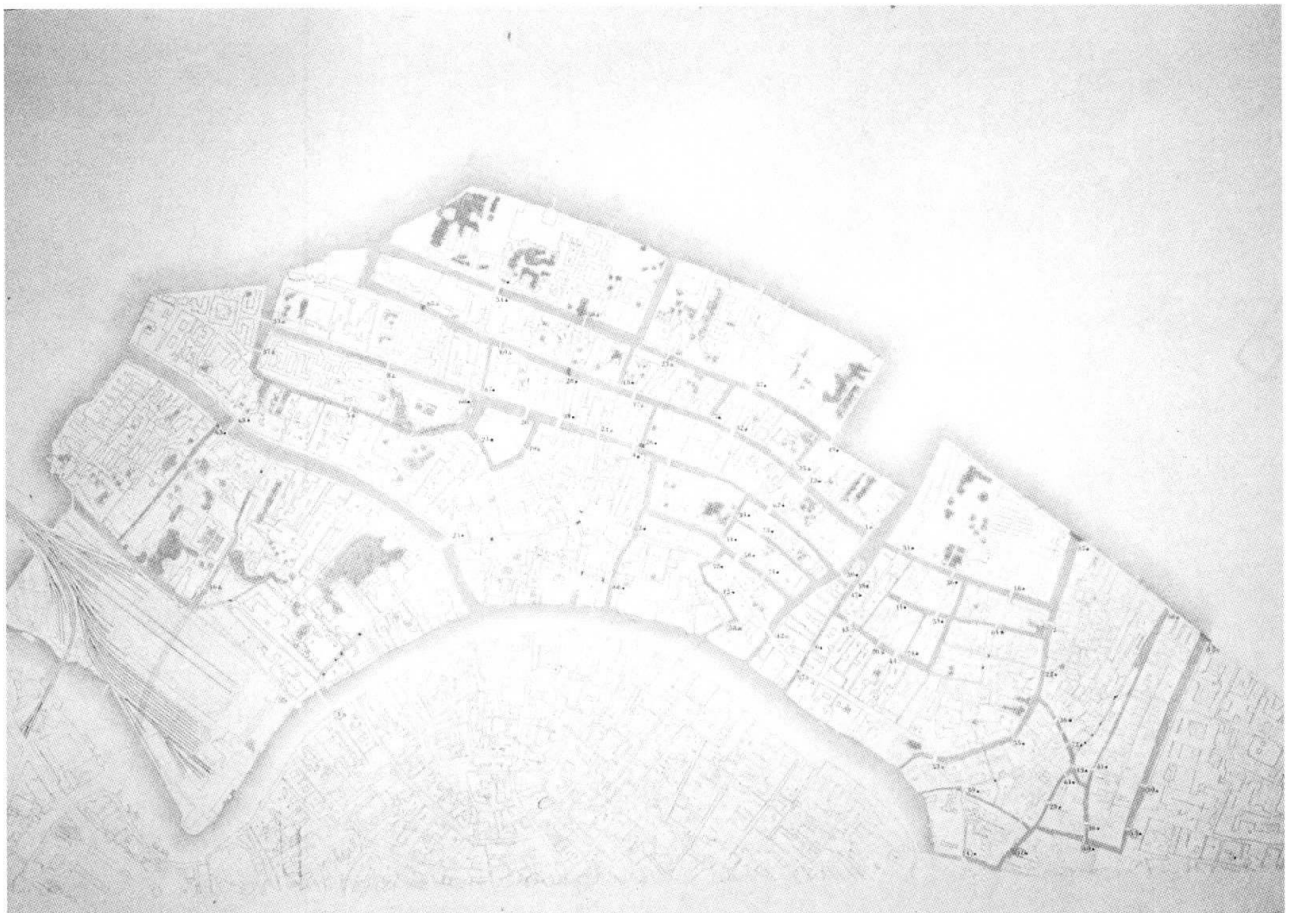
Fig. 7 Example of district map.

Our bridge filing system gives quick information on quantity, type of structure and location. To this purpose we have made use of several instruments, namely: six maps (one for each “sestiere”, as venetian districts are called ) (1:2000 scale), synthetical and analytical tables.

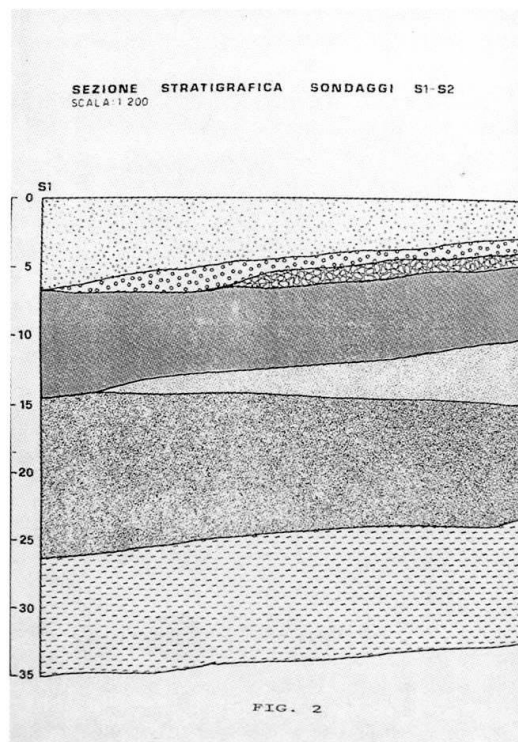
photo 2

The various buildings bear onto a stratum of alluvial sediments from the nearby Tiber river, consisting of a succession of highly compressible strata which have responded and continue to respond to the periodic oscillations of the level of the river. In fact from the geognostic tests carried out (in the course of which 4 "Casagrande"-type piezometers were installed) it was found that the hydraulic pattern of the area is constantly evolving and is directly connected to the variation in level of the river. In the case of the last few years, long periods of intense rain and longer periods of drought have occurred. All this together with the heavy weight of the complex has produced, throughout the history of the building, a series of static failures such as local fractures, distortions and differential settlements, of which cracking is the most highly visible signal.

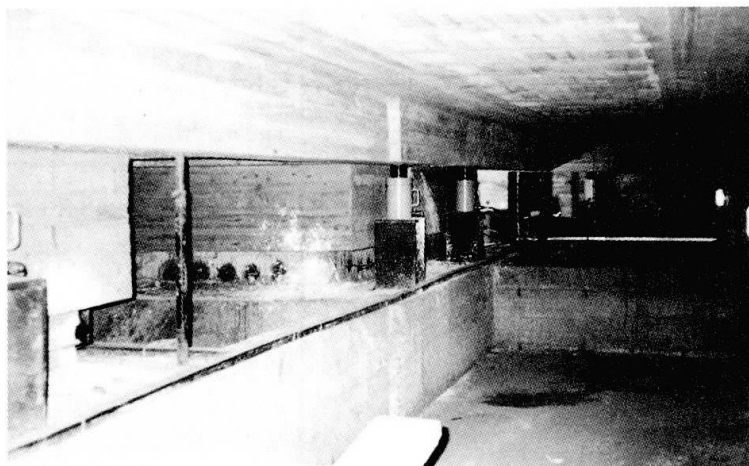
photo 3

This system (photo 3) was carried out using micropiles of diameter 200mm, placed next to the the perimeter load-bearing wall and connected by means of a strong ring beam (0.50 m x 0.80 m) and was loaded by oleodynamic jacks (photos 4-5) which lifted the building, reducing the load to the existing foundations which were also reinforced with a layer of concrete and finally some prestressed Dywidag bars.

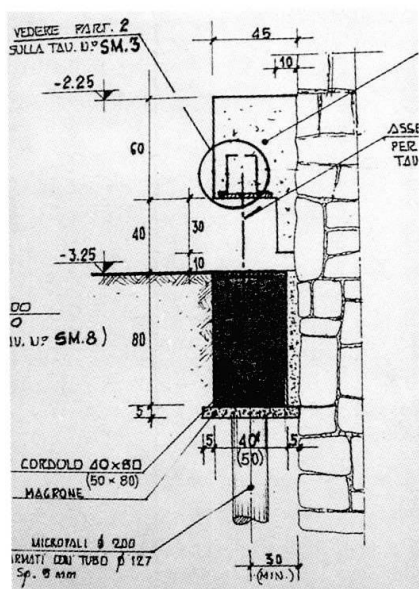
photo 4

Where the reaction of the jacks could have produced highly eccentric forces with consequent tilting moments, a horizontal bracket connected to the

head of the micropiles, was placed in niches made in the wall, so that the load could be received close to the baricentre of the wall.

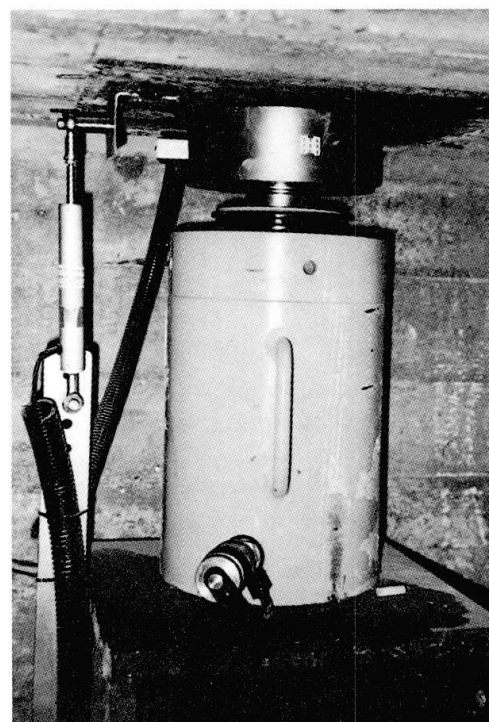
photo 5

In particular, 12 "load sensors" were placed (photo 5) between the piston of the jack and the steel plate set inside the bracket of the old foundation (they gave an indication of the load transmitted by the jacks), 12 displacement sensors capable of indicating the relative displacement between the new and old foundations and 10 deformometers (photo 6) placed on the larger cracks present in the upper levels were used to verify that unforeseen detrimental effects would not occur during the loading

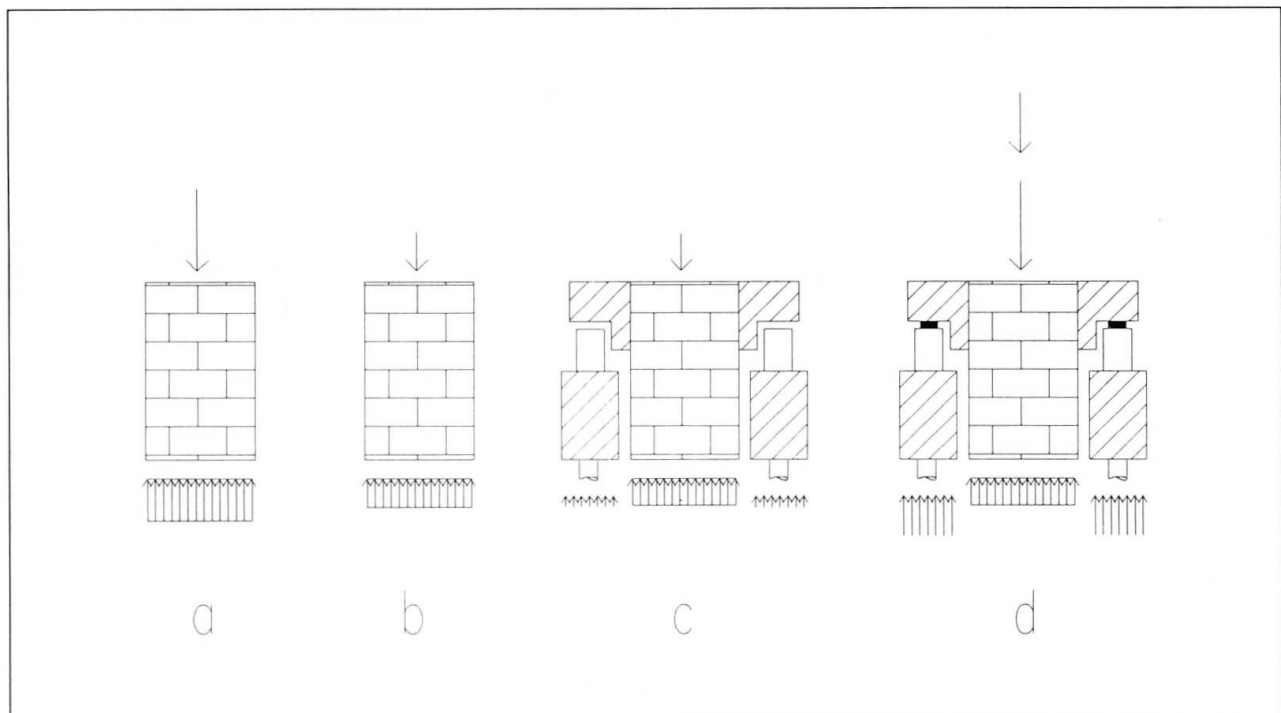
picture 1

The new foundations were loaded in phases. Some phases coincided with the increase in load due to the restructuring works at the various floor levels and therefore with the different phases of the super structure works. Initially, the removal of the fill from the vaults and some floors partially unloaded the existing foundation (picture 1 a,b) , then, as the repair works were carried out, the new foundations began to function by carrying all the new loads themselves (picture 1 c,d).

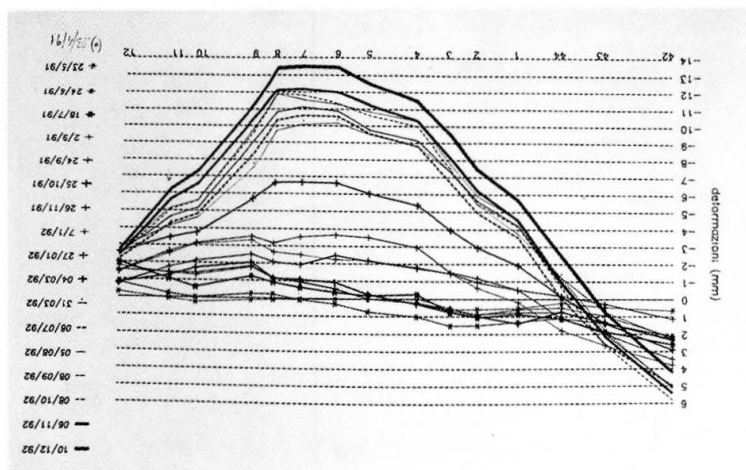
photo 7

The results of the topographical measurements are represented in the diagram (photo 7); they were precisely measured at key positions along the perimeter wall (photo 8) (picture 2), with reference to the façade of the ex-men's prison on Via San Michele. These graphs were made after the first phase of the transfer of loads to the micropiles. In the diagram the development of the settlements in correspondance with the key positions along the façade (each curve represents a measurement), they become closer and therefore the increments in the settlements tend towards zero. This trend clearly indicates that the transmission of the loads to the parallel foundations is very effective. In fact we can observe a participation of the micropiles to the bearing capacity of the existing foundations although they are not called to support the total load.

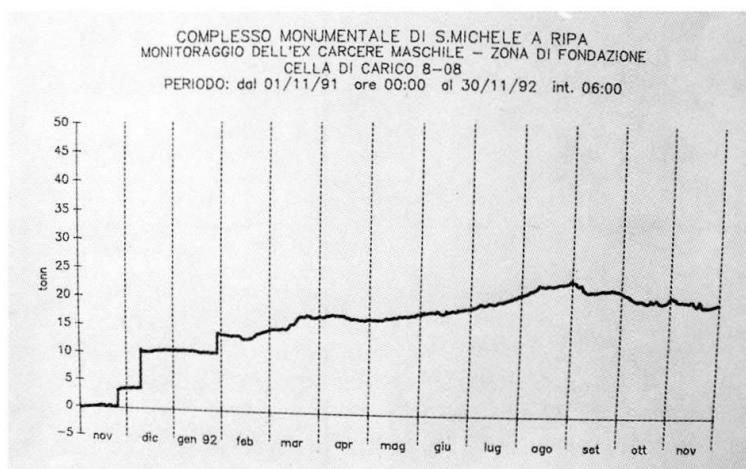
photo 9

This result is confirmed by the diagram of the load sensor which indicates the value of the loads on the foundations in correspondance to the jacks (photo 9). In this diagram the different phases of the load transfer, through the jacks, are evident from the variations of the forces. During the monitoring period it is possible to detect a gradual increase of the pressure in the jacks, corresponding to the trend observed in the adjustment of the settlements of the structures which, together with the sudden variations verified during the loading phases, appear to have a positive drift: the load on the foundation structure increases over time.

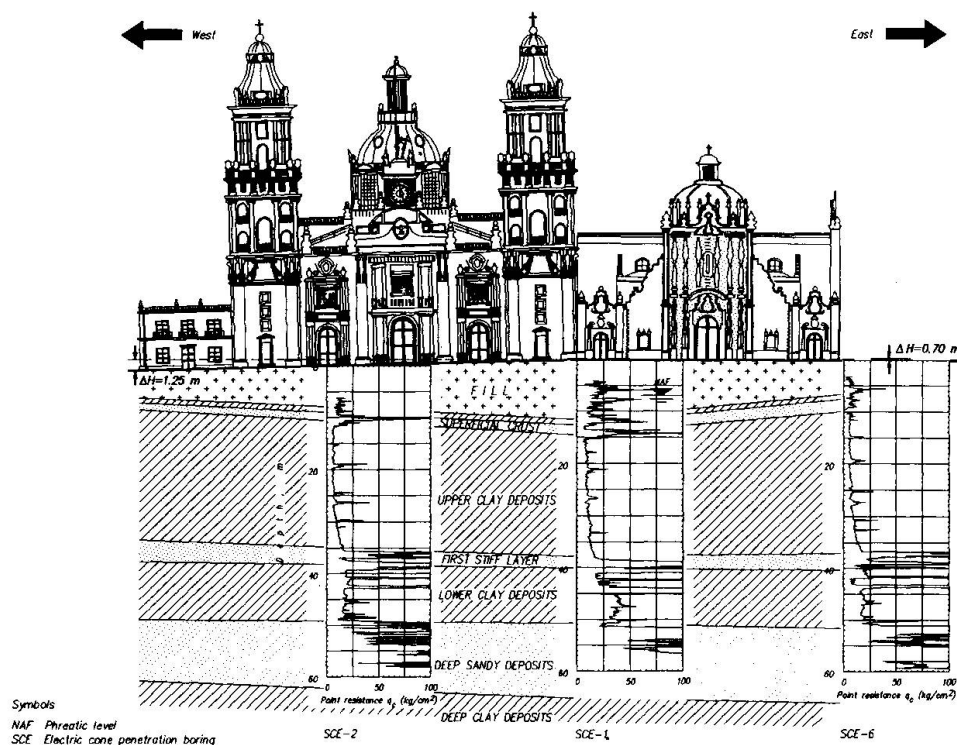
Aztec buildings were also constructed over artificial fills, which consolidated the underlying upper clay strata (fig. 1).

FIG 1 STRATIGRAPHY AT THE SITE AND DIFFERENTIAL SETTLEMENTS AT GROUND LEVEL

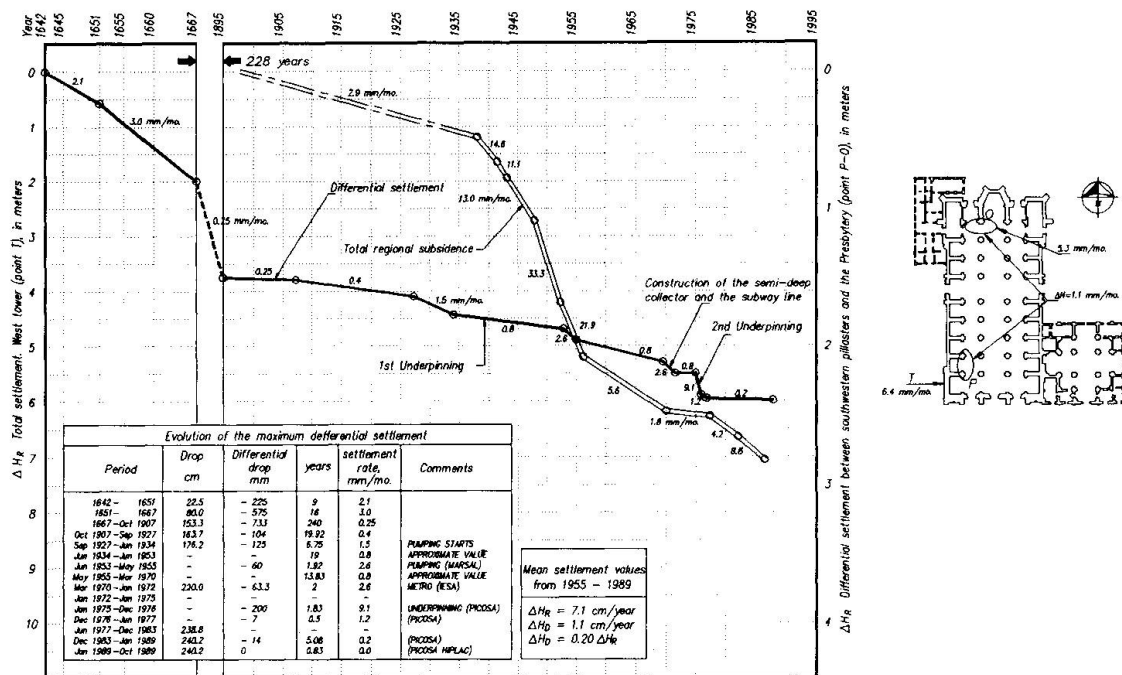
Differential settlements in the Cathedral due to non-homogeneous distribution of compressibilities within the underlying soft clay deposits, accounts for 20 percent of the total differential settlements between the apse and the west tower (fig. 3).

FIG 3 MAXIMUM REGIONAL AND DIFFERENTIAL SETTLEMENTS

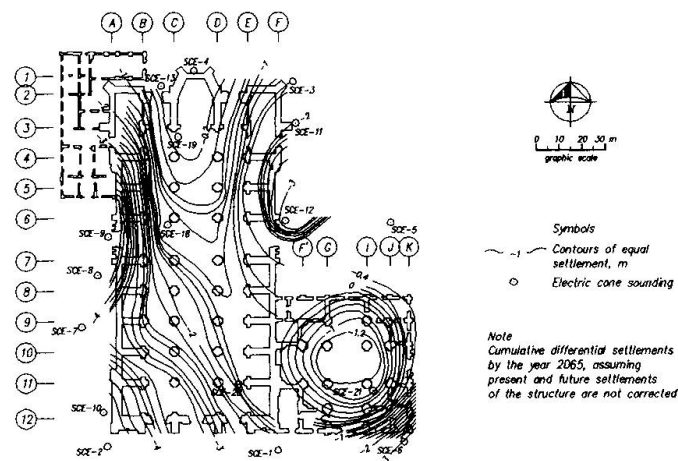
Average total regional settlement in the lake zone is 7.50 m since the turn of this century, which will roughly double in the next 75 years, according to analyses made on the basis of compressibilities determined from undisturbed samples. Future regional subsidence will give rise to more differential settlements in the Cathedral. Predictions of settlement over the periods of 1990 to 2010 and 1990 to 2065 have been clearly plotted (fig. 4).

Towards 2010, differential settlements between the apse and the west tower will be 3 m; between the apse and the east tower, 1.6 m and between the central line and the corners of El Sagrario, 0.7 m. In 2065, settlements in the same points will increase to 4.4 m, 2.0 m and 4.2 m respectively. Clearly, these buildings would collapse between 2010 and 2030, if remedial actions are not taken to improve the behavior of their foundations. These structures have satisfactorily resisted many earthquakes through the centuries, but this situation might change as progressive settlements and distortions will implacably increase their seismic vulnerability.

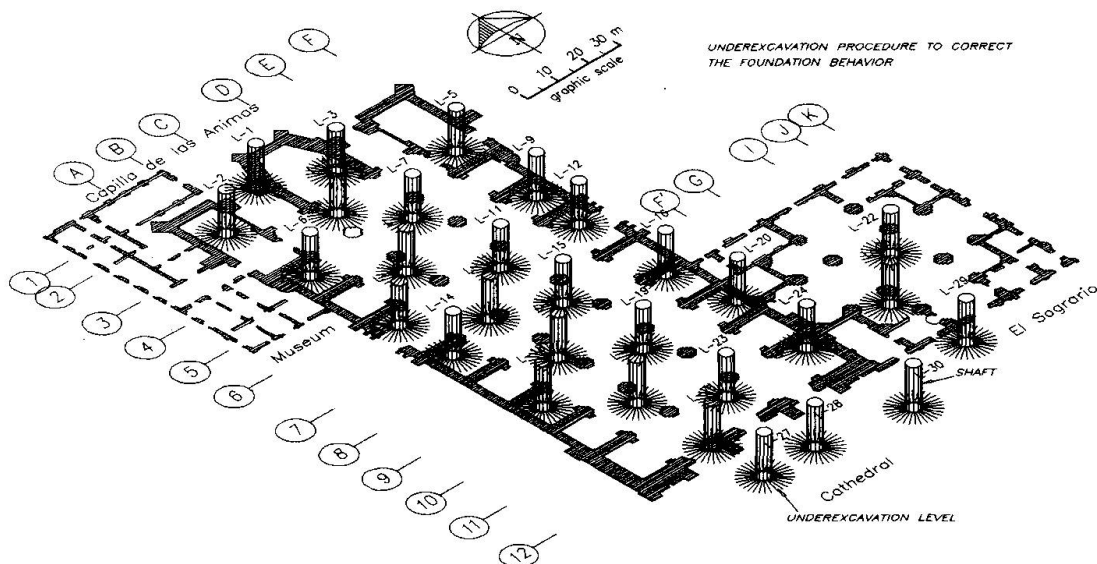
This procedure started to be implemented in 1991 and some of its results can now be seen, as the construction of shafts (fig. 5) and the effect of continuously pumping water have modified deformation trends by reducing the magnitude of differential settlements and stopping the tilting of lateral naves and their external walls. Future work will result in reversing the movements of naves and walls; columns and walls will also rotate until conditions existing in 1934 can be restored. The project does not intend to straighten the building completely.

FIG 5 SHAFT AND RADIAL UNDEREXCAVATION BORINGS LOCATION

Briefly stated, the underexcavation method consists of removing soil by means of horizontal borings drilled from a large diameter vertical shaft; excavation is carried out below the foundation level, preferably within the plastic clays. The volume of soil excavated gives rise to controlled settlements whose velocity can be adjusted at will. Selective excavation allows the correction of distortions in the platform and the superstructure. Analytical tools for predicting the effects of underexcavation derive from plasticity based methods, commonly used in tunneling. Perforation of a hole within the soil mass produces displacements; if the hole collapses and a new one is drilled, surface settlements will increase. Successive drilling and underexcavation will eventually cause the required amount of corrective settlement.

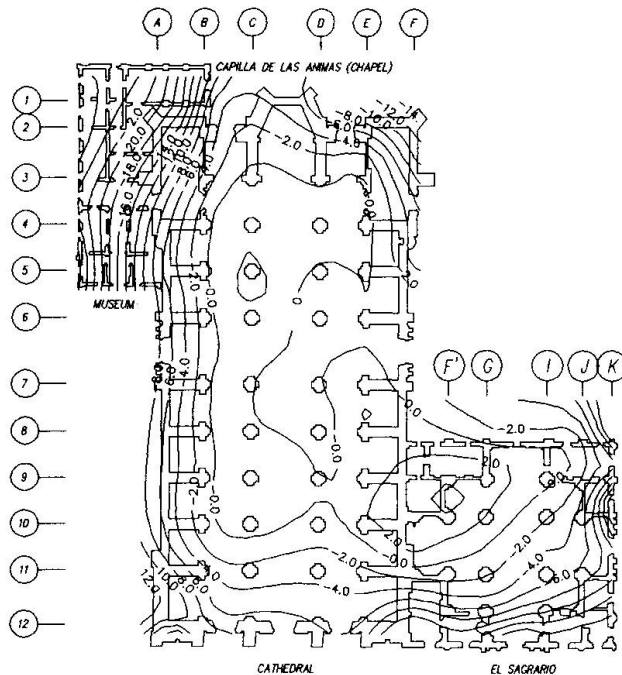
FIG 6A CONTOURS OF EQUAL SETTLEMENT RATE, IN mm/year; MEASUREMENTS FROM JAN 7, 1991 (N20) TO SEPT 2, 1991 (N28)

Figures 6A and B shows annual rate of settlement contours for the Cathedral and the Sagrario before and after the construction of the shafts. Clearly, the effect has been definitely beneficial for the condition of both structures in terms of the floor level configuration. Also, no significant damage to the structures ensued as a consequence of these movements. Up today the main driving factor for achieving this is, the selective operation of dewatering system for the excavations of the shafts.

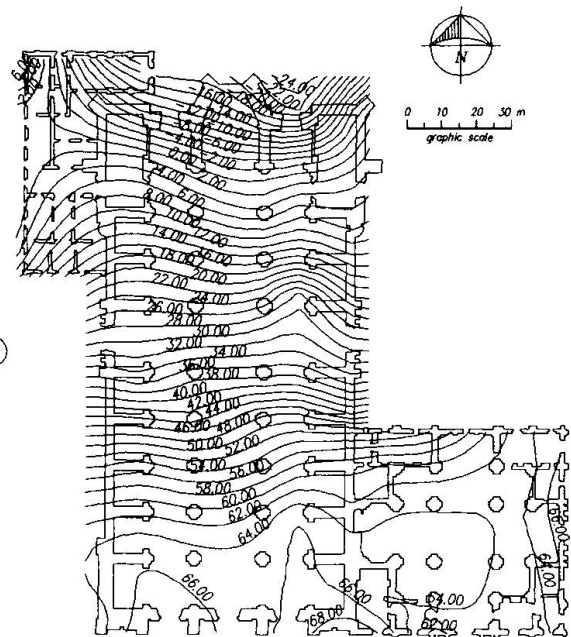
FIG 6B CONTOURS OF EQUAL SETTLEMENT RATE, IN mm/year; MEASUREMENTS FROM OCT 25, 1991 (N-10) TO OCT 26, 1992 (N-25a)

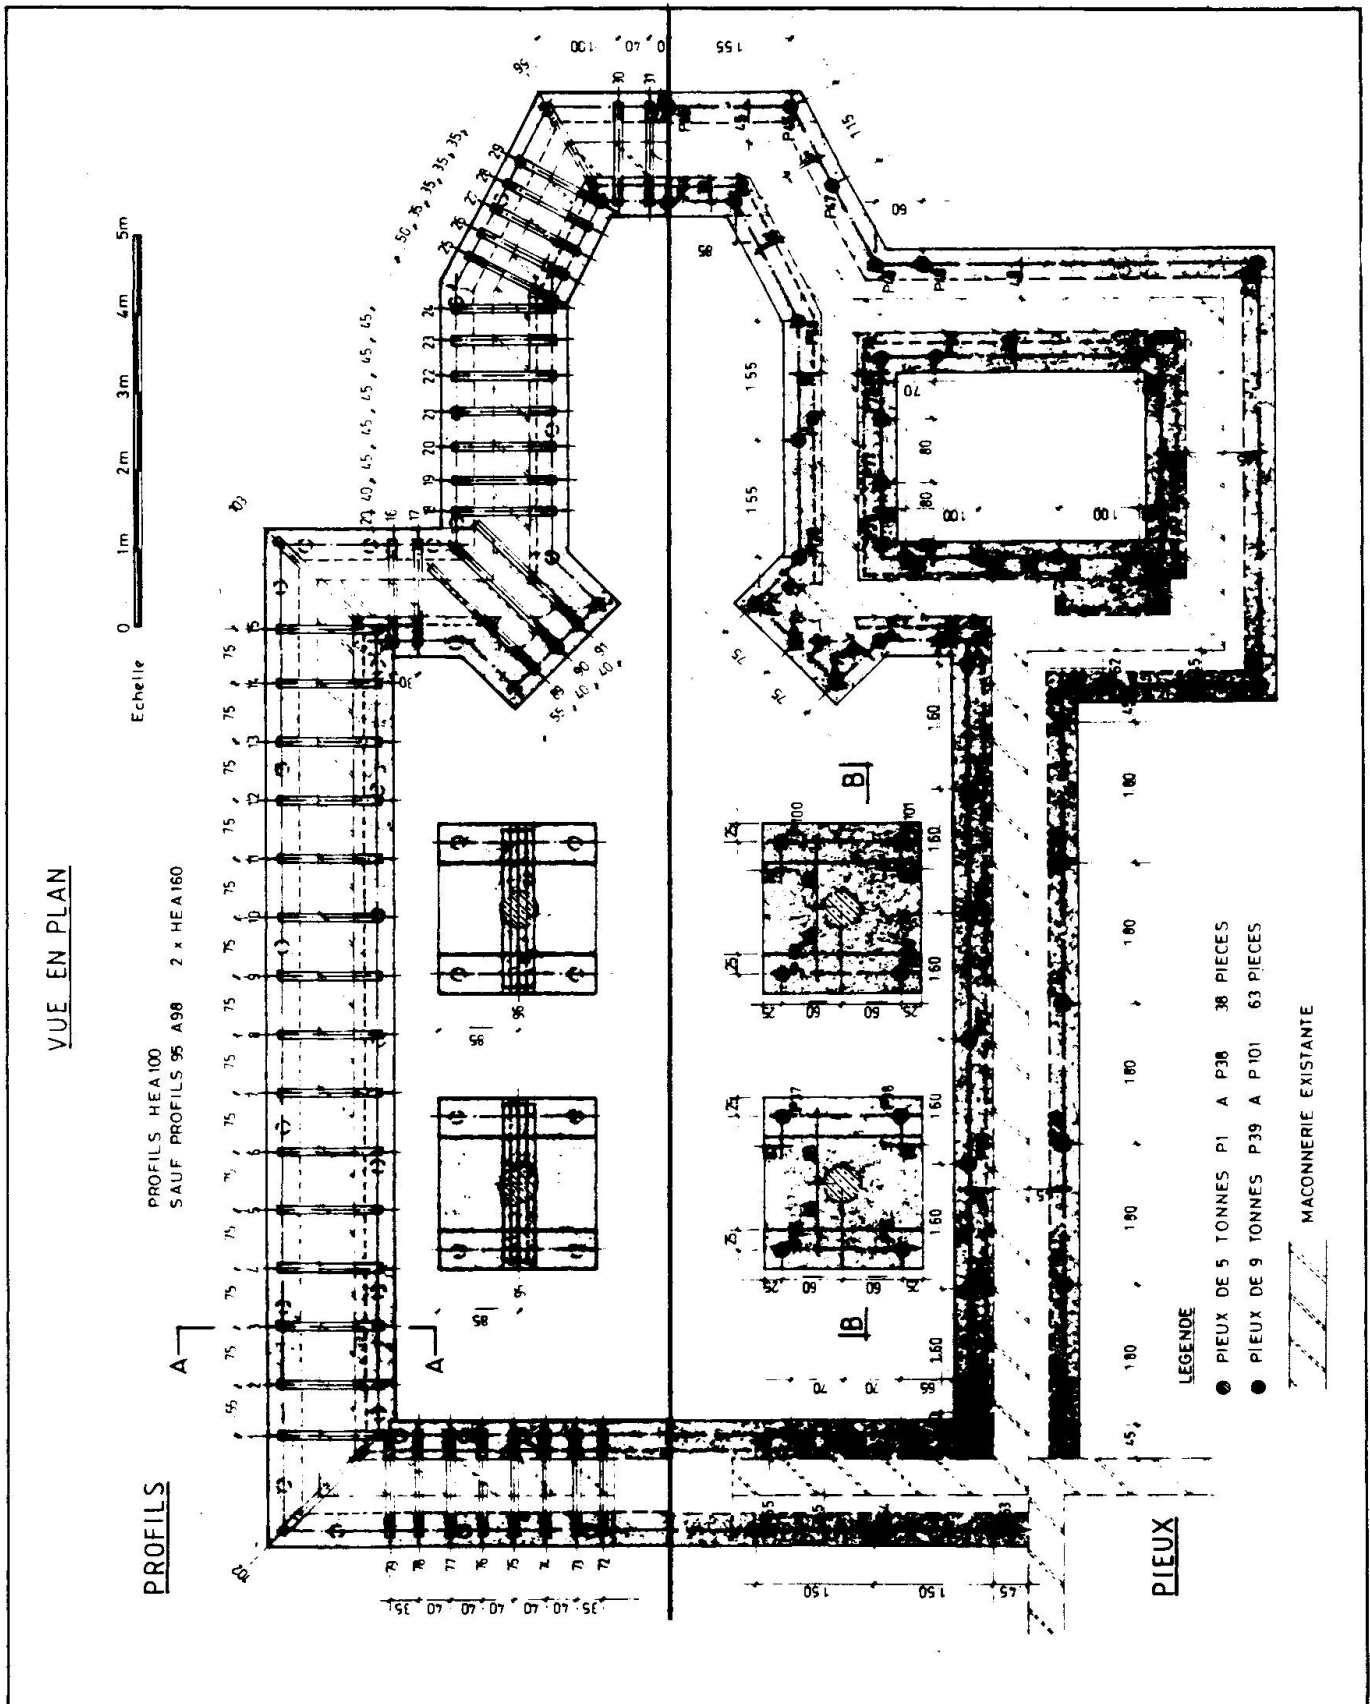
Fig. 3

En fonction de la localisation et de l'intensité des charges à reprendre, l'ingénieur-conseil a prévu des pieux de 50 et 90 kN de capacité portante.

Les pieux présentaient un diamètre de 0,15 m et une barre d'armature centrale de type GEWI.

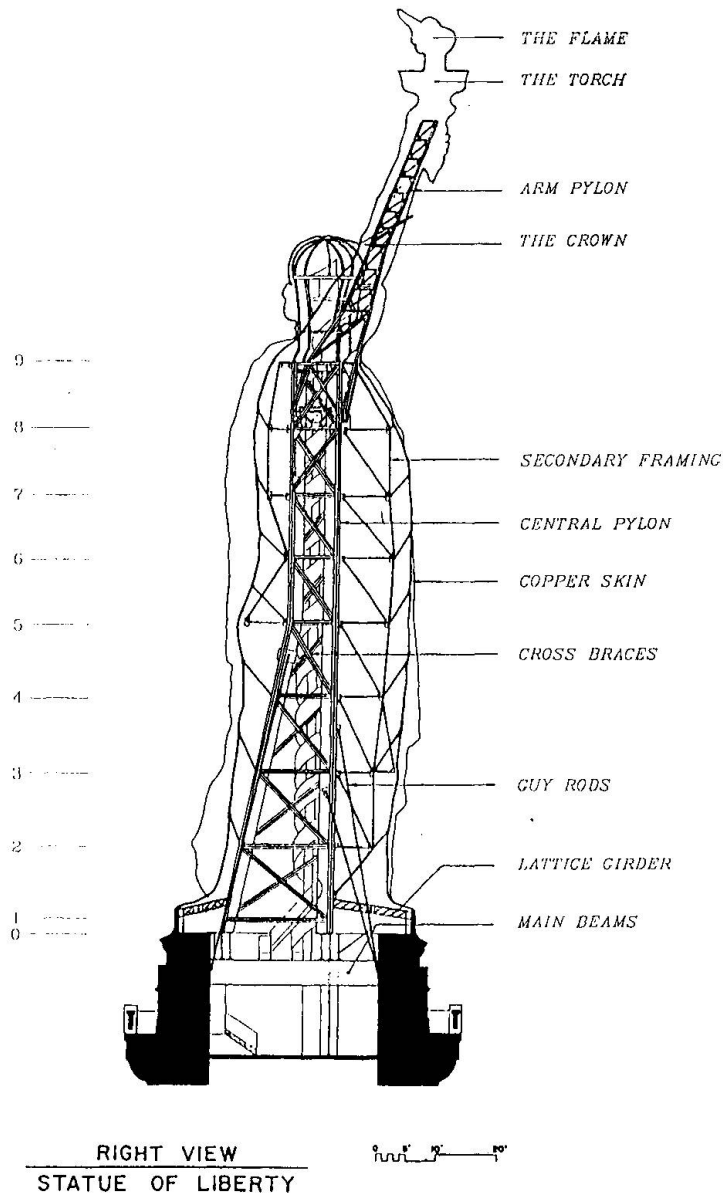
**Fig. 1** The Structure of the Statue

Earlier monumental works in copper repoussé (the technique of hammering copper sheets in relief) supported on an iron armature was stabilized by mass masonry on the interior. An example of this is the colossal statue of St. Charles Borromeo constructed near Arona, Italy, in 1697.

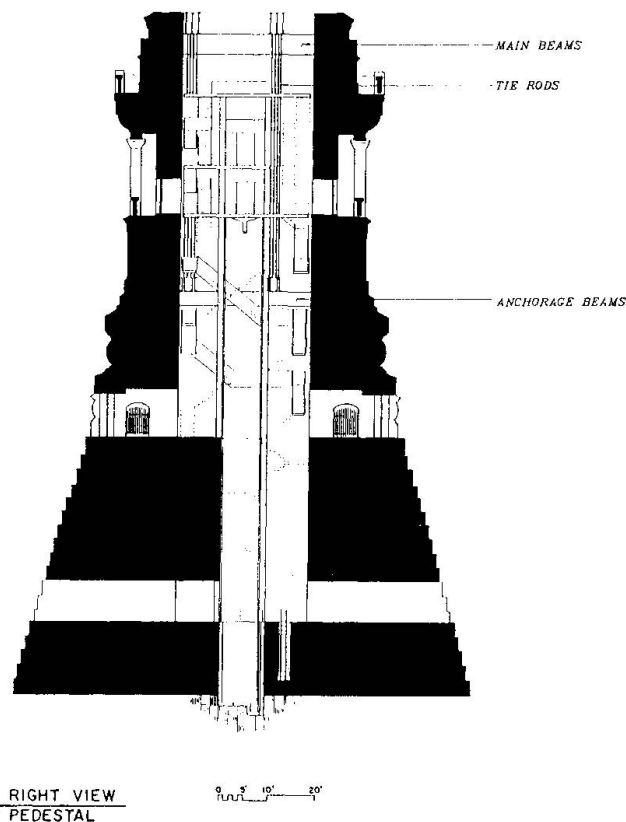
*Fig. 2 Foundation, Pedestal and Anchorage*

helped to identify two potential problems: weakness in the right shoulder and looseness of the anchorage of the Statue. The accelerometer measurements were taken to verify the results of the dynamic analyses in terms of the dynamic response of the Statue to wind, i.e., frequencies, accelerations and displacements. These measurements were correlated with wind measurements taken from an anemometer mounted on the torch platform.

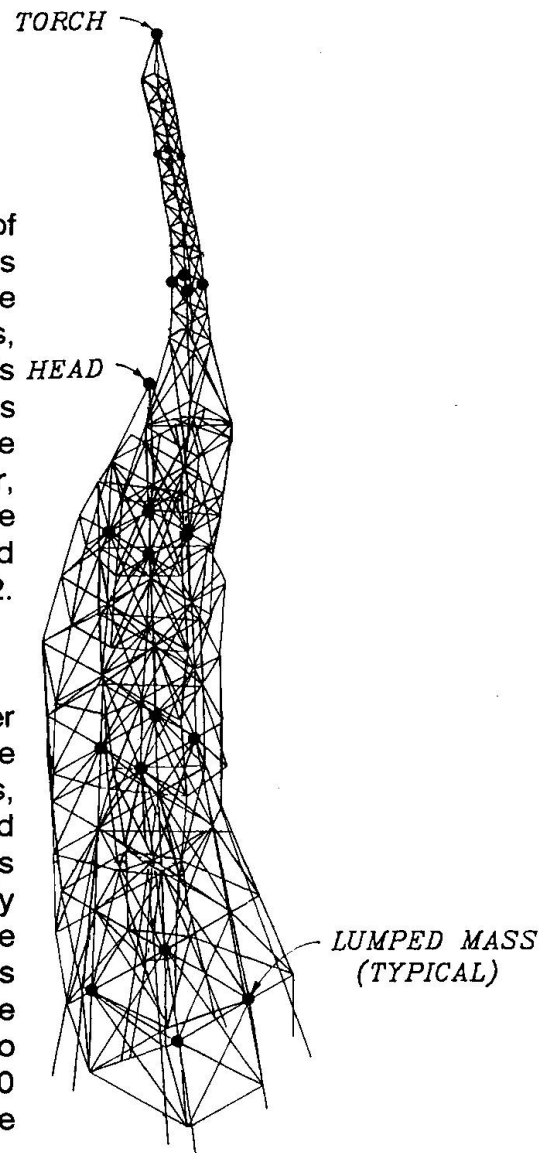
Fig. 3 Finite Element Model

The main pylon of the Statue, including the shoulder and the arm framing, was modelled as a three dimensional space truss. The geometric properties, including member sizes and makeup, were obtained largely from field reconnaissance surveys. Any stiffness contributed by the copper skin was conservatively omitted from the model; however, the influence of the "secondary" framework, which transfers the reactions from the skin to the main pylon, was included. The results of the dynamic analysis show that the two lowest modes, having frequencies of 1.66 hz and 1.90 hz, contribute over 95 percent to the response of the Statue under wind loads.

### 3.2 Finite Element Model (Fig. 3)

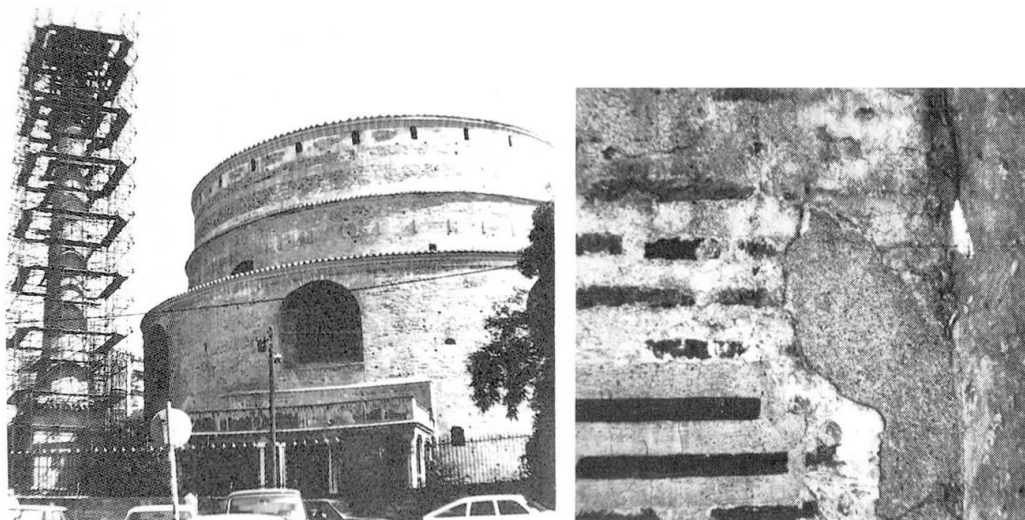
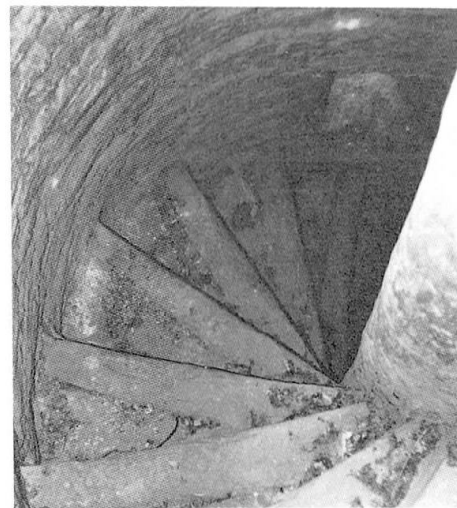
**Fig.1**

(a) Rotunda-Minareret: Southern view. (b) Masonry close-up: Merely visible horizontal crack. (c) Internal staircase. (d) Balcony and upper cylindrical part

The Minaret is located at a distance of 3.50m western of Rotunda (see Fig.1a). It consists of a 4.50x4.50m square cross-sectioned base, 7.50m in height and is founded on a thick stiff red clay layer approximately 6.00m below the ground level. The base is supporting the trunk of the Minaret consisting of two successive twenty-sided truncated conical parts of 22.00m total height crowned by the muezzin's balcony and the highest fifteen-sided cylindrical part 6.00m in height (see Fig.2). The external diameter of the trunk decreases gradually from 3.25m to 2.10m and finally to 1.75m at the highest cylindrical part. The narrow entrance (0.85x1.95m) is located at the northern face of the base. The internal helical staircase with gradually decreasing diameter ( $D=1.80-1.45m$ ) leads up to the balcony at a height of 29.50m. The small muezzin's doorway (0.50x1.50m) is located at the southern face of the cylindrical trunk penetrated till the top by the narrow staircase ( $D=1.35m$ ). Five narrow loopholes are located along the height of the southern side of the trunk.

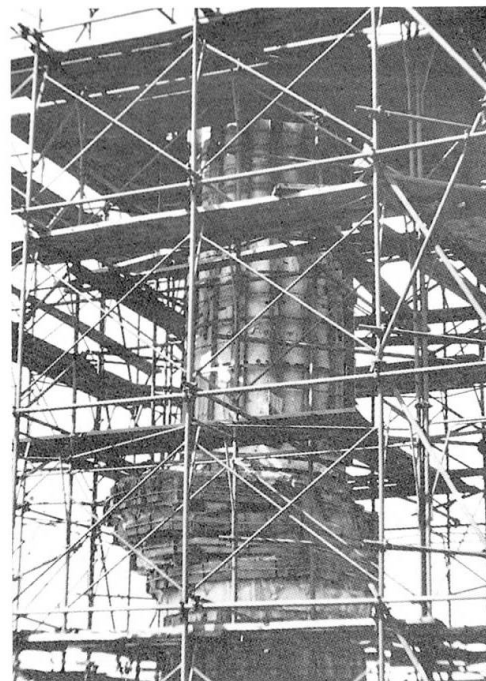
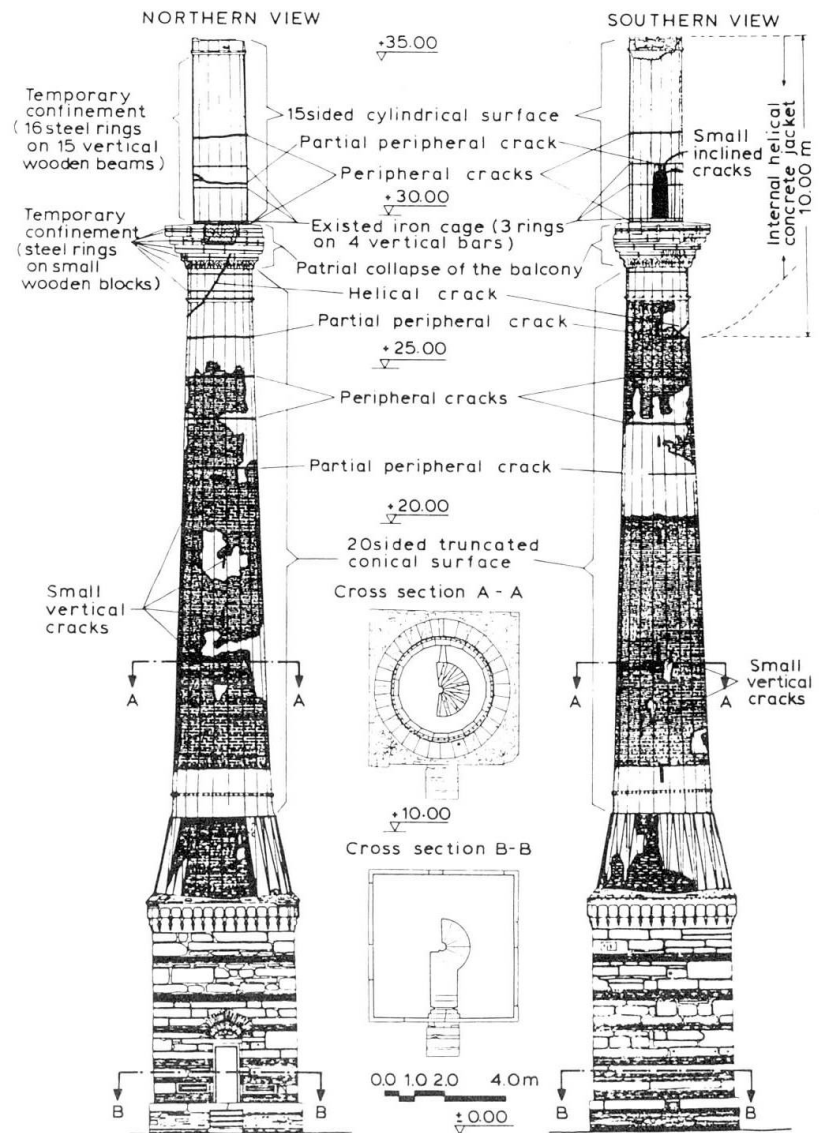
**Fig.2** Northern and Southern elevations of the Minaret. Cracking pattern, external emergency interventions

As it can be easily seen in Fig.2, the base of the Minaret is unplastered. The plaster covering has been collapsed at the major part of the trunk, while at the rest of the surface, as well as at the upper cylindrical trunk, it is heavily cracked. Limited superficial deterioration of masonry, especially at the northern face of the trunk has been detected and confirmed by the hammer tests. The wooden beams at the highest steps of the staircase have been heavily corroded due to rain water passing through the open top, as the wooden acute conical roof of the Minaret fall down, probably during an earthquake, at the beginning of the

present century. Successive horizontal peripheral cracks have been ascertained at the upper two fifths of the Minaret and have been drawn in Fig.2. There is one helical crack starting from the highest loophole, following the ascending steps and cutting the balcony. All the cracks, being under vertical compression, are just visible (see Fig.1b). During the earthquake of June 20,1978 (epicenter 30km from Thessaloniki, magnitude 6.5 grades in Richter scale) a part of the balcony collapsed and the upper half of the cylindrical trunk was slightly translocated (see Fig.1d,2). It must be pointed out that, despite of the damages, no permanent horizontal drift of the structure has been ascertained and no foundation problem has been detected.

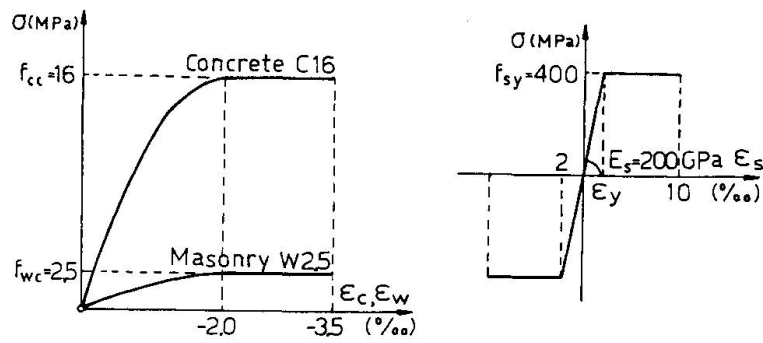
**Fig.3** Idealized stress-strain curves for masonry and intervention materials (Concrete, Steel)

Significant difference in the composition of mortars between the highest cylindrical part and the rest of the Minaret below the balcony has been found out, although the compressive strengths of the mortars were almost equal. Consequently, either the Minaret had been erected in two phases, or the part over the balcony had probably been collapsed and rebuilt. In Fig.3 the idealized masonry stress-strain curve adopted for the analyses and the stress-strain curves of concrete and steel for the strengthening interventions are shown.

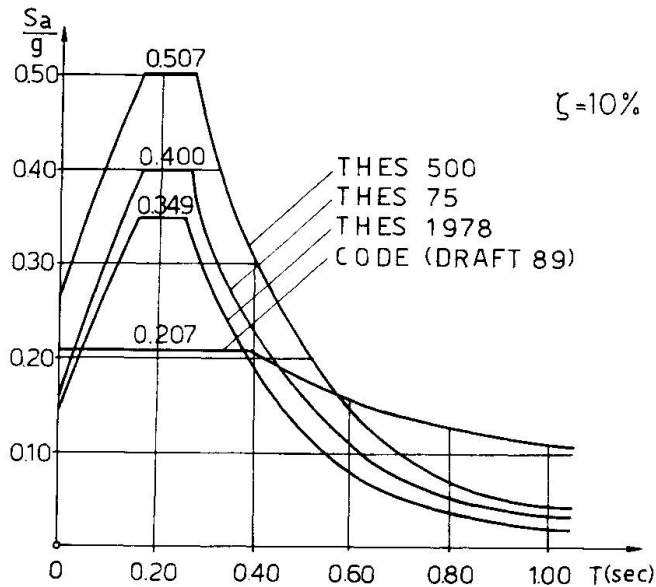
**Fig.4** Design seismic acceleration spectra

To determine the soil shear modulus ( $G$ ) throughout the foundation depth, two bore holes were drilled very close to the Minaret and the Cross Hole technic was carried out. Resonant Column Tests on foundation red clay samples were also performed. Based on the obtained values of  $G$ , the deformational characteristics of appropriate soil springs, necessary for a reliable analytical model, were estimated. The analytical procedure was performed using four elastic acceleration response spectrums. Three of them were based on the seismic excitation of 1978 at the region of Thessaloniki. The motion at bedrock of this earthquake was multiplied by the factors 1.000, 1.267, 1.756 and then, using the SHAKE program [2], the ground motions at the site of Minaret were determined. The first motion (THES 1978,  $a_{\max}=0.172g$ ) corresponds to the earthquake of 1978 since the other two correspond to similar earthquakes for return periods of 75 (THES 75,  $a_{\max}=0.218g$ ) and 500 years (THES 500,  $a_{\max}=0.302$ ). For the estimation of the latter maximum ground accelerations a statistical evaluation of the strong ground motions at the territory from 1500 till 1990 was performed. The adoption of such a long return period (500 years) was necessary because of the monumental character of the structure and the need of a long-life intervention. The fourth response spectrum corresponds to the new Greek Seismic Code (draft 1989). These response spectrums, after being appropriately smoothed and normalised, were multiplied by the foundation factor  $\theta=0.8$  and were divided by the behaviour factor  $q=1.5$  to take design spectrums (see Fig.4).

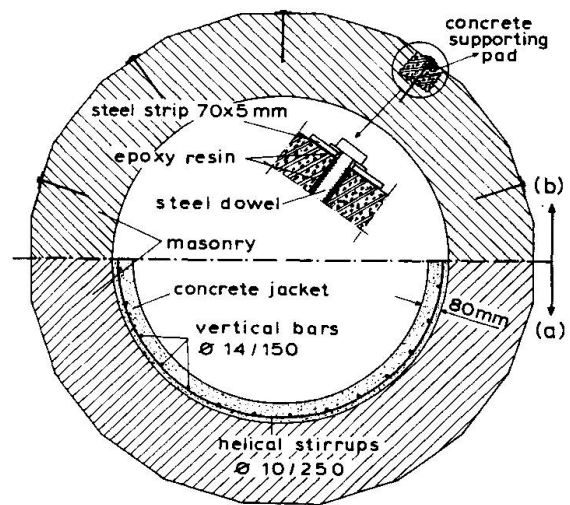
**Fig.6** Semisections of Minaret trunk: (a) Internal concrete jacket, (b) External steel strips

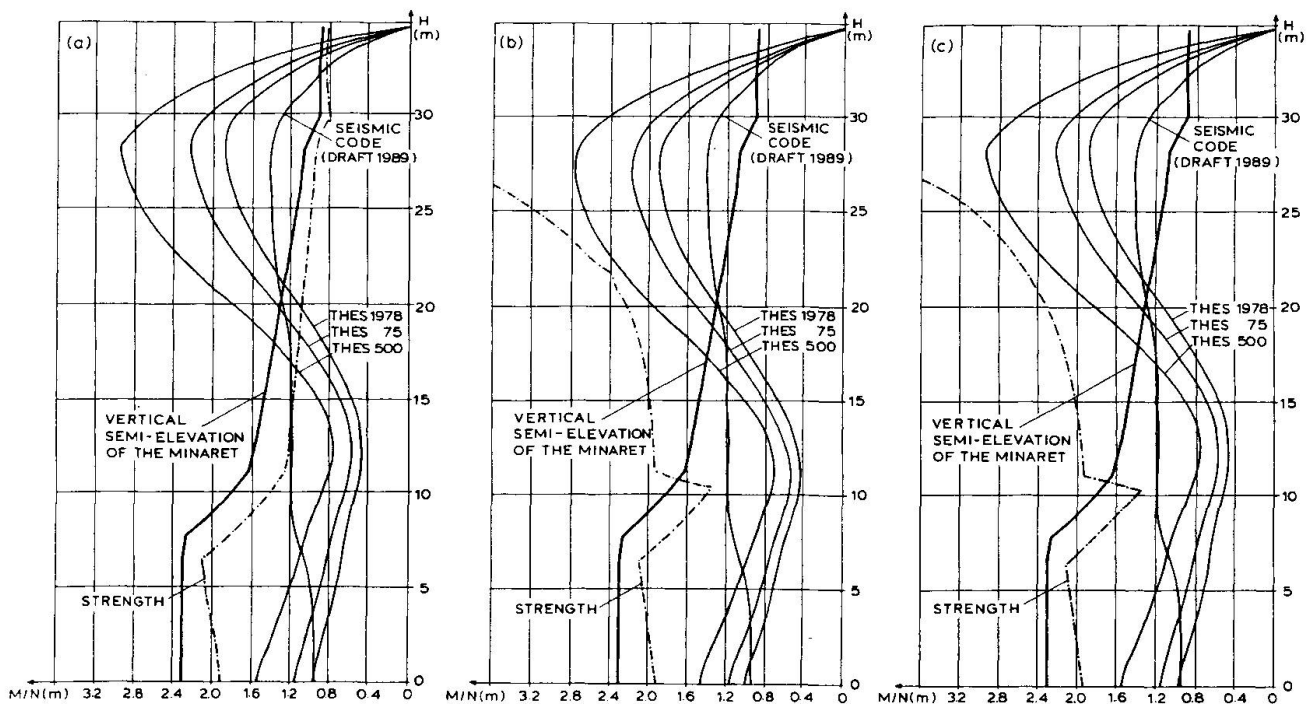
**Fig.5** Eccentricity curves under seismic spectra and strength eccentricity curve: (a) Virginal state, (b) Concrete jacket, (c) External steel strips

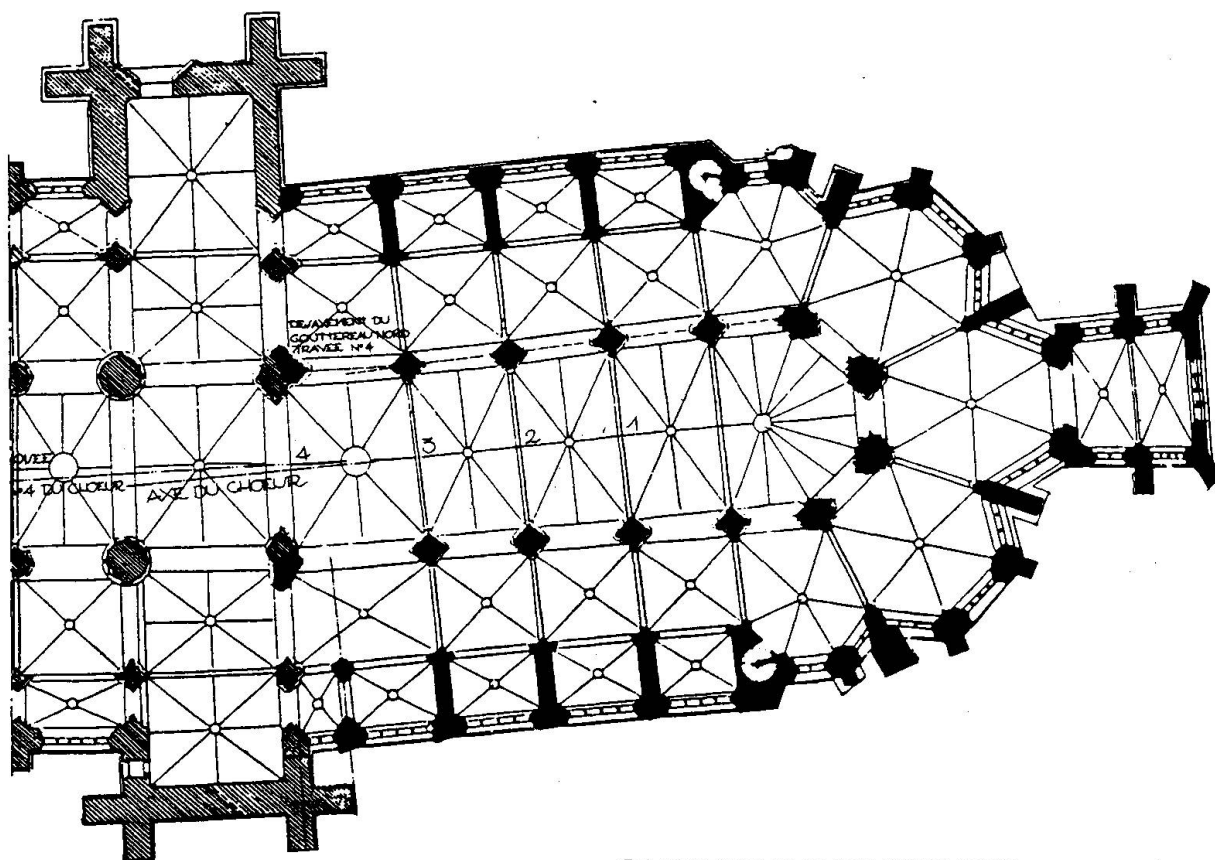
CATHÉDRALE DE QUIMPER  
PLAN DU CHŒUR

D'APRÈS CHAUSSÉPIED, CONGRÈS ARCHEOLOGIQUE 1914

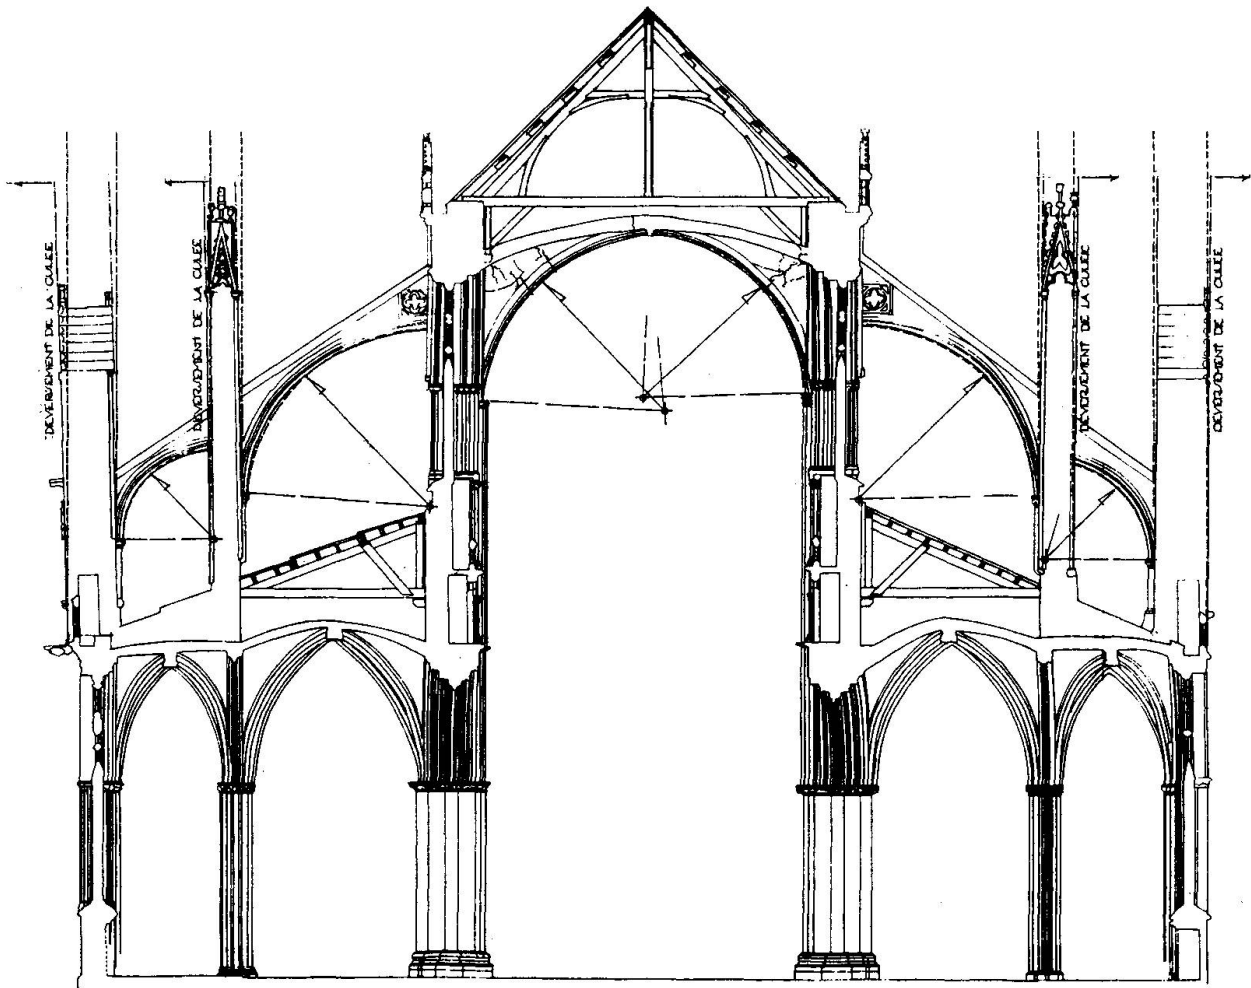
ETAT DES DEFORMATIONS

En particulier, on a pu noter un important déversement de la culée externe des arcs boutants, alors que le mur gouttereau des chapelles situé en dessous, avait gardé sa verticalité.
