**Zeitschrift:** IABSE reports = Rapports AIPC = IVBH Berichte  
**Band:** 70 (1993)  
**Rubrik:** Keynote lecture

## Compatibilité de la thérapie avec le monument

Appropriate Measures for the Preservation of Monuments

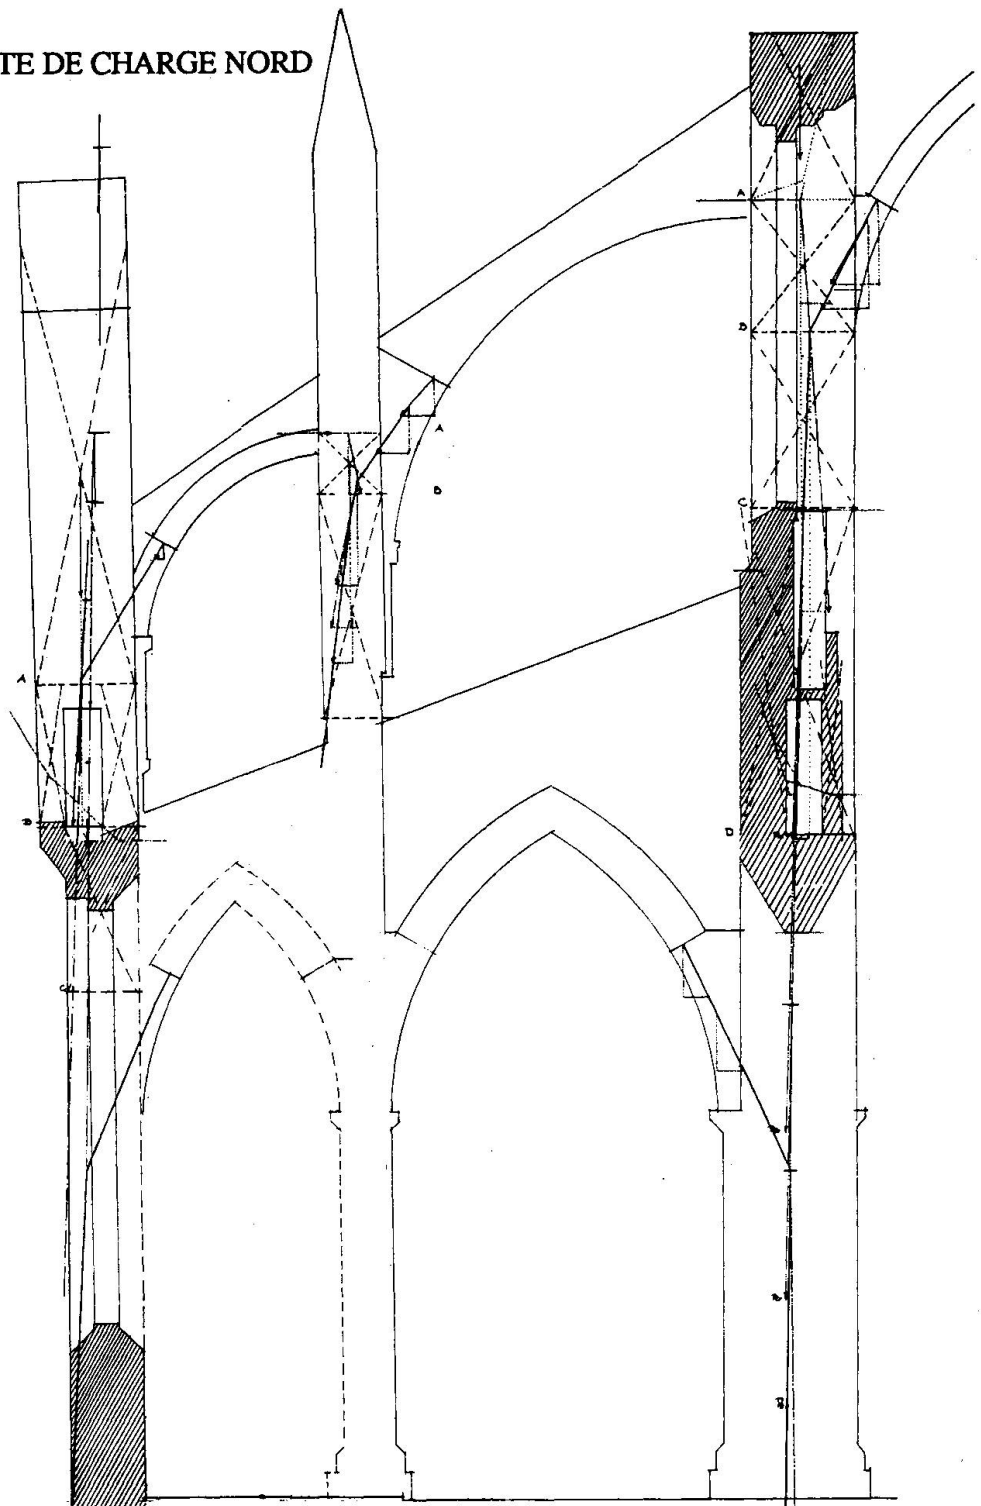
### SYNTHESE DESCENTE DE CHARGE NORD

- Stabilité limite de la culée médiane d'arcs boutants. La résultante passe à l'aplomb du parement externe, au pied de la culée. Mais le mur diaphragme de séparation des chapelles qui monte jusqu'au comble de bas côté, peut assurer un épaulement satisfaisant de la culée.

- Stabilité défaillante de la culée externe, avec sortie de résultante au niveau du chéneau de toiture du bas côté, ce qui explique l'articulation observée dans les alignements des aplombs extérieurs, (révélée par la stéréophotogrammétrie). Ce phénomène est accentué par le fait que, contrairement à la manière couramment adoptée dans l'architecture gothique, (ce qui fut le cas à Quimper dans la nef), les culées externes du chœur ne sont pas prolongées vers le bas par un contrefort, mais s'appuient sur une corniche qui est en porte à faux et aggrave l'effort au déversement. Par effet en chaîne, des désordres sont apparus naturellement sur les arcs boutants et la voûte du chœur. Mais les valeurs quantitatives sont de faible importance, ce qui a permis à l'ouvrage d'absorber ces excédents.

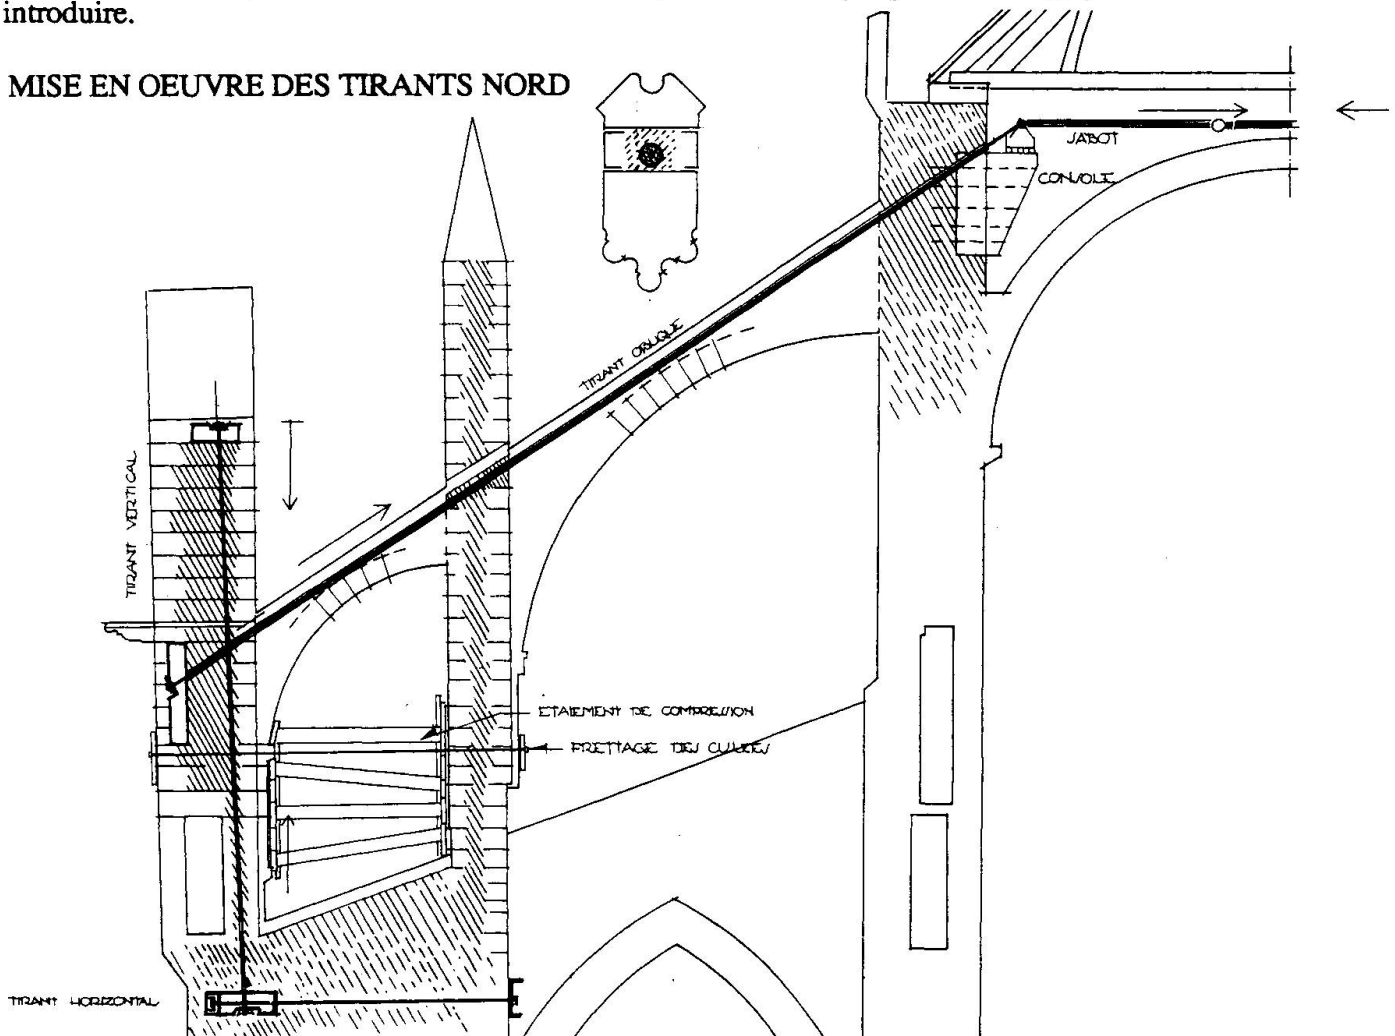
#### MISE EN OEUVRE DES TIRANTS NORD

L'état "d'équilibre idéal" auquel on voulait arriver fut obtenu par calculs en partant du point de résultante souhaitée, et en remontant le funiculaire, notant à chaque point névralgique les actions à introduire.

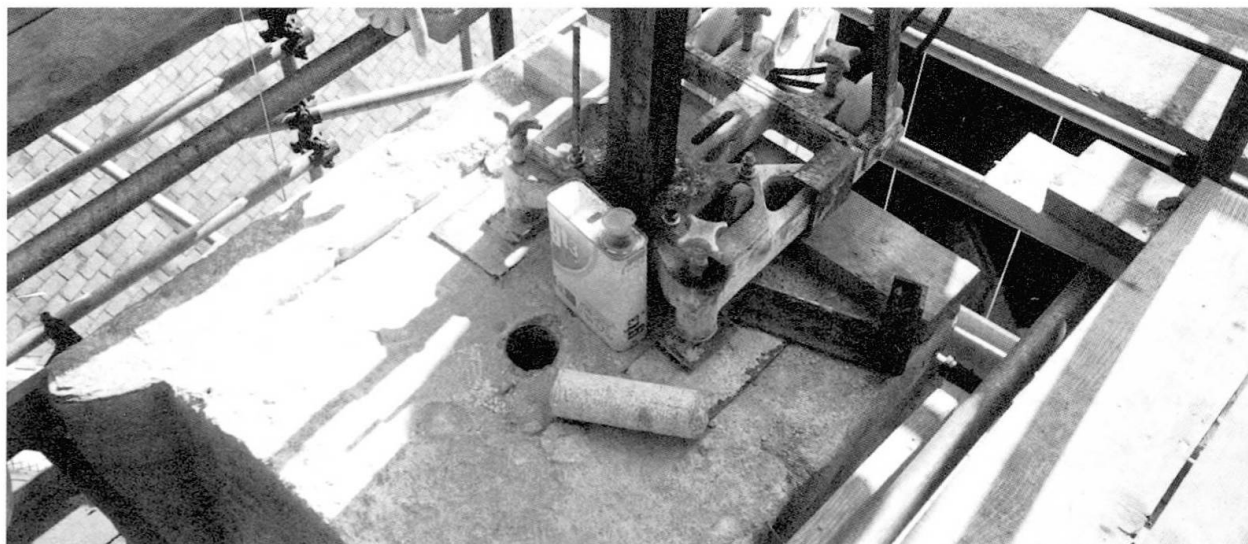
### FORAGE DES TIRANTS SUBVERTICAUX

L'intérieur de la gaine PVC a été garni de mousse de polyuréthane pour isolation et maintien du tirant dans l'axe de la gaine.

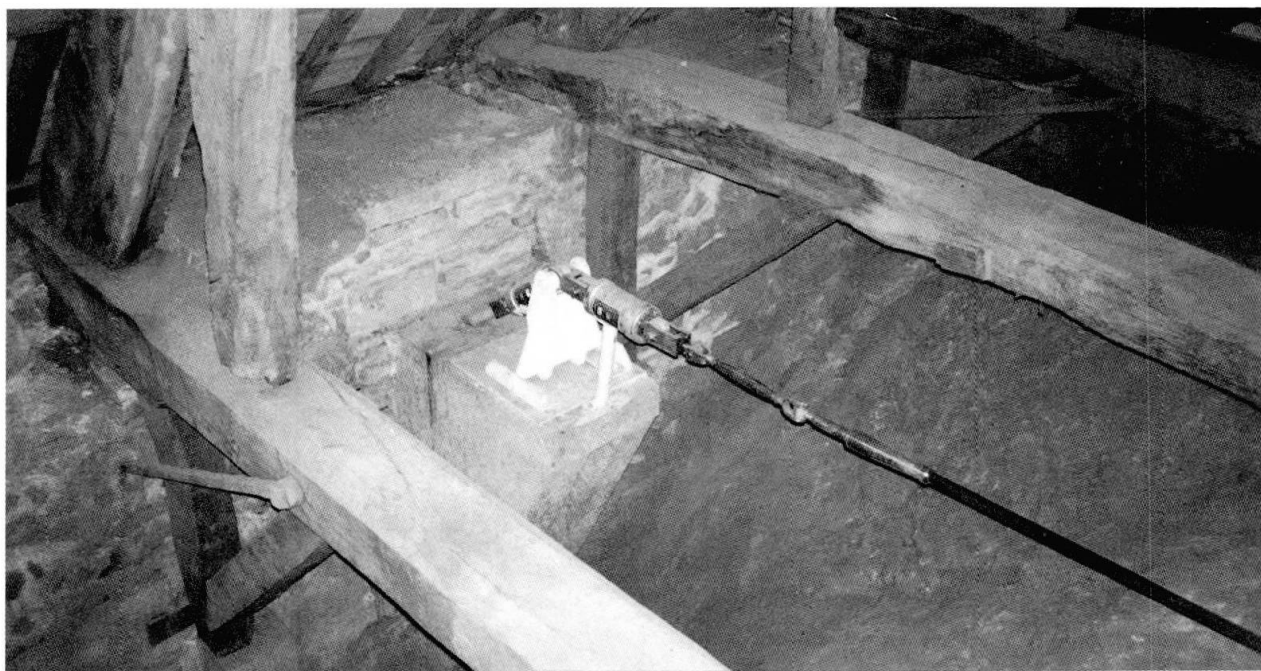
ACCROCHAGE DE TRAPEZE EN COMBLE

- Le tirant de liaison était prévu en acier inoxydable avec enrobage d'un isolant thermique. Mais du fait du coefficient de dilatation très élevé de l'acier inoxydable, seule une isolation par manchon chauffant semblait pouvoir donner une stabilité satisfaisante. Cette formule a été écartée pour des raisons évidentes de maintenance, et la solution a pu être trouvée dans l'emploi de matières composites dérivées de la fibre de carbone (thermiquement stable, incombustible, non magnétique, etc...). Les résultats ont immédiatement marqué une stabilisation de la tension à plus ou moins 6%, de la tension nécessaire.

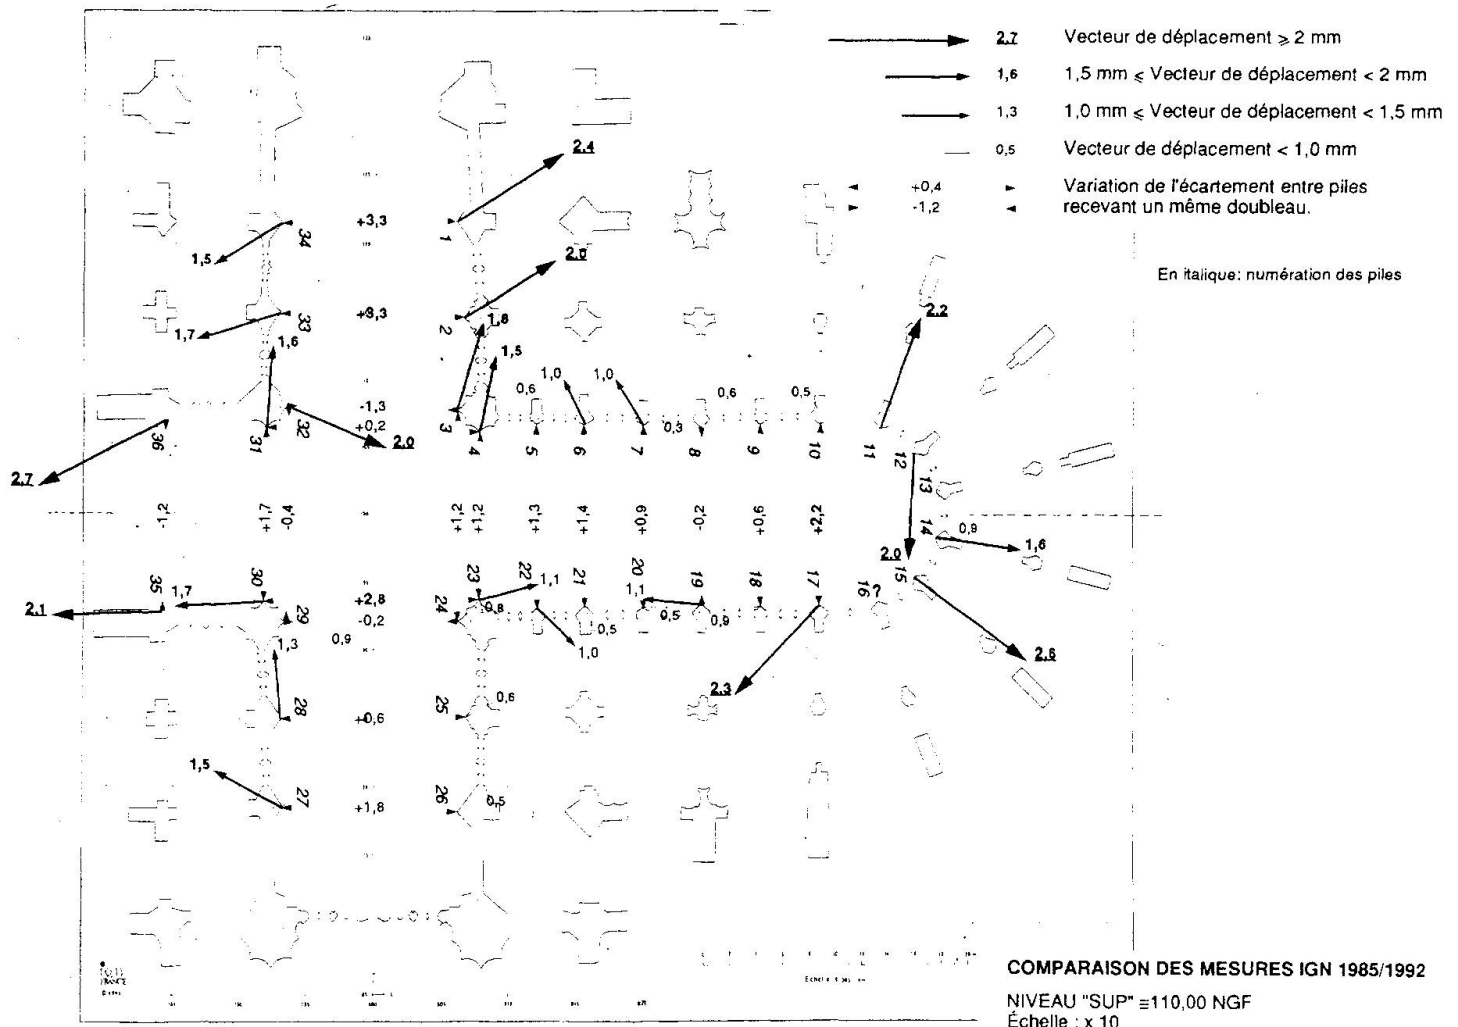
Quatre principaux phénomènes apparaissent (10) :

- tendance d'ouverture radiale ou tangentielle affectant la majorité des piliers du Rond-Point,
- poursuite du déversement des 2 piliers de Nef adossés aux gros contreforts Ouest,
- tendance des supports de voûtes de Transept à s'écarter transversalement,
- tendance de certains supports du Transept à se déverser vers le Nord,

Au total 1 pilier sur 4 se serait déplacé en tête de plus de 2 mm (9 piliers sur 36).

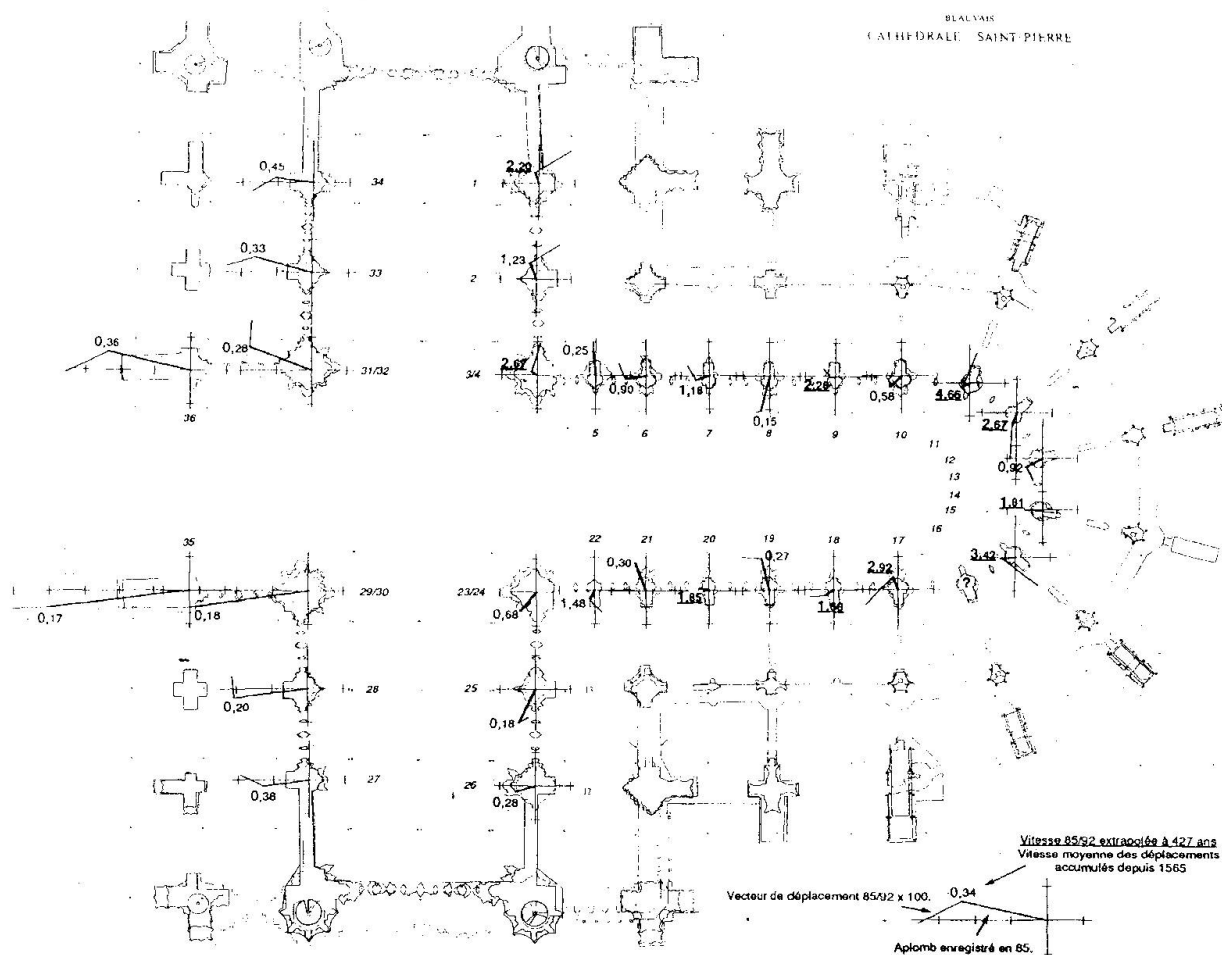
13 piliers existent depuis 750 ans : Piliers 6, 8, 10, 11, 12, 13, 14, 15, 16, 17, 19, 21, 23/24,  
5 piliers existent depuis 700 ans : Piliers 7, 9, 18, 20, 22,  
12 piliers existent depuis 460 ans : Piliers 1, 2, 25, 26, 27, 28, 29/30, 31/32, 33, 34, 35, 36  
2 piliers existent depuis 420 ans : Piliers 3/4, 5,  
2 piliers existent depuis 390 : 2 contreforts Ouest

COMPARAISON DES VITESSES DE DÉPLACEMENT EN TÊTE DES PILIERS :  
DES ORIGINES À 1985 ET DE 1985 À 1992

Prenant pour hypothèse que les structures ont été élevées sur des aplombs corrects (<sup>11</sup>), le diagramme ci-après expose pour chaque pilier la valeur du rapport de "la vitesse 1985/1992" à la "vitesse moyenne déduite des déplacements cumulés des origines à 1985" (par ex. pour les 2 piles occidentales de la croisée du Transept, à partir du début du chantier de la Tour-Lanterne : 1992-1565=427 ans).

Les valeurs de ce rapport, inférieures à 1 dans 11 cas sur 14, indiquent qu'il s'est trouvé dans des points particuliers, des phases de plus rapide déformation dans le passé. Cela est attesté pour les 4 Piliers du Carré, dont l'histoire est décomposée en 3 périodes contrastées : 1565/1573, 1573/1605 et 1605/1992. L'énergie dissipée dans le sol du Carré par la chute de la Tour-Lanterne a produit au pied des 4 gros Piliers une compression du terrain dont les effets ont agi un certain temps sur les massifs supports de ces piliers. En revanche on note une accélération : zone d'enlèvement des tirants du Chevet.

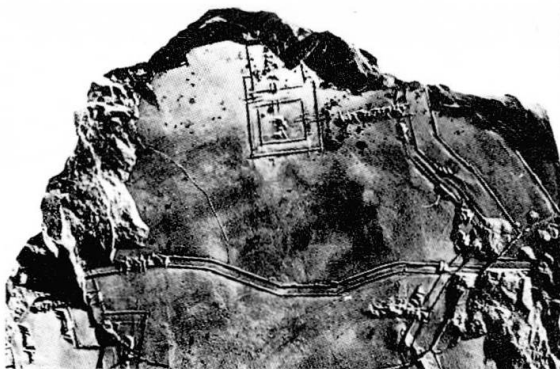
Fig. 3 Clay tablet with a stage-tower plan /7/

of Gilgamesh /6/ (Fig. 2). Ziggurats were built out of adobe and brick, since natural stone was scarce. The elements were simply placed and connected by clay or asphalt. Reed mats were applied at fixed levels of the ziggurat inner shafts - in order to achieve a better distribution of loading. Wooden anchors had to increase the stability of the ziggurat mantle walls. General impressions of the stage-towers, as seen originally by their builders, are given in Fig. 3 and Fig. 4.

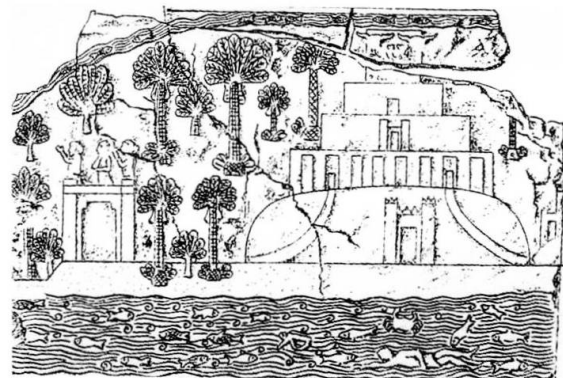
Fig. 4 Relief from Nineveh showing a stage-tower /2/

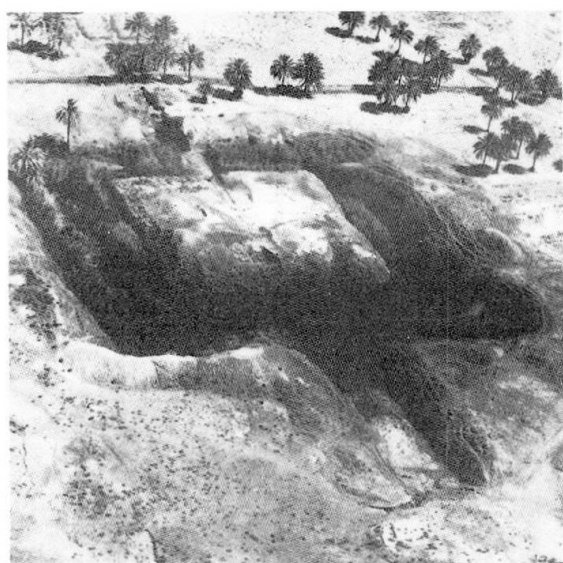
**Fig. 5** Archaeological traces of the Tower of Babel /1/

To-day there is only the trace of the Tower of Babel (Fig. 5), a very imperfect echo of the past glory (Fig. 6).

The typical feature of all the previously cited original notes on Babylon and its Tower was that they contained many references to engineering. Some of them concerned E-temen-an-ki's structure, especially the s.c. E-sag-ila Tablet /2/ - here until now left without a detailed analysis. Those descriptions are very important since, presently, only poor traces of the Tower could be found (Fig.5). Different scholars used these notes to develop their Tower images /3/ (Fig. 7).

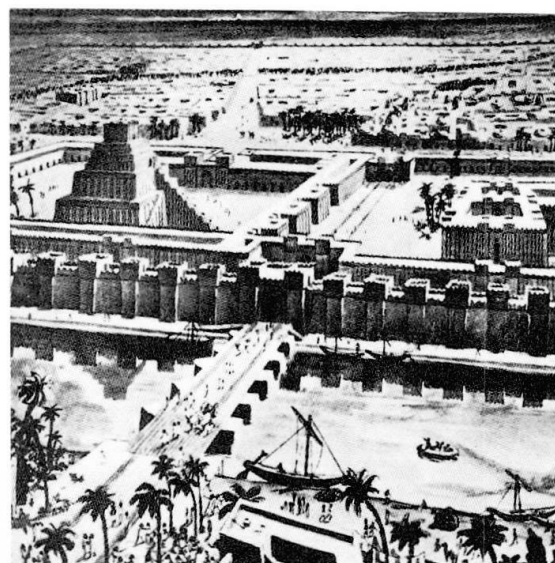
**Fig. 6** Reconstruction of the Sacred Area (Temenos) in Babylon /1/

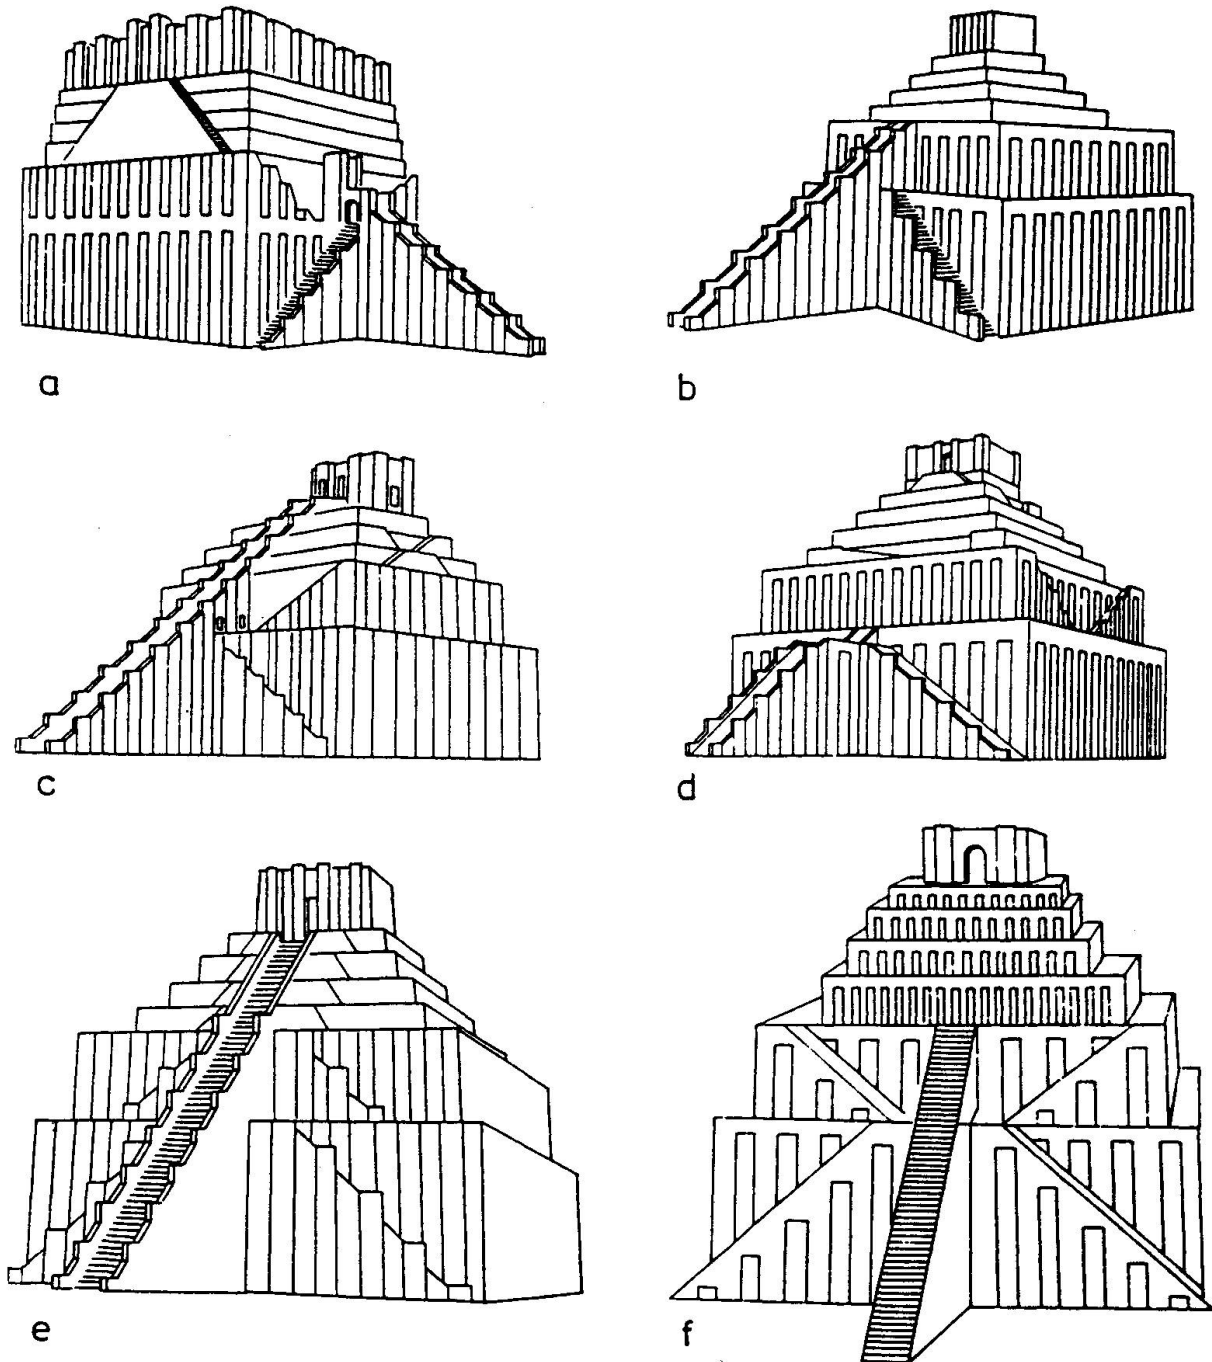
Fig. 7 Reconstructions of the Tower of Babel - by

a - Koldewey /2/	b - Dombart /2/
c - Andrae /2/	d - Busink /6/
e - Moberg /2/	f - Unger /2/

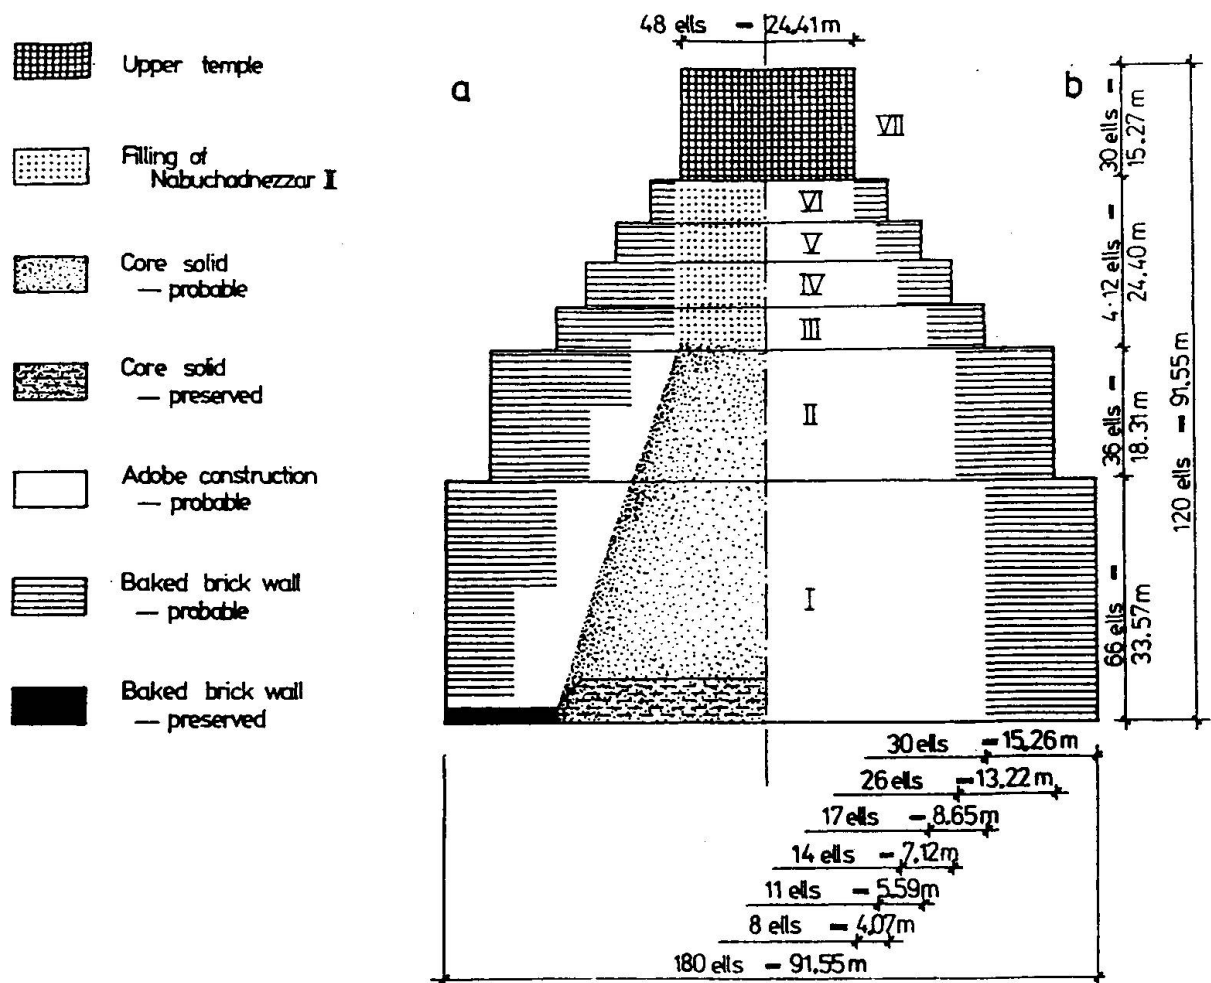
The structural volume of the established shape was also point of research. According to /2/, the mature construction of E-temen-an-ki was that given by the vertical section of Fig. 8 a. Author of this report postulates the Tower structure to represent a co-operating composite of two main parts (Fig. 8 b):

- the square container like enveloping wall, constructed out of baked bricks connected by asphalt - being, according to the sexagesimal counting system of the Babylonians, in thickness one sixth of each story length, and
- the cased inner shaft made out of adobe and debris of former constructions, together with local sandy clay soil - everything with layers of reed inside.

Fig. 8 Structural characteristics of the Tower of Babel - by  
a - /2/ b - author

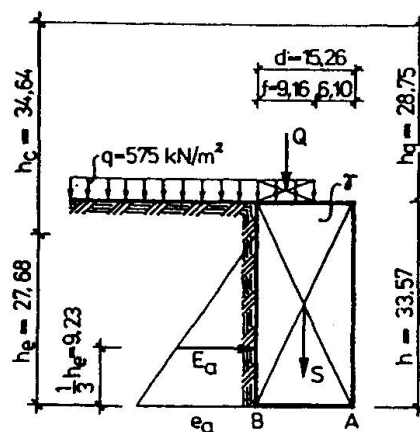
Another check should be referred to the ziggurat mantle wall (Fig. 9) - its strength and stability. The normal stresses at the bottom of this important structural element can be developed using the conservative system of a retaining wall, taking into account the dead load in question and the horizontal pressure of the inner shaft material. The concentrated vertical loads are the following:

Besides that, the Tower wall stability, i.e. rotation about  $A$  and sliding along  $AB$  (Fig. 9), should be verified. Concerning rotation, the resisting and disturbing moments are, respectively:

Fig. 9 Tower of Babel mantle wall analysis /3/

- The stability requirements regarding possible rotation and shift of the enveloping wall, in the conditions of rigid subsoil, were fairly satisfied. Thus, statically considered, the structural composition of the ziggurat core (adobe) and enveloping wall (baked bricks joined by asphalt), was safe.

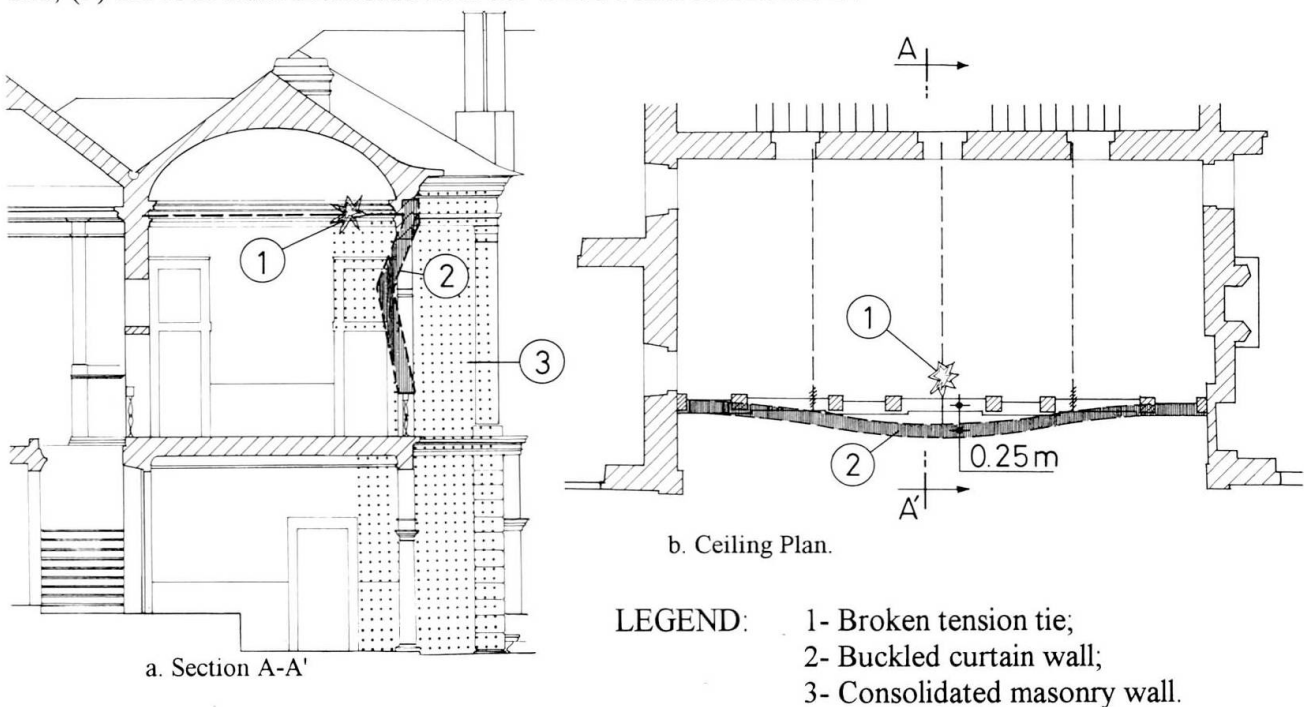
The site report of the Summer of 1988, showed that the North Loggia facade was on the verge of collapse. The first floor marble columns displayed a horizontal inward displacement which reached 0.25m at the facade midspan. The cornice had horizontal outward displacement of 0.25m, Fig. 6. The facade's generalized bent shape resulted from: (1) a midspan ruptured iron tension bar; (2) the continuous debris falling from the roof the inner plaster painted shell ceiling adjacent to the facade; and, (3) the roof truss deterioration in the wood beam connections.

Fig. 6 - North Loggia Facade Collapse Mode.

The existence of heavy compression loads on the 11.50m long "curtain" open wall (4.0m height and 0.25m thick) support system created the ideal conditions for the 2.0m tall marble columns to buckle. The bracing provided by the iron bar ties with a 35mm x 55mm section disappeared when the rainwater, (infiltrating through cracked roof tiles and opened masonry joint), corroded the anchorage eyebar, Fig. 6. The wood roof beams also showed extensive deterioration mainly in the connections at the creast (broken roof tiles) and at the edge supports. Consequently, the bracing effect that once existed through the roof trusses slowly vanished as rotten wood connections developed.

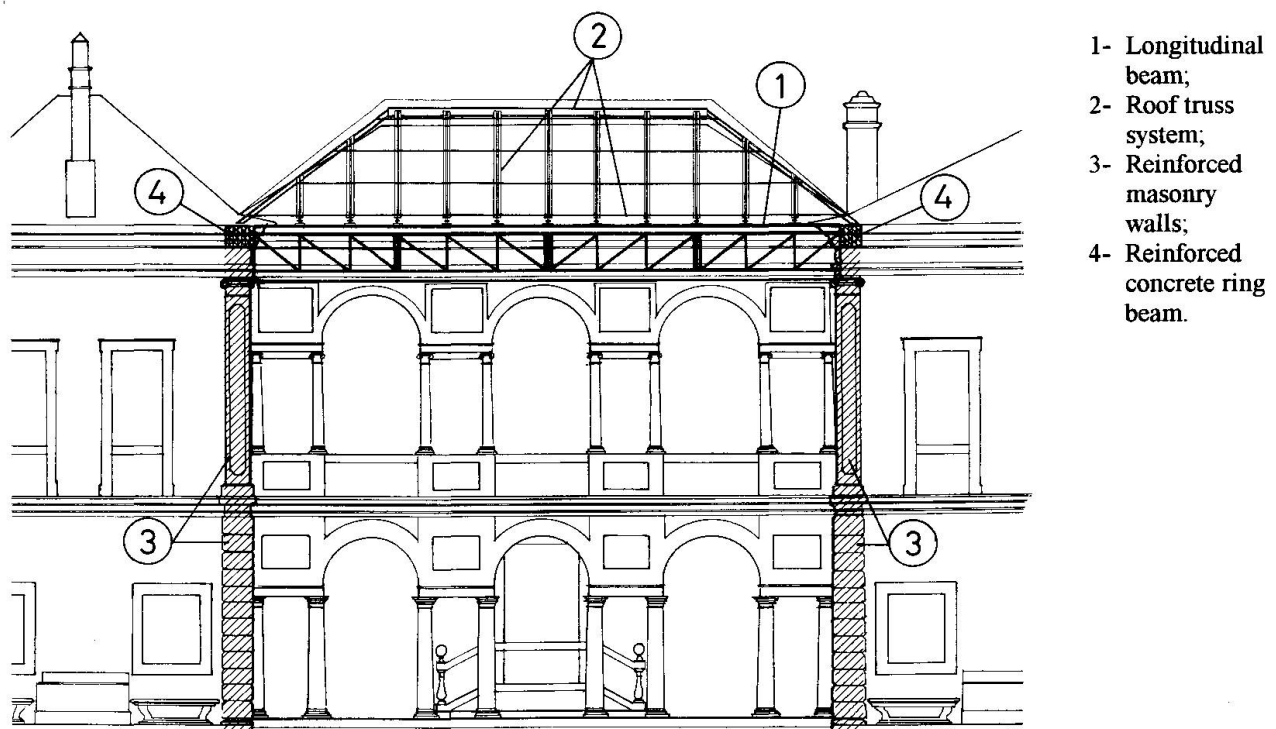
The objectives with this recommended structural solution were: (1) to reduce the cornice dead load on the columns; (2) to transfer the roof loads applied on the exterior thin wall to the thicker side walls via the longitudinal steel girder; (3) to provide a continuous spatial bracing between the U-shaped masonry wall envelope, the open exterior "curtain" wall and the roof system; and, (4) to increase the safety factor of the existing structure, Fig. 7.

Fig. 7 - North Loggia Facade - Structural Solution

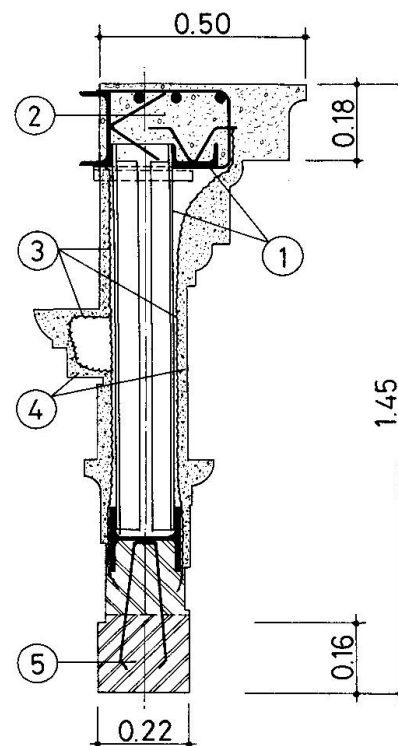
In order to guarantee the overall stability careful site inspection was conducted of the masonry walls. Through several 25mm holes drilled in the walls it was verified that the existing mortar filling the joint had either disintegrated after 300 years in service (probably washed away by infiltrated rainwater) or was in such poor condition that had to be strengthened. A limited "*reticolo cementato*" technique was used in a 3.00m wall portion. About six hundred 1.0m- long holes were drilled, filled with cement mortar and a 8mm steel rebar. In order to reduce the possibility of steel corrosion the exterior wall was protected with cement epoxy-based mortar. The steel longitudinal beam was coated in rich galvanized zinc to protect it from corrosion and in order to match the existing building cornice, a diamond-shaped zinc coated wiremesh covered with epoxy coated mortar was used, Fig 8.

The architectural detail was easily obtained through the use of these wiremesh panels. The beam top flange was composite with concrete and made continuous with the wall reinforced concrete (RC) ring beam. On the beam top flange stainless steel hinged supports were installed to connect the steel roof truss system. Before constructing the steel roof, the wood truss connections were thoroughly repaired, the inner plaster painted shell ceiling was inspected and a steel tension tie was installed to brace the longitudinal beam, Fig. 9.

Fig. 8 - Longitudinal beam cross section.

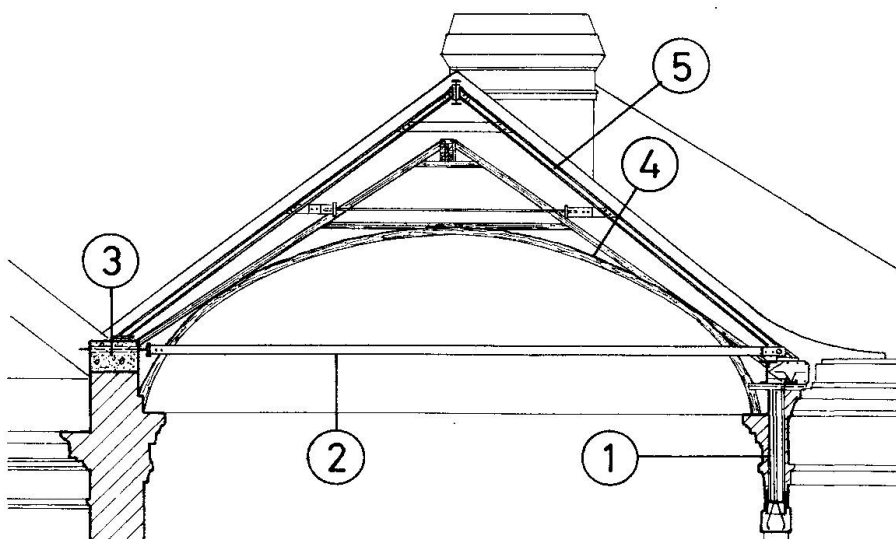
- 1- Longit. Steel Beam;
- 2- Tension Tie;
- 3- RC Concrete Ring;
- 4- Painted Plaster Dome;
- 5- Roof Steel Truss.

Fig. 9 - Palace North Loggia - Ceiling Cross Section.

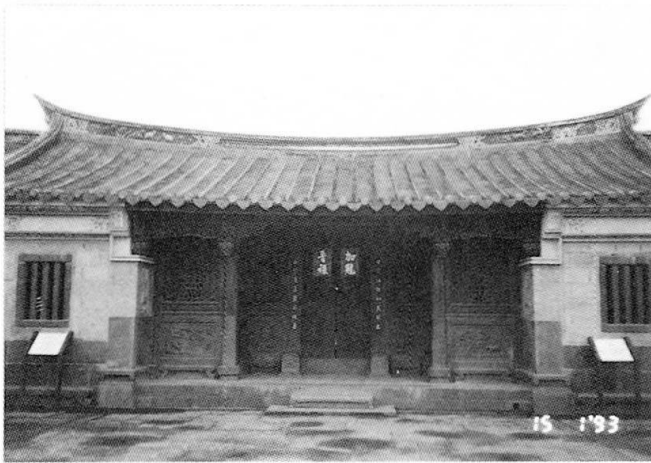
Three types of bricks laid horizontally in the facade of the lower building are in the southern Fukien style. Those on the rear part of the building are clay bricks. The face brick walls of the side buildings are engraved with tortoiseshell patterns. These probably resulted from a later addition or repair work. The stone slates below the stone waist piece are rather elaborately engraved in the pattern of tables. The entire facade of the dwelling looks neat and handsome. Although its altitude is relatively low, there is a sense of equilibrium (Fig.5).

Fig. 5 The bricks and tiles

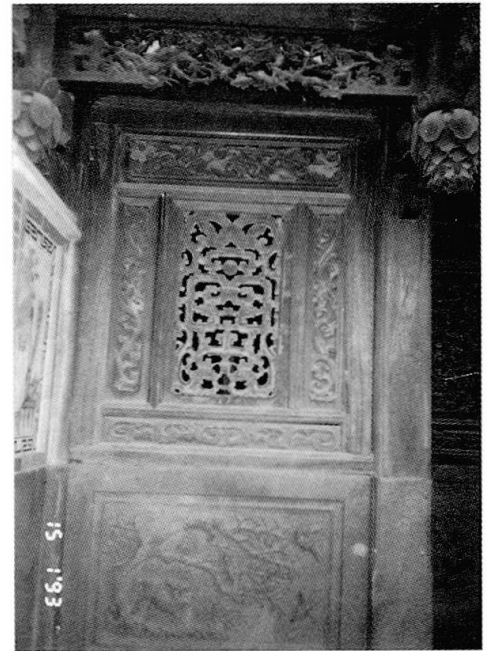
- D. The fine wood carving and the windows and doors: The main gate and the slide windows of the main hall are carved hollow. The ornamented waist panels design and engraving techniques are different from one another. The wainscots and waist panels of the doors and bar windows are all carved in one whole piece. The bar windows are of various designs, and since most of them are composed of many single pieces, they are fragile and not easy to preserve. Most of them have decayed and became loose which makes them rather difficult to repair after they are dismantled (Fig.6).

Fig. 6 The fine wood carving on window and door

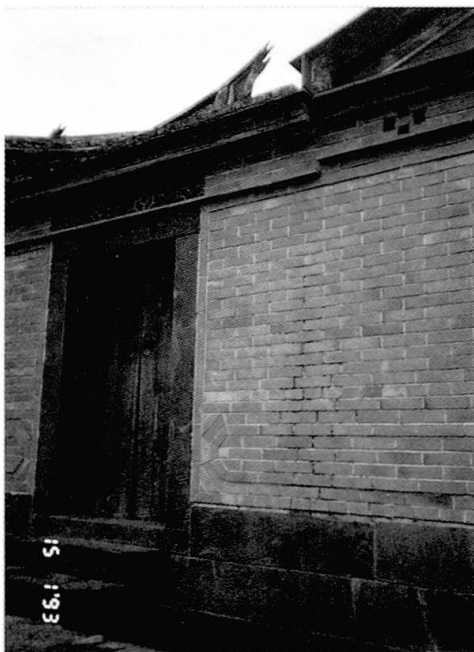
Fig. 7 Unequal settlement between main hall and wing house

Due to the misunderstanding of the materials used before and bad repairing the rebuilt homestead are being damped and even forming the crack on the corner of the door and window. Even the connection of the main and winged house are also cracked. The door are thus deformed. The rebuilding work are merely less than five years. The reason of those damage are mainly caused by misuse of cement in stead of clay and gypsem. The foundation are used by concrete instead of original stone layer. These are the first preservation works in Taiwan. Experience gain from them will be good for future works (Fig.7-8).

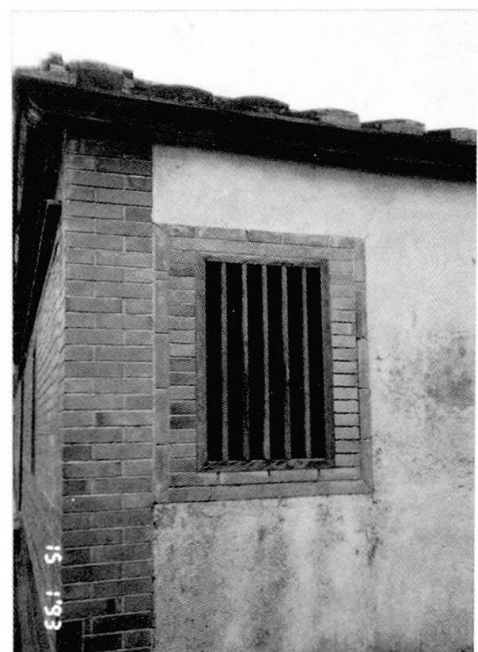
Fig. 8 The damped wall

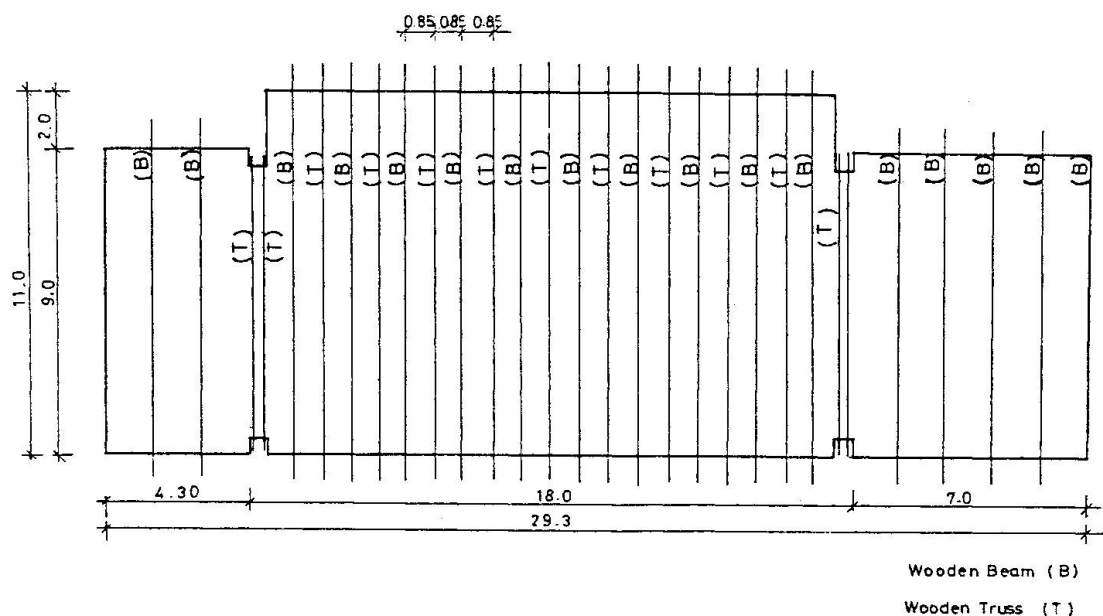
This building was well maintained and in a good condition. Nevertheless, there was water leakage in one of its major halls. Figure (1) shows the layout of the hall under study. This hall is one of the most luxurious halls in the palace. The ceiling and walls contain precious masterpiece decorations. The main hall was 18 meters long and 11 meters wide. Connected to this hall from one side was an entrance hall (9 m x 7 m) and from the other side to a hall (9 m x 4.3 m) connecting it to the main throne hall.

Fig. (1) Layout of the Hall (in the Old Building) showing Locations of Beams and Trusses

From inspecting the hall false ceiling of the main building, sagging of the decorated false ceiling was noticed as well as traces of water leakage. But nevertheless, from inspecting the hall from the space between the false decorated ceiling and the roof, longitudinal cracks were quite visible in beams and trusses.

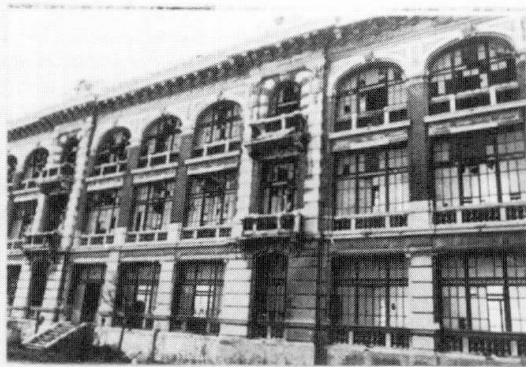
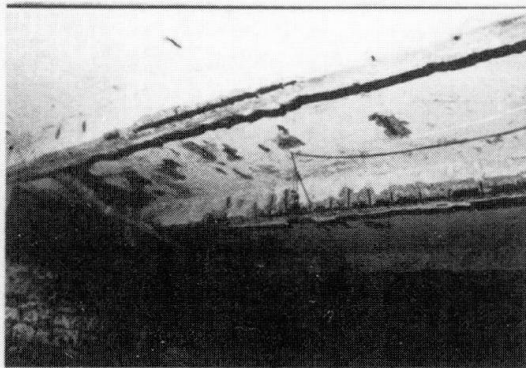
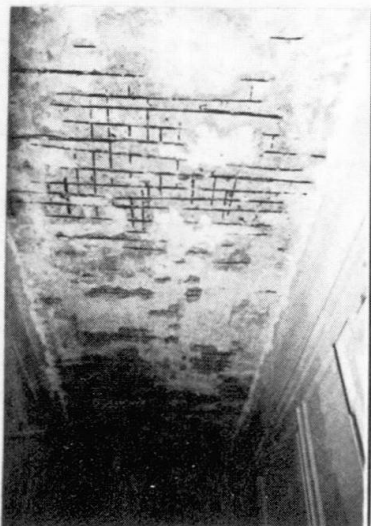
Figure (2) shows the extension building and a sample of the damaged parts. The building was abandoned for sometime and badly maintained. Traces of water leakage could be seen from water piping system at the basement, at the bathroom and at ceiling walls of the top floor (due to rain). Cracks and spalling of concrete could be seen in reinforced concrete elements, while some uncovered corroded steel reinforcement bars were detected.

Fig. ( 2 ) Photos taken to the Extension Building showing a sample of the damaged parts

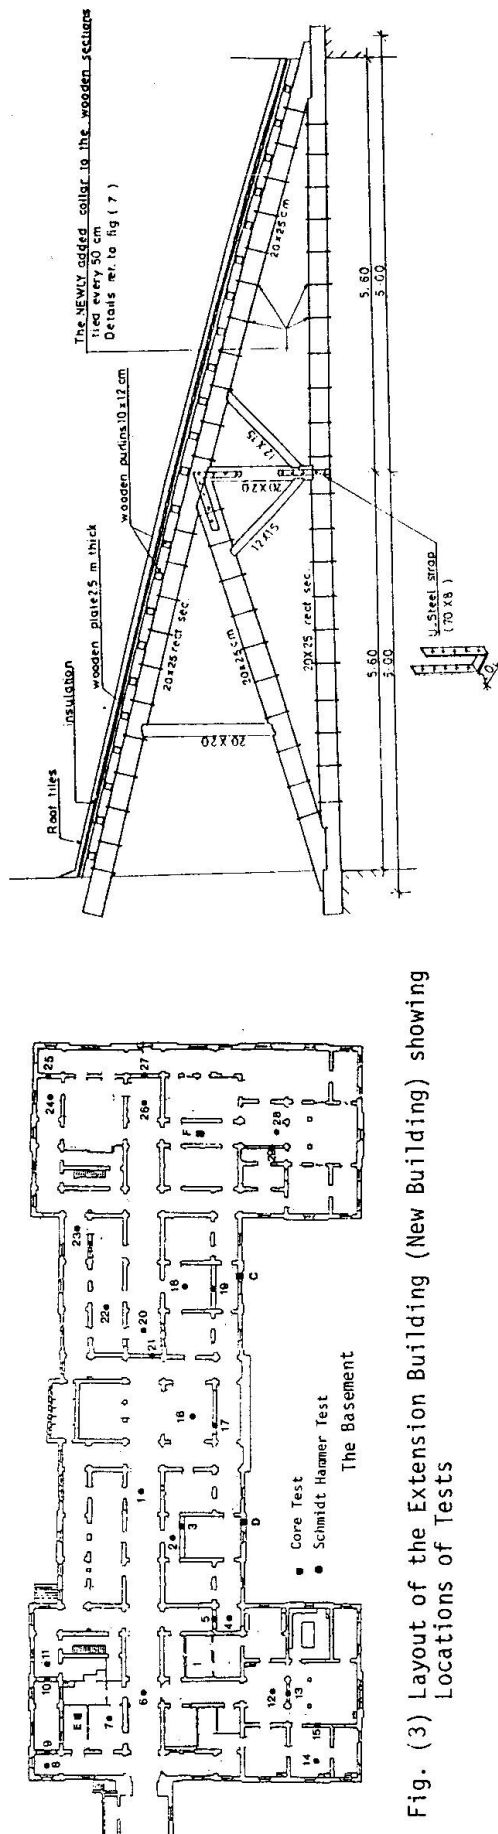
Fig. (3) Layout of the Extension Building (New Building) showing Locations of Tests

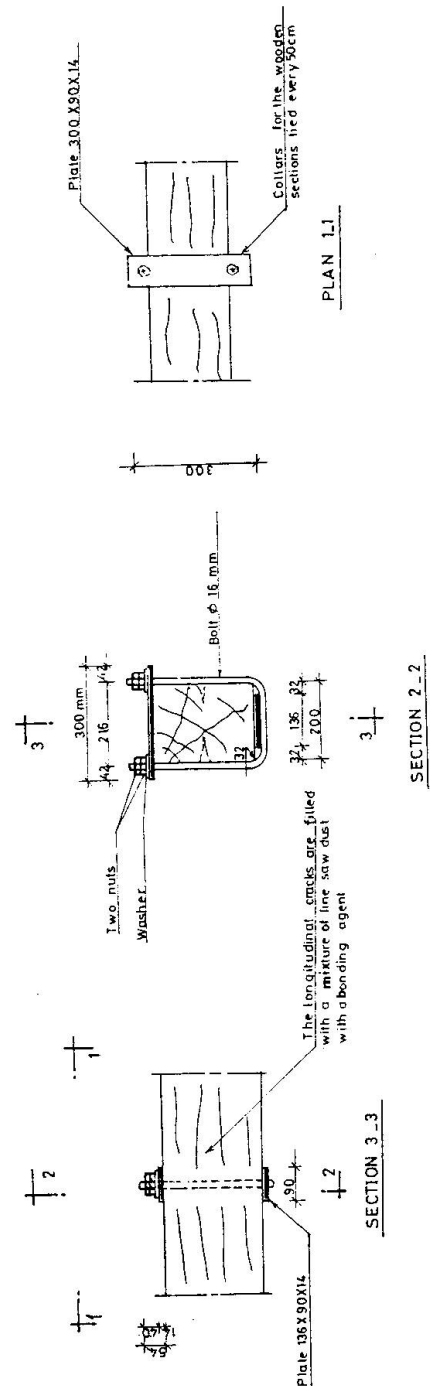
Fig. (5) Collar Details which were connected to the Truss Members

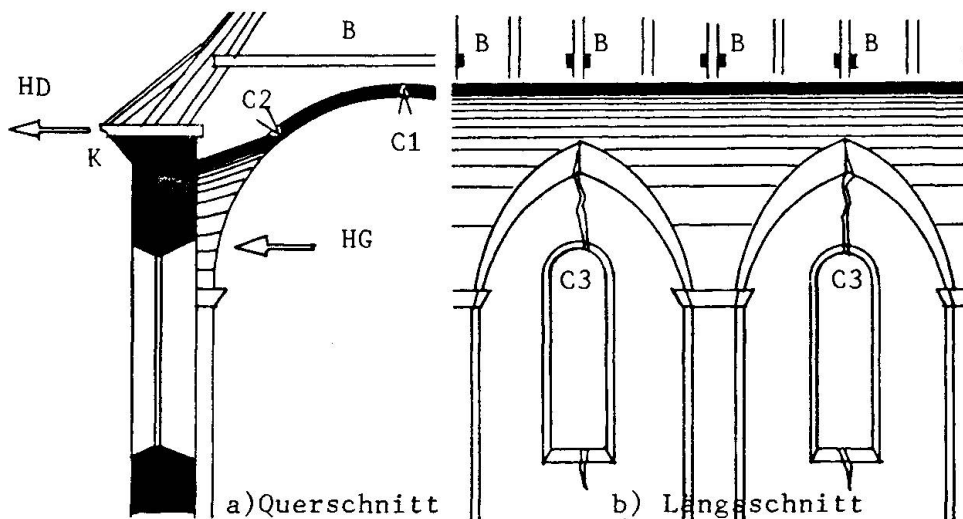
Fig. 1: Tonnengewölbe mit Stichkappen, Kehlbalken B

Die Bewertung der zu Rissen führenden kurzfristigen Zustandsänderungen sei für die Bauweise nach Fig. 1 an einem Tonnengewölbe mit Stichkappen mit den fast immer im Scheitel an der Unterseite auftretenden Rissen C1 und den manchmal zu beobachtenden Rissen C2 an der Gewölbeoberseite in Kämpfernähe vorgenommen. Den einfachen Berechnungen wurde der Modellquerschnitt gemäß Fig. 2 zugrunde gelegt.
