**Zeitschrift:** IABSE reports = Rapports AIPC = IVBH Berichte  
**Band:** 70 (1993)  
**Rubrik:** Keynote lecture

## Compatibilité de la thérapie avec le monument

Appropriate Measures for the Preservation of Monuments

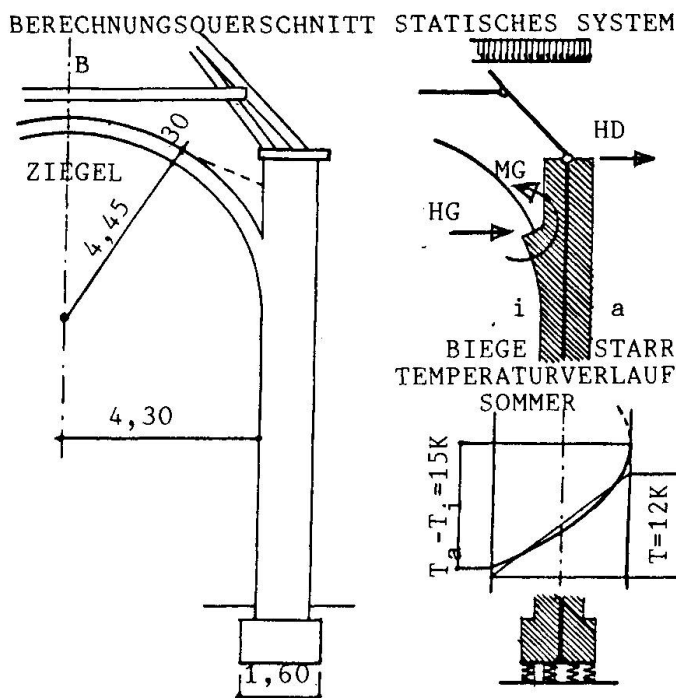
Der Steifigkeitseinfluß von Stichkap-pen ist in einer größeren Gewölbedicke erfaßt. Im Rechenmodell werden das Gewölbe als elastischer Kreisbogen, und die Wände vorerst als biegestarr angenommen, aber die drehelastische Einspannung im Bau-grund für mittleren Boden mit dem Steifemodul von  $70 \text{ N/mm}^2$  berücksichtigt. Angenommene Materialwer-te des Ziegelgewölbes [1]:

Elastizitätsmodul:  $E_{\min} = 3 \cdot 10^3 \text{ N/mm}^2$ , Querdehnzahl 0,2, Temperaturdehn-zahl  $\alpha_T = 7 \cdot 10^{-6}/\text{K}$ . Der Horizontal-schub des Gewölbes, HG, auf 1m Gebäudelänge beträgt hier rund  $20 \text{ kN/m}$  für das fest eingespannte Kreisgewölbe.

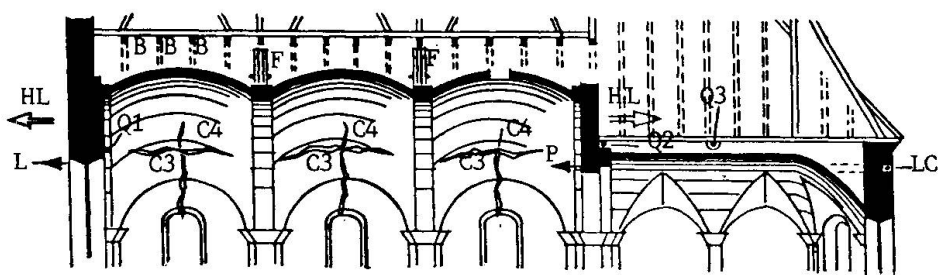
Fig. 3a: In Joche unterteilte Gewölbe, Längsschnitt

Sowohl in Bauwerken gem. Fig. 1 und Fig. 3 sind vorwiegend lotrecht verlaufende Risse, C3, in den Längswänden der Kirchenschiffe zu beobachten. Wenn vorausgesetzt wird, daß diese Seitenwände der Gebäude im Sommer errichtet wurden und frei von Eigenspannungen sind, dann wird im Winter der obere Bereich deshalb Längszugspannungen erfahren, weil diese Zonen kälter als die unteren werden und durch die Fundierung als auch durch das eigene Gewicht gezwungen werden, gerade zu bleiben.

In der Bauweise gemäß Fig. 3 ist die Überwölbung in Joche unterteilt, die durch Gurtbögen getrennt sind. Das statische Verhalten der Gurtbögen und die anschließende und mitwirkende Zone der flachen Kuppeln ist in Querrichtung ähnlich dem Beispiel der Tonnengewölbe. Bei diesem - vor allem für das Barock typischen System - ragen die Kuppeln besonders hoch in den Dachstuhl hinein, sodaß die Horizontalschübe HD größer als in dem vorhergehenden Beispiel sind. Die Schalenbereiche zwischen den Gurtbögen sind in Kirchenquerrichtung wesentlich biegesteifer als die Gurtbögen bzw. als das Tonnengewölbe gem. Fig. 1. Bei allen Lastfällen, die zu einer horizontalen Verschiebung der Kämpferbereiche K nach außen führen, treten beim System gemäß Fig. 3 an den Stellen, vergleichbar C2 der Fig. 1, nicht nur Biegerisse auf, sondern auch eine völlige Durchtrennung der Ge-

wölbeschale an den Stellen C4 der Fig. 3, wie sehr oft zu beobachten ist. Die horizontale Verschiebung der Mauerkrone K nach außen führt dazu, daß die Mauerrippen in Fig. 3b, die offenbar als horizontale Stützung der Gewölbeschalen gedacht waren, sich von der Mauerkrone ablösen und die dabei entstehenden bis zu 20 mm breiten Spalten C5 die Funktion dieser Rippen wirkungslos machen.

Die flachen Kuppeln der Konstruktion gem. Fig. 3 üben als doppelt gekrümmte Schalen auch horizontale Reaktionen in der Längsrichtung des Gebäudes aus, die in Fig. 3a mit HL bezeichnet sind. Diese Horizontalkraft überträgt sich durch Schalenwirkung der Kuppeln auf die Längswände des Gebäudes und verstärkt auf diese Weise die Längszugspannungen in den Seitenwänden und trägt verstärkt zu C3 bei.

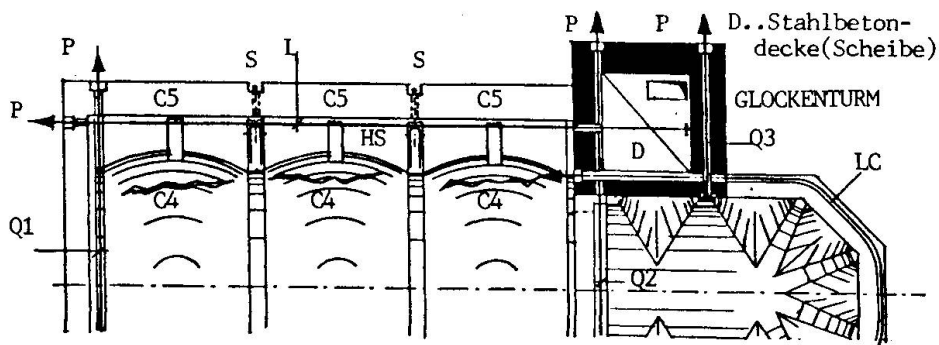
L, LC horizontale Längs-, Q1, Q2, Q3 horizontale Querspannglieder  
Fig. 3b: In Joche unterteilte Gewölbe, Grundriß zu 3a im Dachgeschoß

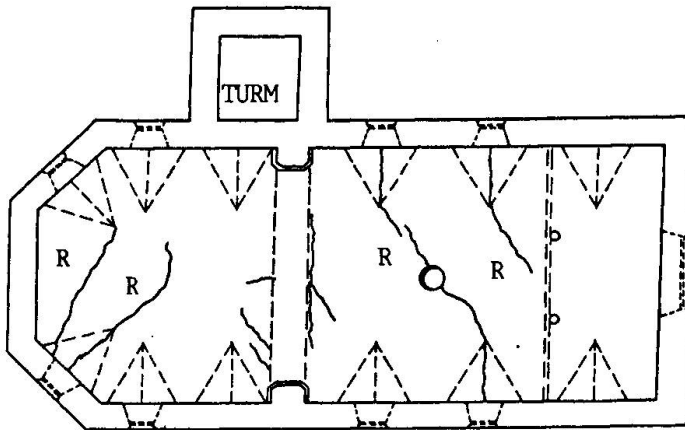
Fig. 4: Draufsicht auf Tonnengewölbe mit untypischem Rißbild R

Fig. 4 zeigt schräg verlaufende Risse im Tonnengewölbe einer kleinen Kirche auf gutem Baugrund, die mit oben dargelegten Überlegungen nicht in Einklang zu bringen waren. Die Ursache der Rißverläufe ließ sich erkennen als die Befragung der Bewohner ergab, daß während des II. Weltkrieges in kaum 70 m Entfernung von der Turmseite der Kirche ein kleiner Steinbruch errichtet wurde, der dzt. nicht mehr in Betrieb ist.

Deutlich sieht man, daß der Turm ablenkend auf die Richtung der Risse infolge der Erschütterungswellen wirkt.

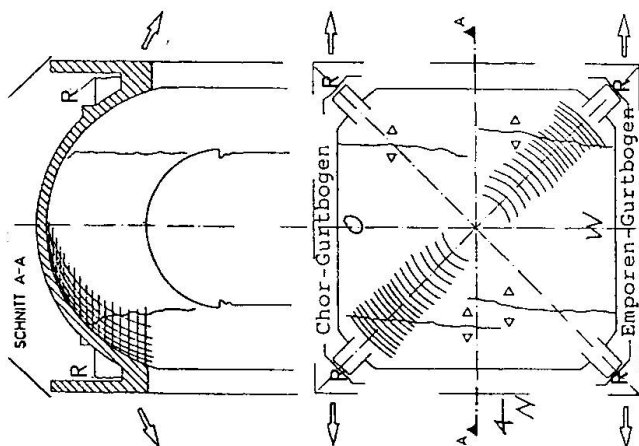
In Fig. 5 sind im Grundriß Risse in einer Kuppel dargestellt, die in Tirol in Itter nach dem Erdbeben im Friaul 1976 verstärkt auftraten [2]. In dem Zentralbau hätte man nach statischen Gesichtspunkten Risse in Radialrichtung im unteren Teil der Kuppel erwartet. Die Orientierung der Risse zeigt aber deutlich ein Ausweichen der Nord- und Südwand nach außen, was auch zu der Trennung R der als horizontale Stützung der Kuppel gedachten Mauerrippen führte. Die Analyse der Risse und deren Lage ergibt:

Fig. 5: Rißbild einer Hängekuppel, auf Gurt- und Schildbögen

Erstens liefert ein Temperaturunterschied von  $\Delta T = 12 \text{ K}$  Zwängungsbiegespannungen von mind.  $\pm 0,13 \text{ N/mm}^2$ , die aber proportional dem E-Modul des Mauerwerkes je nach dessen Güte auch bei  $\pm 0,2 \text{ N/mm}^2$  liegen können. Diese Spannungen treten fast in der gesamten Kuppel auf.

Zweitens ergab der geologische Befund, daß die Flanken des schmalen Bergrückens, auf dem das Gebäude steht, zu langzeitigen Hangbewegungen neigen und durch Erdbeben besonders dazu aktiviert werden können. Tatsächlich zeigte der alte Estrich des Kirchenfußbodens zwei Längsrisse als Anzeichen dafür, daß die in be-

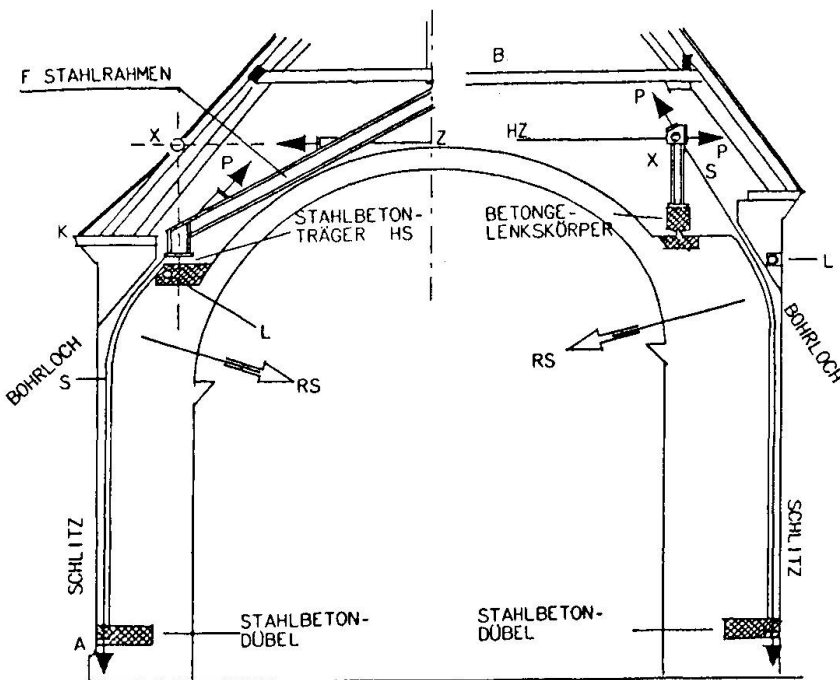
Die Fig. 6 zeigt drei Beispiele, wie man die gleiche Wirkung durch Konstruktionen erreichen kann, die im Kirchenschiff vom Benutzer der Kirche nicht gesehen werden können. Der Druck gegen den Horizontalschub des Bogens wird durch die Reaktionskräfte R des gekrümmten Abschnittes von Spannkabeln S erreicht.

Die Endverankerung dieser Spannglieder befindet sich möglichst tief unten am Punkt A. Von dort aus läuft das Spannkabel in einem lotrechten Schlitz in der Wand und in einem geneigten Abschnitt in einem Bohrloch zur Stützenkonstruktion. Punkte P in Fig. 6 bezeichnen Stellen, wo die Spannglieder S vorgespannt werden. Wenn es die räumlichen Verhältnisse erlauben, wurde die in Fig. 6, rechte Hälfte, dargestellte als einfachste Lösung ausgeführt. Das Vorspannglied HZ stellt ein "hochliegendes Zugband" dar. Um jede horizontale Reaktionskraft auf die Lager der Stützen für P - dargestellt auf der rechten

Als Grundwert für die Ablenkkraft RS in Fig. 6 wurde angenommen, daß sie mit den Horizontalschüben HG und HD möglichst gleichförmige Bodenpressung unter den Längswänden ergeben, wobei die Höhenlage von RS ein festzulegender Parameter ist. Spannkraftverluste durch Kriechen und Wärmedehnungsunterschiede zwischen Spannglied und Mauerwerk sollen zugeschlagen werden, wobei über eine obere Grenze an Vorspannkraft, die wieder Risse oder zu große Druckspannungen erzeugt, nicht hinausgegangen werden darf.

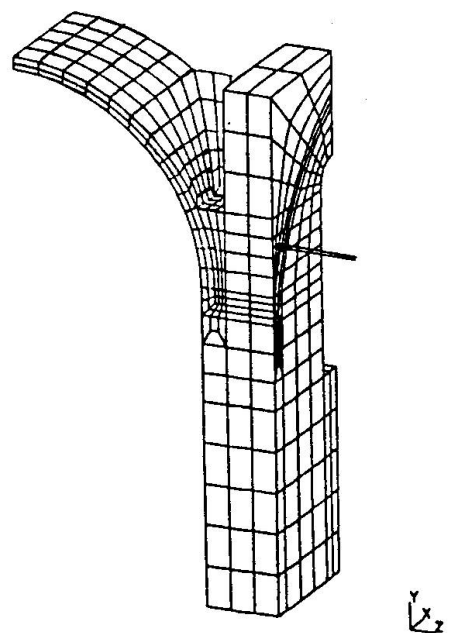
Fig. 7: FEM-Netz zur 3D-Berechnung

Es treten dann nur unwesentliche Zugspannungen an anderen Stellen auf, die für eine weitere Optimierung den Aufwand nicht lohnen. Die FEM-Untersuchungen wurden sowohl als ebenes Problem ohne Stichkappen und als 3D-Problem mit Stichkappen und Fensteröffnungen, Fig. 7, am Institut für Festigkeitslehre und Flächentragwerke der Universität Innsbruck im Kapitel, das von Dr. Stark behandelt wurde, durchgeführt [6].

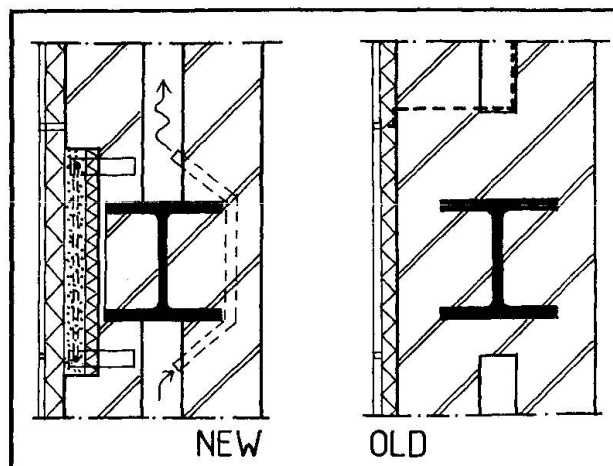
**Fig. 4.** The steel frame of the Gooiland hotel is placed in a brick cavity wall, a solution that caused severe damage. Today the steel is protected against extreme temperature changes

The steelframe is partly placed in a brickwork cavity wall: a peculiar mixture of a 'modern' frame with a traditional construction, that again looks like it was given a functionalist' image by the tile covering. The cavity was meant only to provide thermal isolation and was therefore not ventilated. The tiles were necessary to keep the water out, since by lack of ventilation, water could not vaporize and leave. But when the facades collect heat in the summer, the steel shows a relatively greater extension as compared to the surroundings and cracked the tiled surface. Through these cracks, water entered after all. Since the lead strips on the beams, meant to lead water outside, were cut shorter than originally intended, water could reach the steel. The beams corroded, increasing their volume and pushing the outer wall away.
